GROUP  
**Emissions Recall  
Campaign**

MODEL  
**2017MY  
Sorento (UMa) 3.3L GDI**

NUMBER  
**SC136**

**TCU UPGRADE - LAMBDA 3.3GDI 6AT TCU  
ROM ID MISMATCH (SC136)**

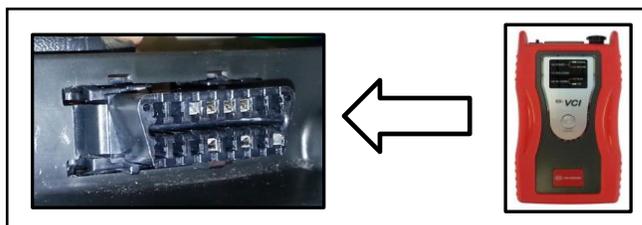
3. Connect the Main 16-pin DLC cable (GHDM – 241000) to the VCI.

4. Connect the Main 16-pin DLC cable (GHDM – 241000) to the OBD-II connector, located under the driver's side of the instrument panel.

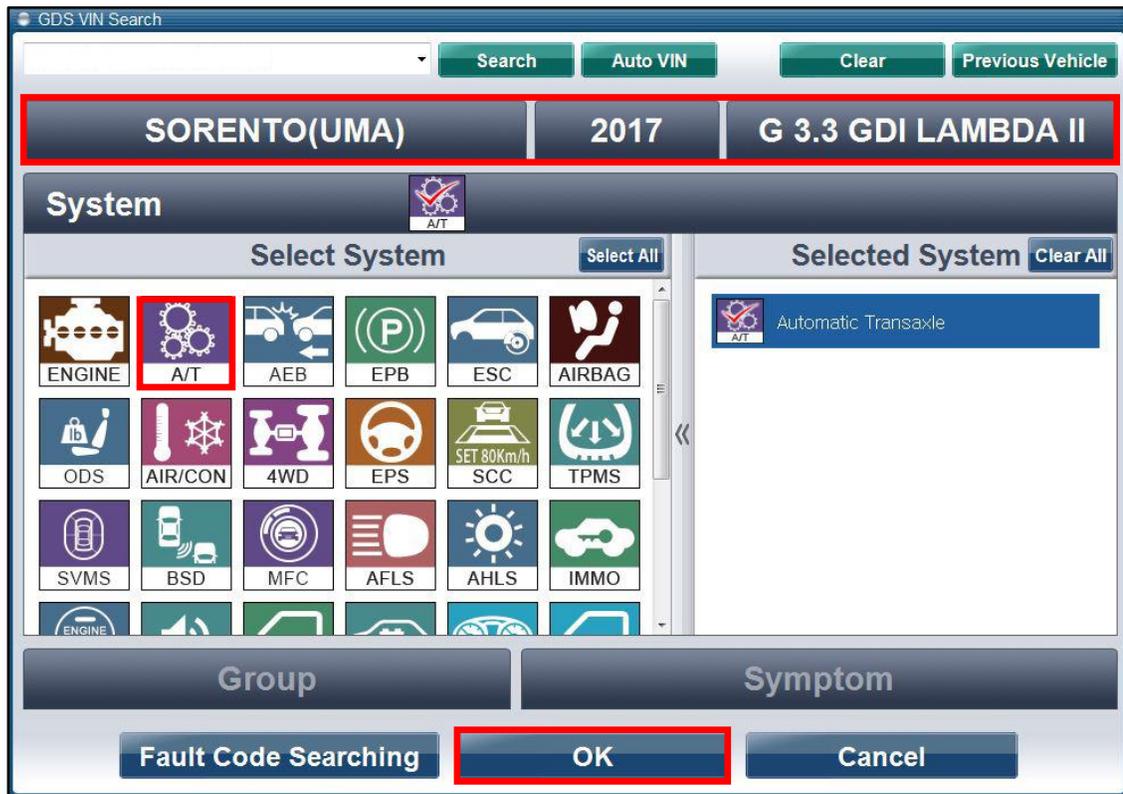
6. Select **AT** system and click **OK**.

7. Select **ECU Upgrade** from the bottom right-hand corner. Next select **Auto Mode**, and then **AT**. Perform the upgrade in accordance with normal GDS ECM upgrade procedures.

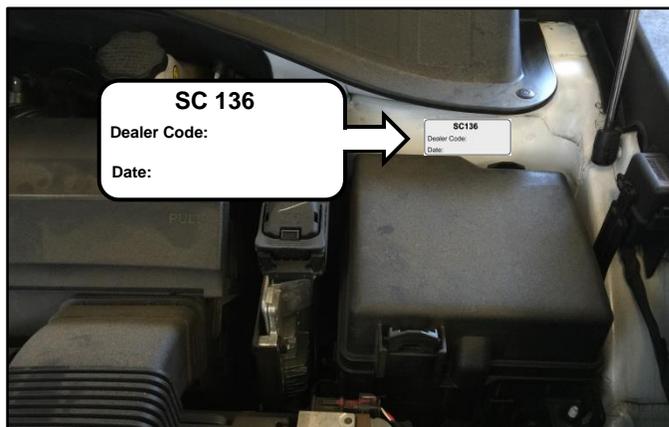
The dealer must fill in the Dealer Code and Date information fields on the Campaign Completion Label. Once complete, affix the campaign completion label under the hood of the vehicle, as shown below.

Apply the SC 136 Campaign Completion Label onto the body in the area next to shock tower, as shown. **NOTE: Be sure to clean the mounting surface to ensure proper label adhesion.**
