ITB16-027

VOLUNTARY EMISSIONS RECALL CAMPAIGN 2015-2016 QX60 ECM REPROGRAMMING

CAMPAIGN ID #: R1621
APPLIED VEHICLE: 2015-2016 QX60 (L50)
APPLIED ENGINES: VQ35DE only

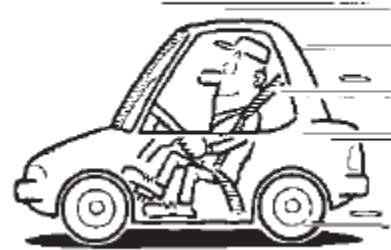
Figure 1

- Most instructions for reprogramming with CONSULT-III plus (C-III plus) are displayed on the CONSULT PC screen.
- Take the vehicle for a 10 minute drive in order to meet the following Idle Air Volume Learn (IAVL) conditions:
 - Engine coolant temperature: 70 -100°C (158 - 212°F)
 - Battery voltage: More than 12.9V (At idle)
 - Transmission: Warmed up
- After reprogramming is complete, you will be required to perform Idle Air Volume Learn. The above condition are required for Idle Air Volume Learn to complete.

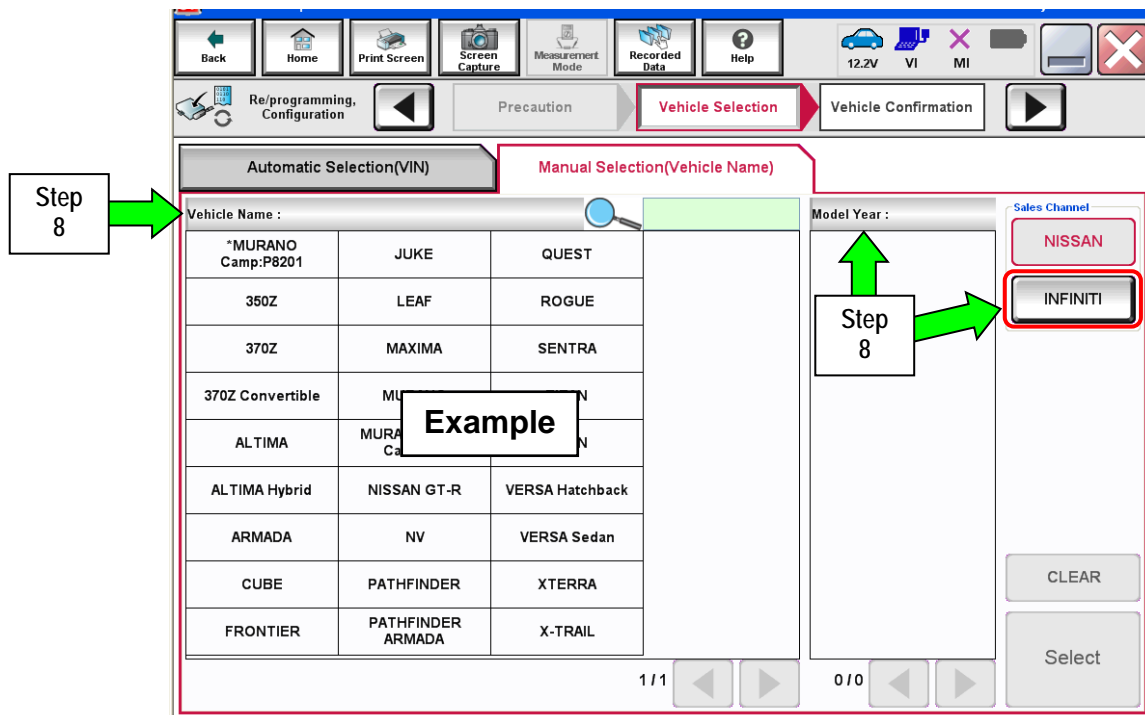
8. Select Infiniti, Vehicle Name, and then the correct Model Year.
 - If the screen in Figure 4 does not display, skip to step 9.

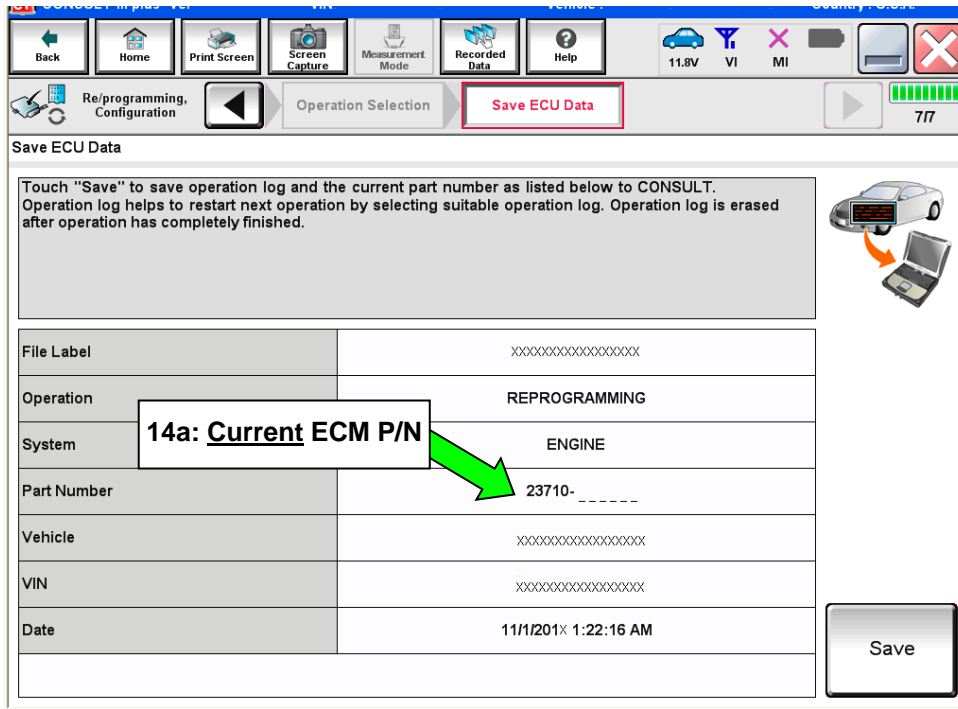
Figure 9

14. When you get to the screen shown in Figure 9, confirm this bulletin applies as follows.

- a. Find the ECM Part Number and write it on the repair order.

NOTE: This is the current ECM Part Number (P/N).

- b. Compare the P/N you wrote down to the numbers in the **Current ECM Part Number** column in **Table A** below.

- If there is a match, continue with the reprogramming procedure. Proceed to step 15.
- If there is not a match, reprogramming is not needed. Proceed to **CLAIMS INFORMATION** section for "Does Not Require Reprogram".

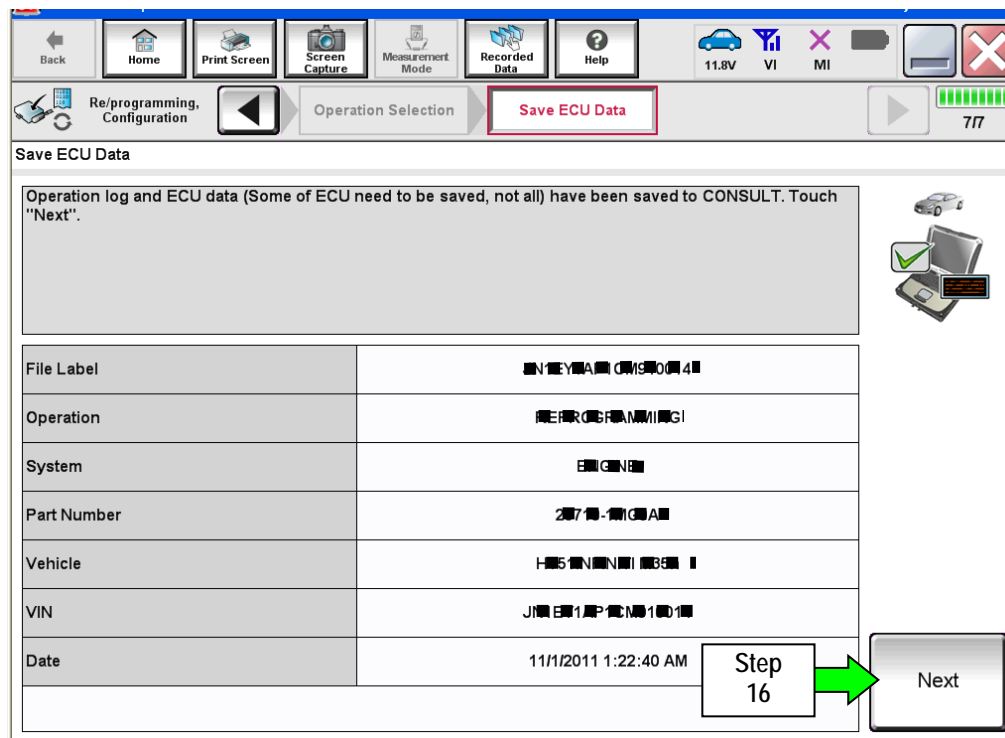
Figure 11

16. Select Next.

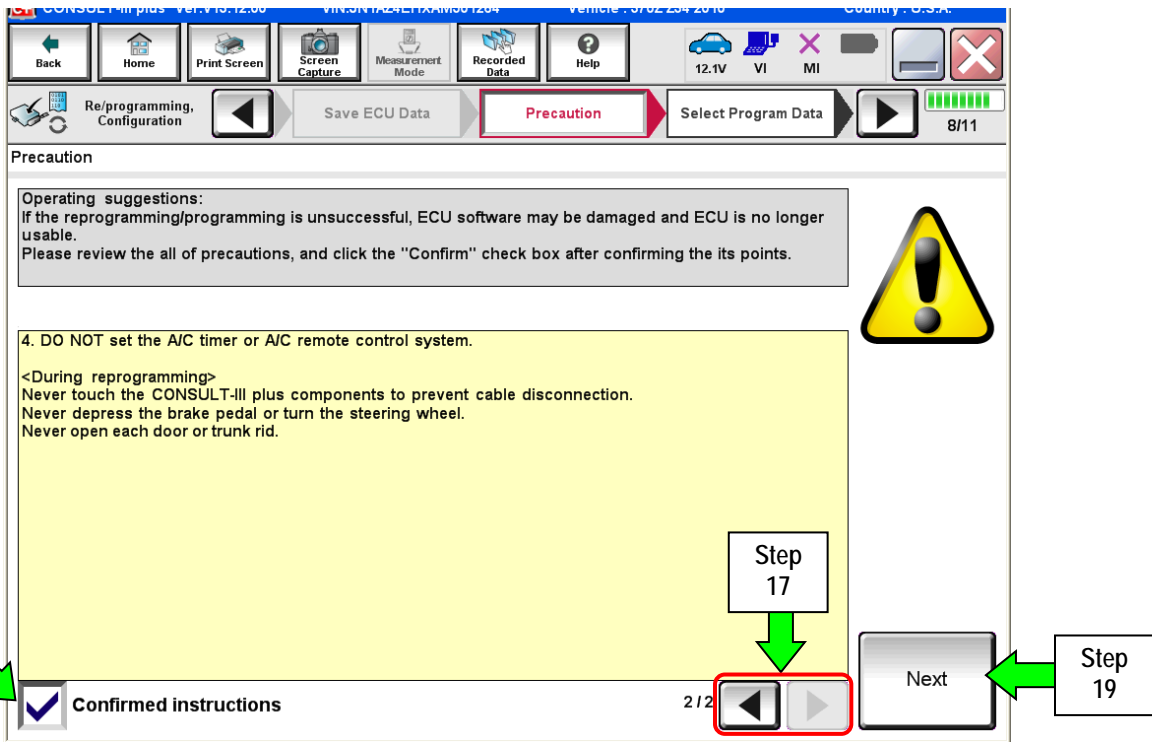
Figure 12

17. Use arrows (if needed) to view and read all precautions.
18. Check the box confirming the precautions have been read.
19. Select Next.

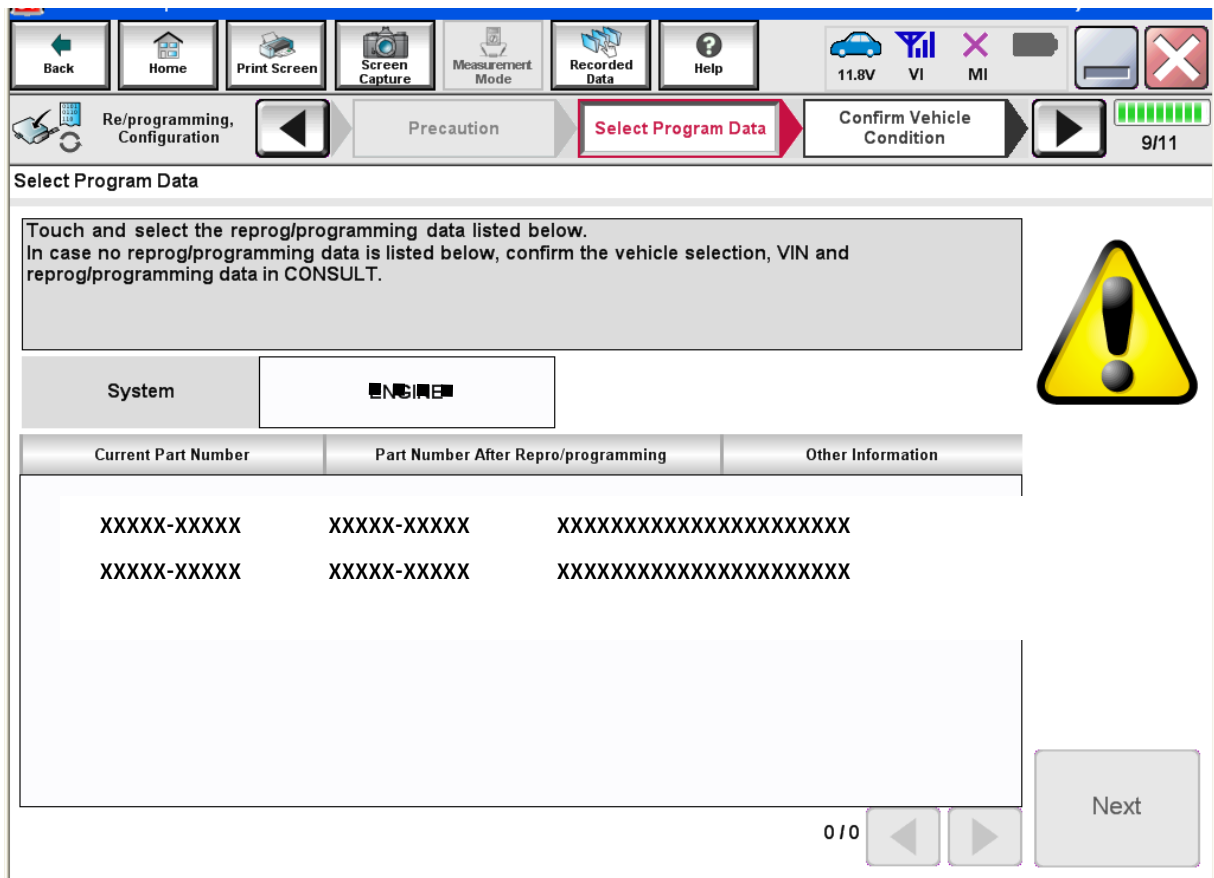
- In some cases, more than one new P/N for reprogramming is available.
 - In this case, the screen in Figure 14 displays.
 - Select and use the reprogramming option that **does not** have the message “Caution! Use ONLY with ITBXX-XXX”.
- If you get this screen and it is blank (no reprogramming listed), it means there is no reprogramming available for this vehicle. Close C-III plus and refer back to ASIST for further diagnosis.

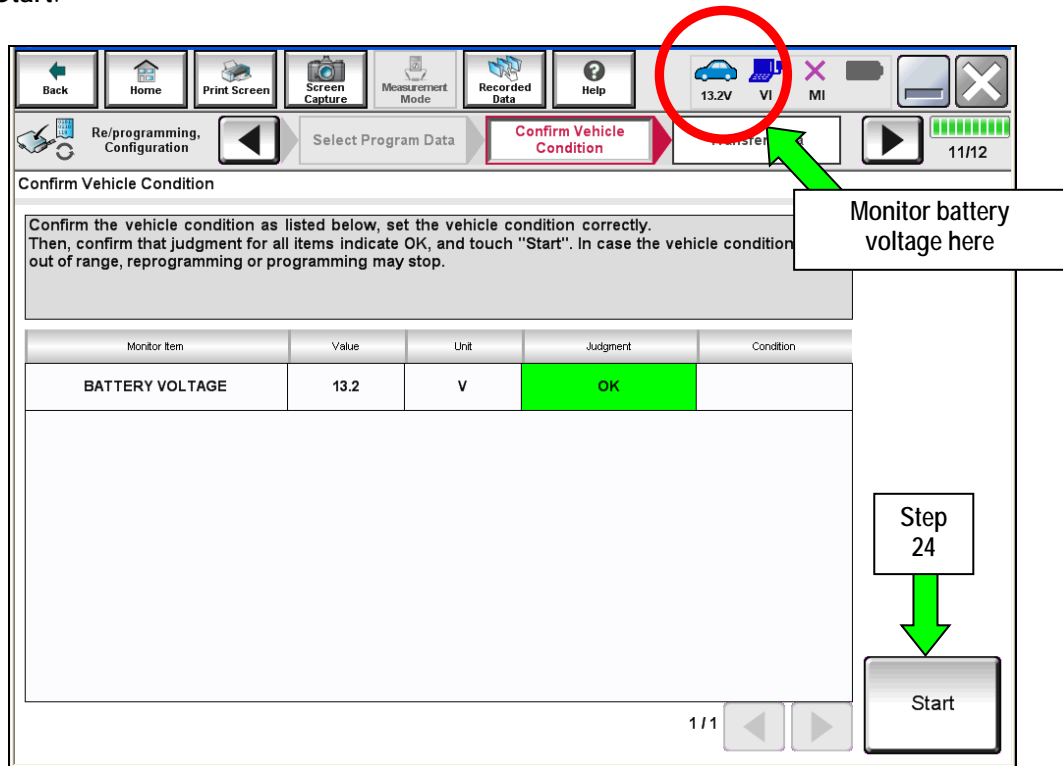
Figure 16

NOTE: In the next step, the reprogramming process will begin when **Start** is selected.

24. Select **Start**.

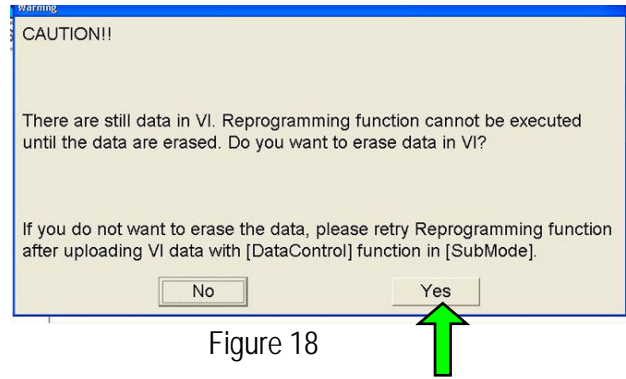
NOTE: If the message shown in Figure 18 appears, there is data stored in the plus VI. Select "Yes" to proceed with reprogramming.

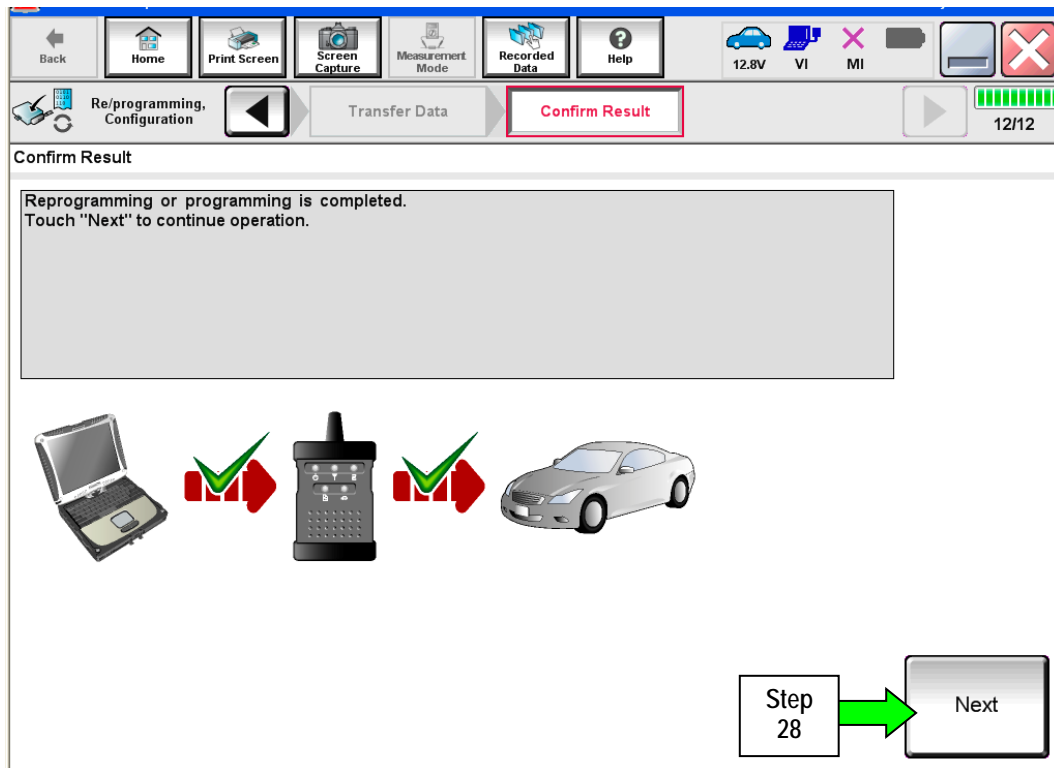
26. When the screen in Figure 19 displays, reprogramming is complete.

NOTE: If the screen in Figure 19 does not display (indicating that reprogramming did not complete), refer to the information on page 15.

28. Select **Next**.

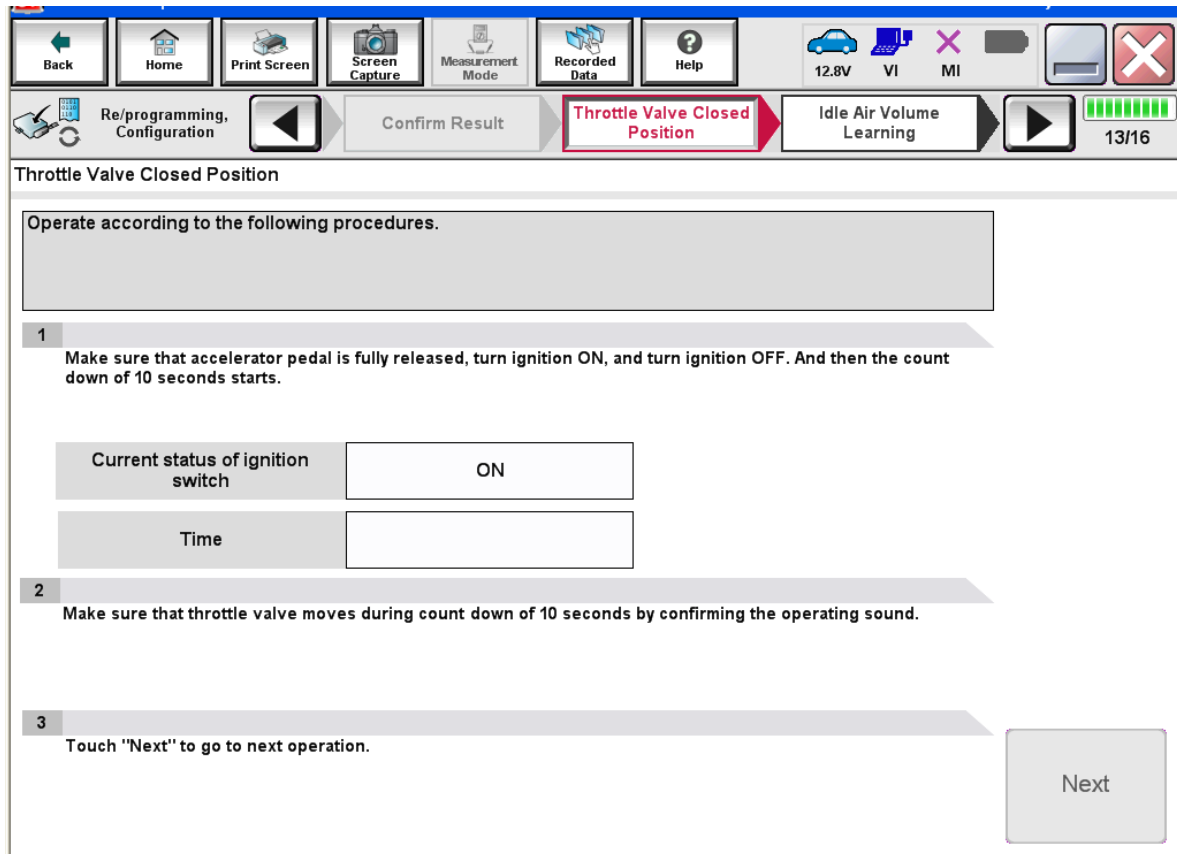
Figure 22

29. Perform **Throttle Valve Closed Position** procedure.

- Follow the on-screen instructions (1, 2, and 3) to complete the procedure.

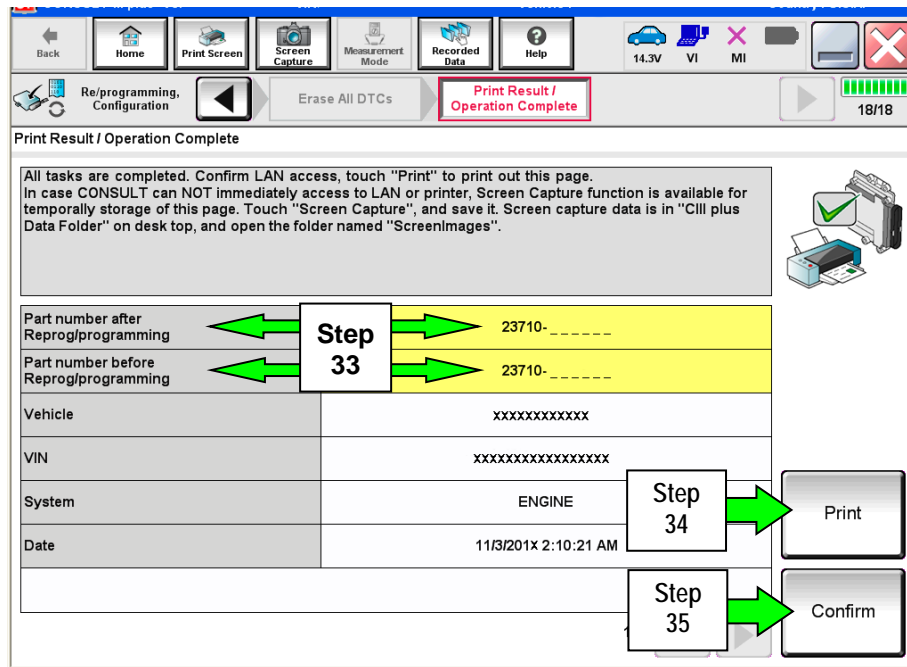
Figure 28

33. Verify the before and after part numbers are different.
34. Print a copy of this screen (Figure 28) and attach it to the repair order for warranty documentation.
35. Select **Confirm**.
