SERVICE BULLETIN

2016 TITAN XD; BUMP FELT ON LIGHT THROTTLE APPLICATION AT SPEEDS OVER 40 MPH

APPLIED VEHICLE: 2016 Titan XD (A61)
APPLIED ENGINE: Gas V8 (VK56VD)
APPLIED TRANSMISSION: 7-Speed A/T (RE7R01B)

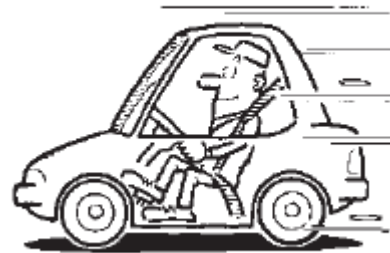
Figure A

- Most instructions for reprogramming with CONSULT-III plus (C-III plus) are displayed on the CONSULT PC screen.
- If you are not familiar with the reprogramming procedure, [click here](#). This will link you to the "CONSULT- III plus (C-III plus) Reprogramming" general procedure.
- Take the vehicle for a 10 minute drive in order to meet the following Idle Air Volume Learn (IAVL) conditions:
 - Engine coolant temperature: 70 - 105°C (158 - 221°F)
 - Battery voltage: More than 12.9V (at idle)
 - Transmission: Warmed up

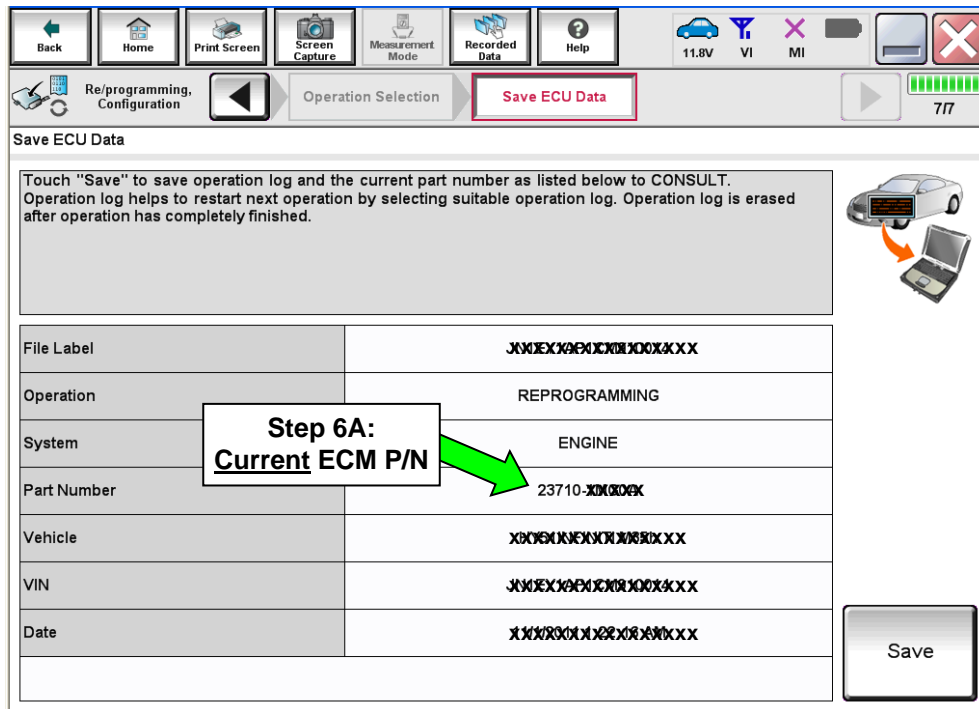
6. When you get to the screen shown in Figure 2, confirm this bulletin applies as follows.

A. Find the ECM **Part Number** and write it on the repair order.

NOTE: This is the current ECM Part Number (P/N).

5. Follow the on-screen instructions and navigate C-III plus to the screen shown in Figure 2 on the next page.
