SERVICE BULLETIN

Classification: AT16-008	Reference: NTB16-085	Date: August 25, 2016
-----------------------------	-------------------------	--------------------------

ENHANCED DIAGNOSTIC LOGIC FOR CVT

APPLIED VEHICLES: 2015-2016 Pathfinder (R52) **with V6 engine only**
2015-2016 Altima Sedan (L33) **with V6 engine only**
2015-2016 Quest (E52)
2015-2016 Murano (Z52)
2016-2017 Maxima (A36)

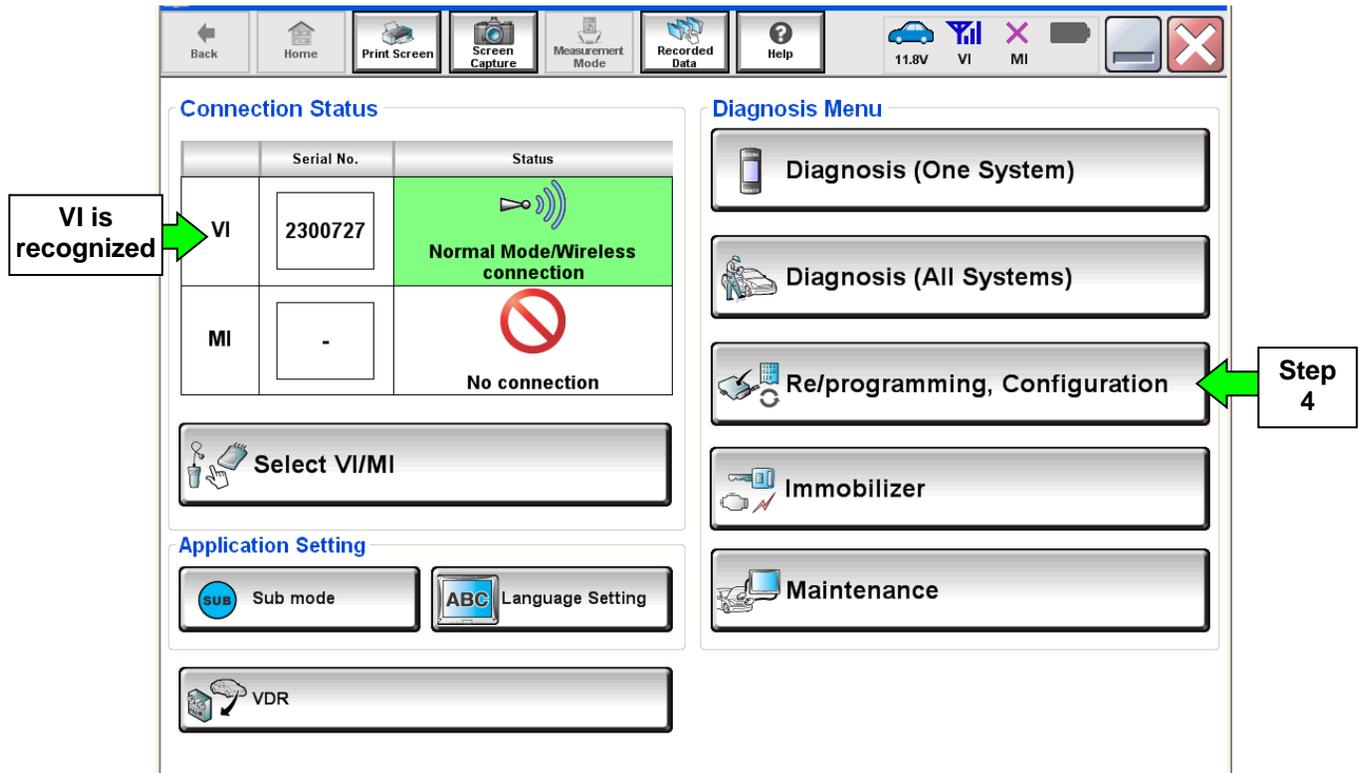
Figure 1

1. Connect the CONSULT PC to the vehicle to begin the reprogramming procedure.
2. Start C-III plus.
3. Wait for the plus VI to be recognized.
 - The serial number will display when the plus VI is recognized.
4. Select **Re/programming, Configuration**.

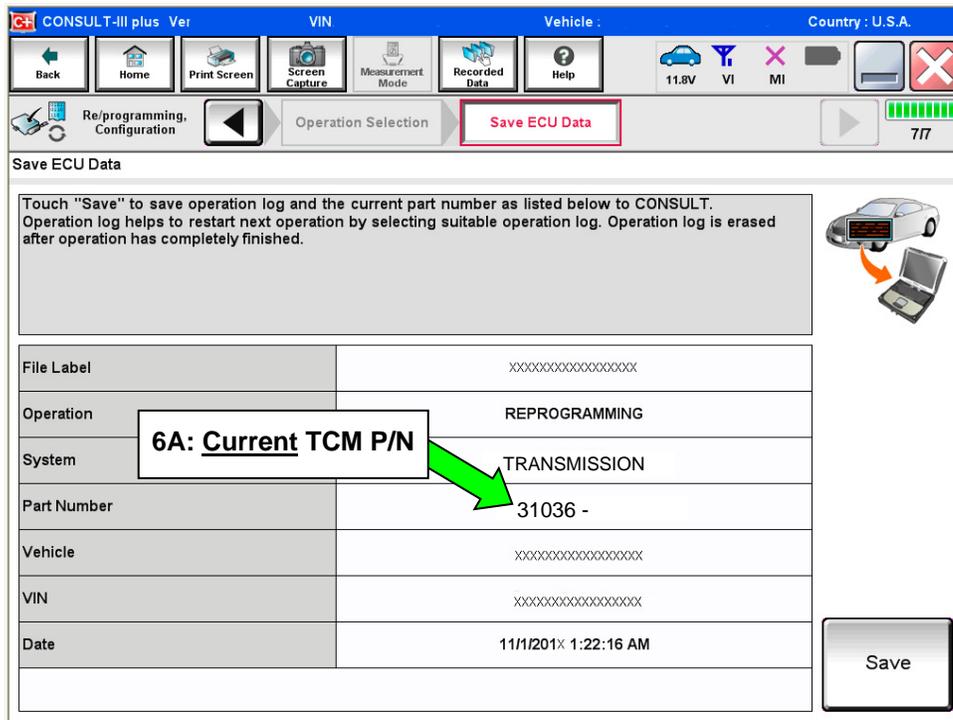
6. When you get to the screen shown in Figure 2, confirm this bulletin applies as follows.

A. Find the TCM **Part Number** and write it on the repair order.

NOTE: This is the current TCM Part Number (P/N).

5. Follow the on-screen instructions and navigate the C-III plus to the screen shown in Figure 2 on the next page.

B. Compare the P/N you wrote down to the numbers in the **Current TCM Part Number** column in **Table A** on the next page.

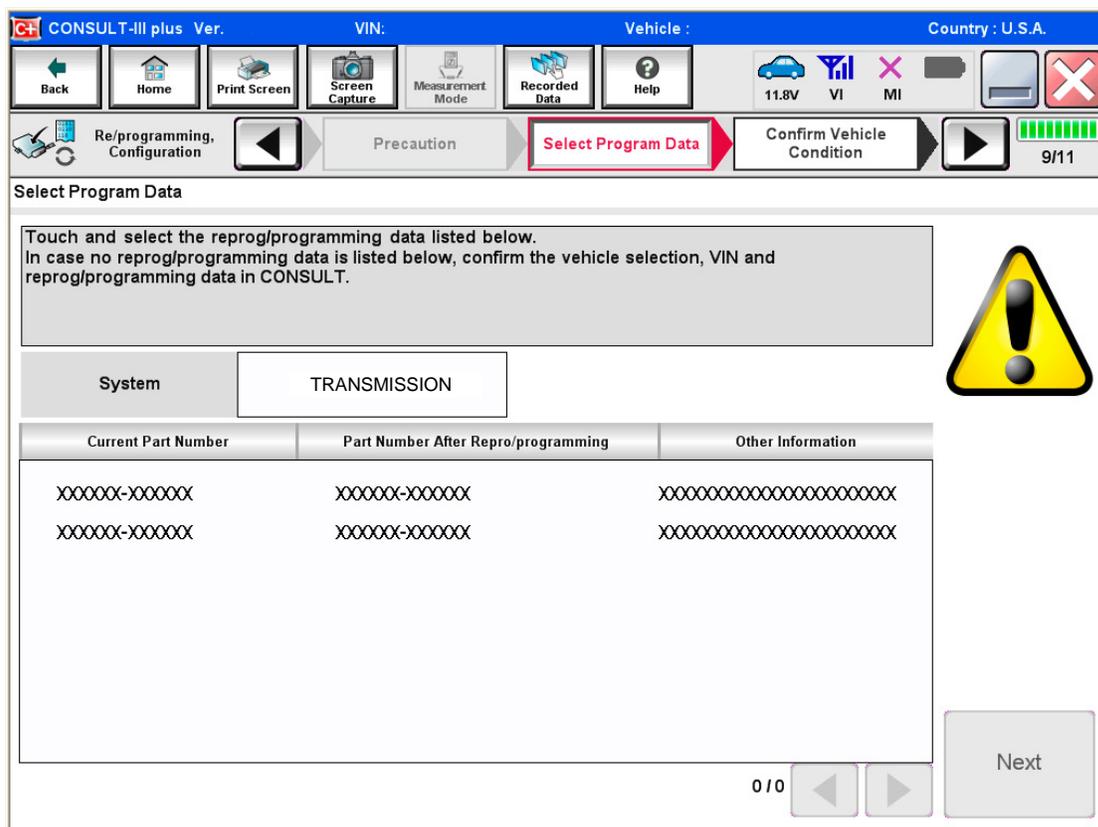
- In some cases, more than one new P/N for reprogramming is available.
 - If more than one new P/N is available, the screen in Figure 3 displays.
 - Select and use the reprogramming option that **does not** have the message “Caution! Use ONLY with NTBXX-XXX”.
- If you get this screen and it is blank (no reprogramming listed), it means there is no reprogramming available for this vehicle. This bulletin does not apply.

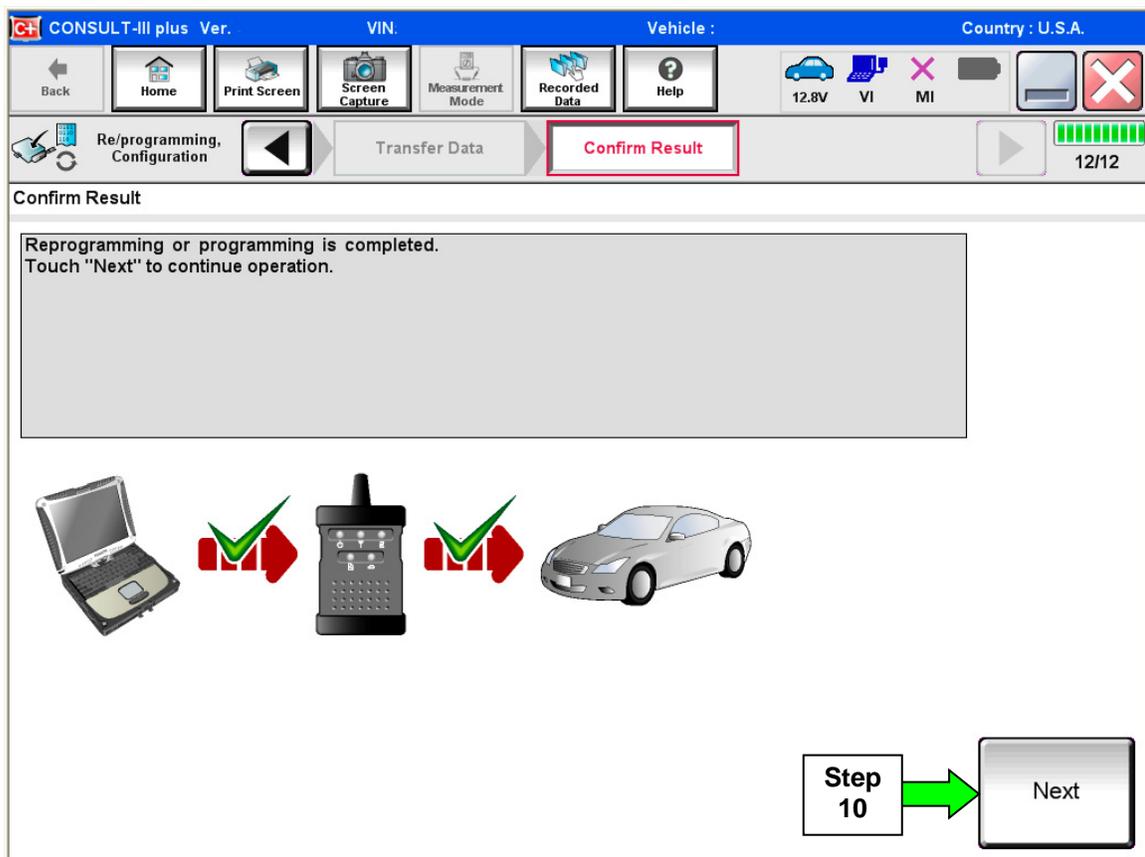
8. When the screen in Figure 4 displays, reprogramming is complete.

NOTE: If the screen in Figure 4 does not display (indicating that reprogramming did not complete), refer to the information on the next page.

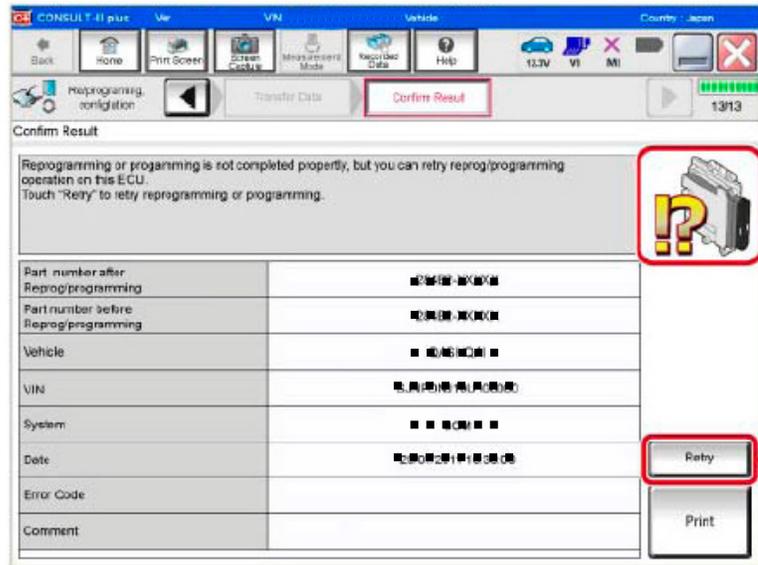
Figure 5

If reprogramming does not complete and the “!?” icon displays as shown in Figure 5:

- Check battery voltage (12.0–15.5 V).
- Ignition is ON, engine OFF.
- External Bluetooth® devices are OFF.
- All electrical loads are OFF.
- **Select retry and follow the on screen instructions.**
- “Retry” may not go through on first attempt and can be selected more than once.

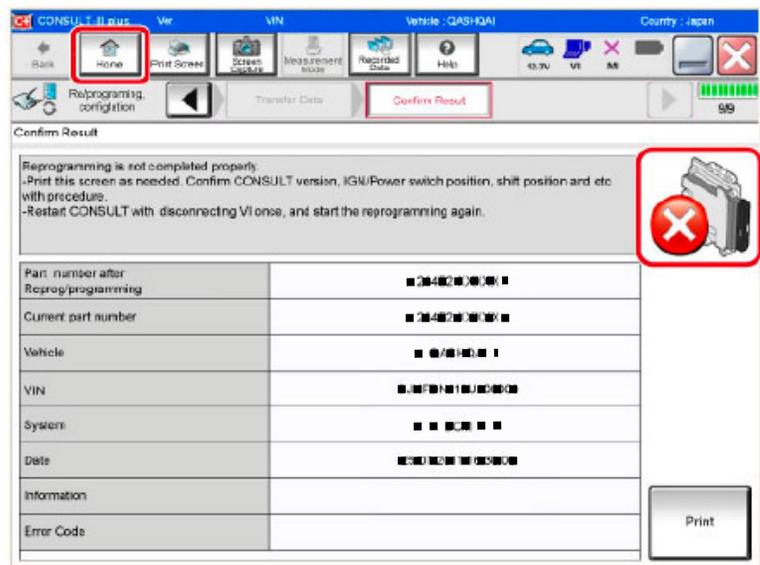
Figure 6

If reprogramming does not complete and the “X” icon displays as shown in Figure 6:

- Check battery voltage (12.0 – 15.5 V).
- CONSULT A/C adapter is plugged in.
- Ignition is ON, engine OFF.
- Transmission is in Park.
- All C-III plus / plus VI cables are securely connected.
- All C-III plus updates are installed.
- **Select Home, and restart the reprogram procedure from the beginning.**

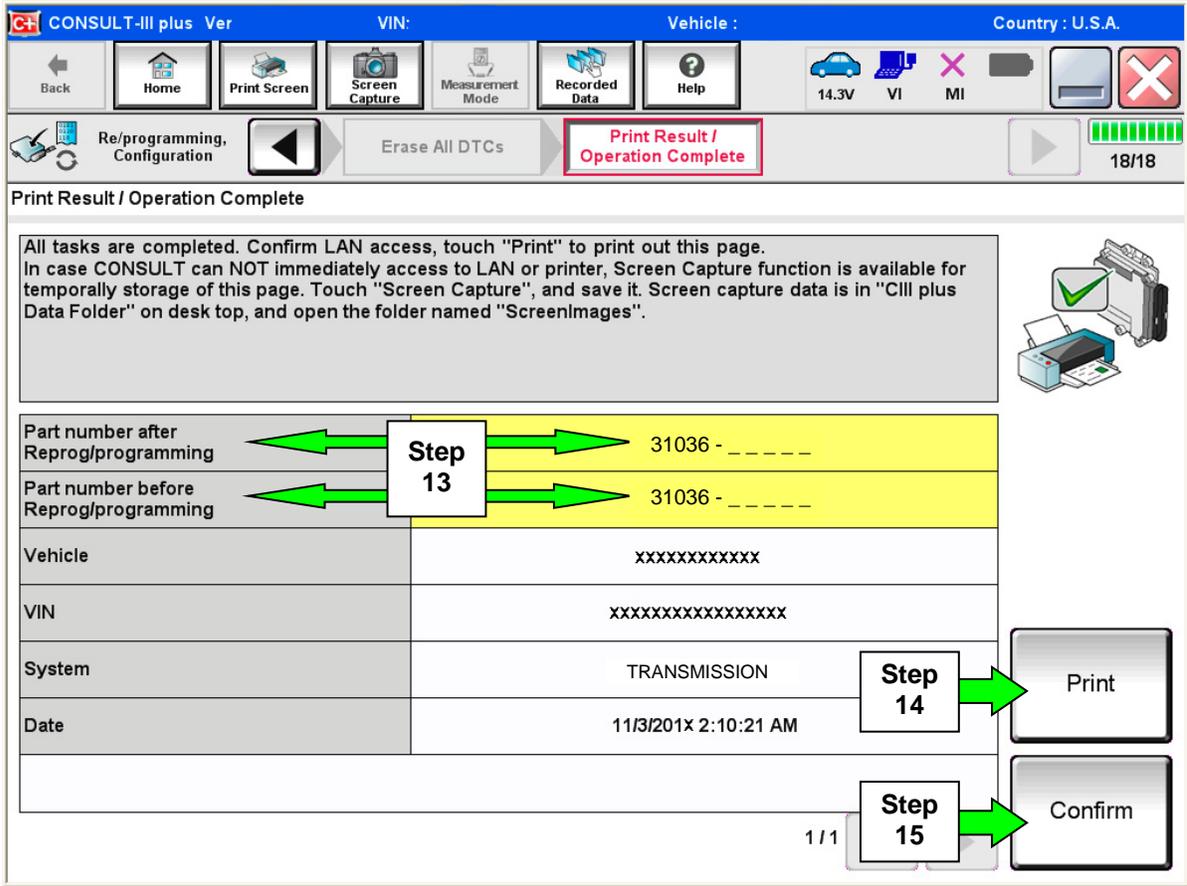
- 11. Follow the on-screen instructions to **Erase All DTCs**.
- 12. When the entire reprogramming process is complete, the screen in Figure 7 will display.
- 13. Verify the before and after part numbers are different.
- 14. Print a copy of this screen (Figure 7) and attach it to the repair order for warranty documentation.
- 15. Select **Confirm**.

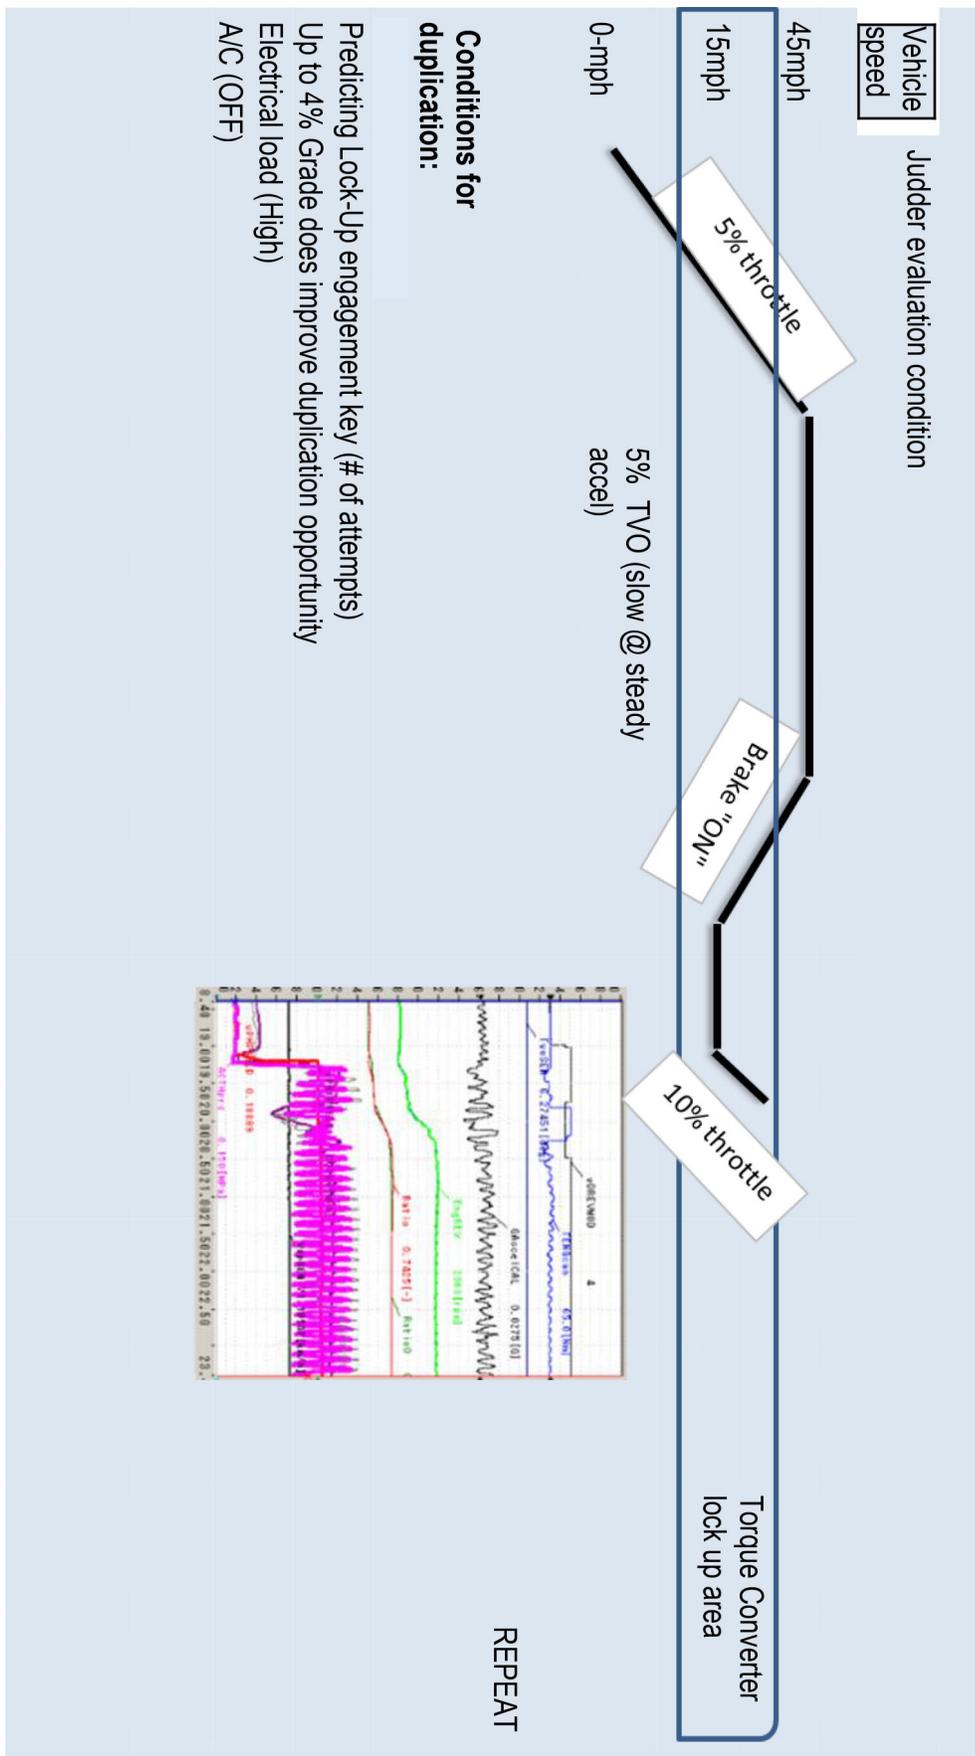
- This new diagnostic logic will monitor conditions in the CVT while the customer is operating their vehicle in their usual daily drive patterns.
- Figure 8, on the next page, illustrate conditions under which judder can be reproduced.
- Specific drive conditions that can be used to test for judder (shake, shudder, single or multiple bumps or vibration) are:
 1. Slowly accelerate from a stop (zero mph), applying only slight accelerator pedal (**0% - 10% throttle opening**) until 40 mph is reached.
 - During acceleration, torque converter engagement (full lock up) can occur between 20-35 mph.
 2. Prior to torque converter lock up, slowly modulate accelerator pedal:
 - A. Decrease accelerator pedal pressure slowly, approaching a closed throttle position.
 - B. Smoothly and slowly reapply accelerator pedal pressure back to approximately 10% throttle opening.

- Slight grade (climbing hill) may aid in performing the above drive conditions.
- DTC detection logic will require three events before storing a DTC.

Figure 8 below illustrates conditions under which judder can be reproduced.
