SERVICE BULLETIN

Classification: AT16-004a	Reference: NTB16-068a	Date: September 8, 2016
------------------------------	--------------------------	----------------------------

2016 TITAN XD; ENGINE RPM FLARE DURING UP SHIFT AND/OR DOWN SHIFT BUMP

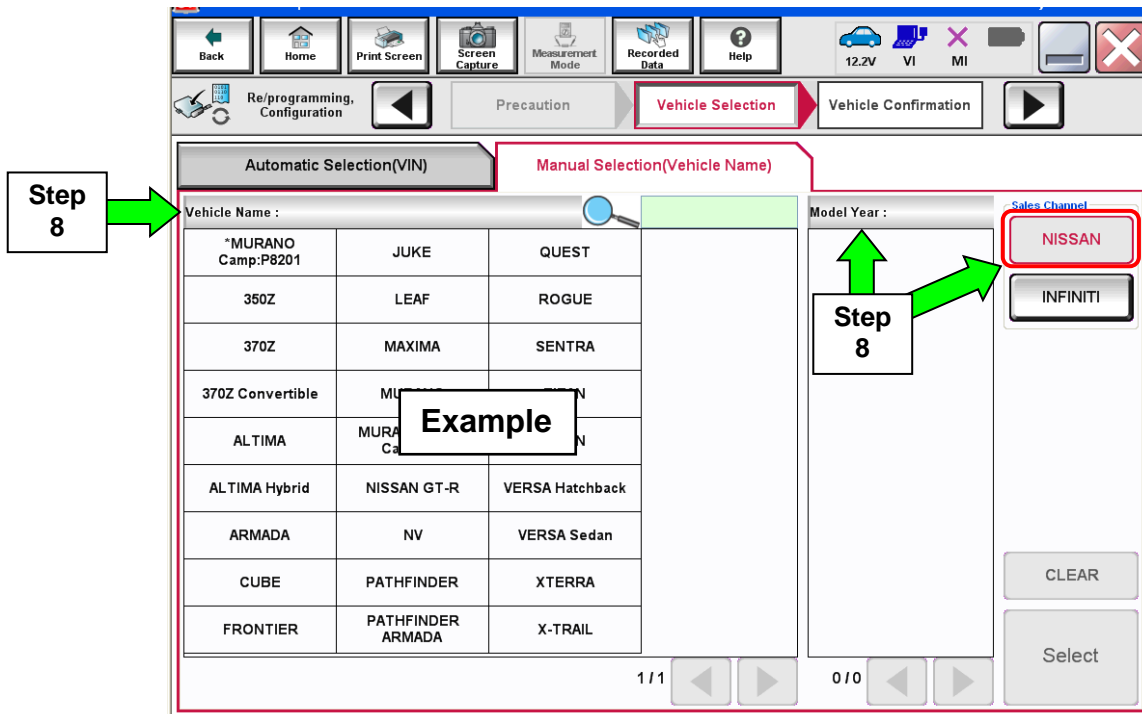
8. Select **Nissan**, **Vehicle Name**, and then the correct **Model Year**.
 - If the screen in Figure 3A does not display, skip to step 9.

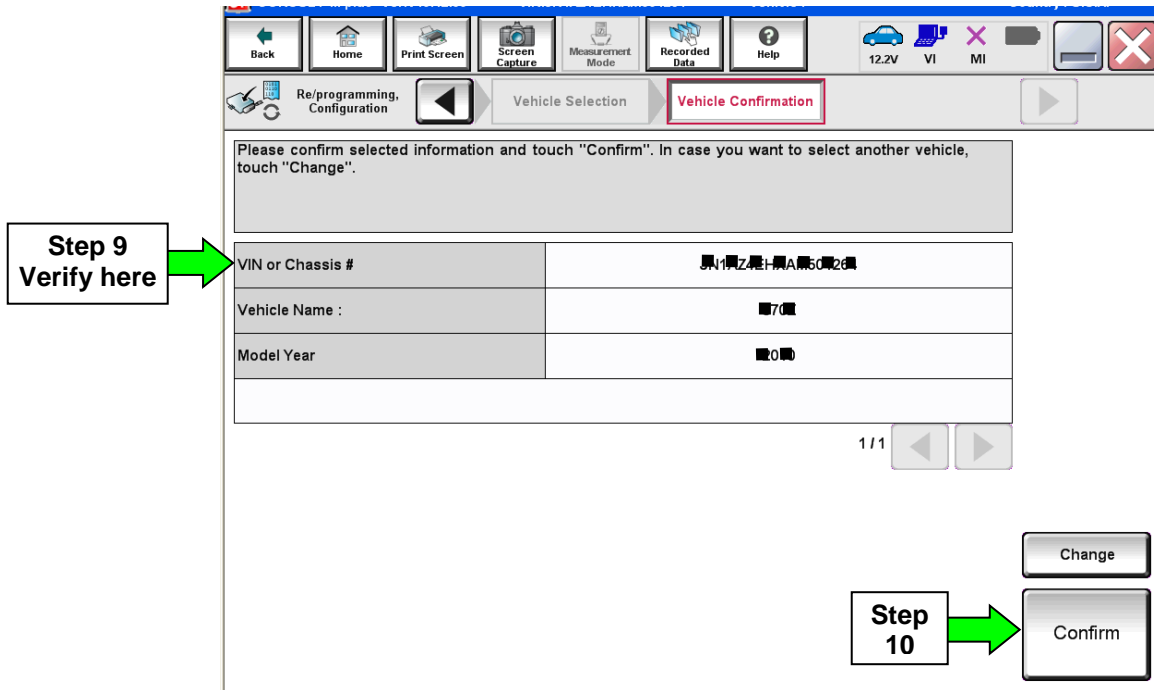
Figure 4A

9. Make sure **VIN or Chassis #** matches the vehicle VIN.

10. If the correct VIN is displayed, select **Confirm**.

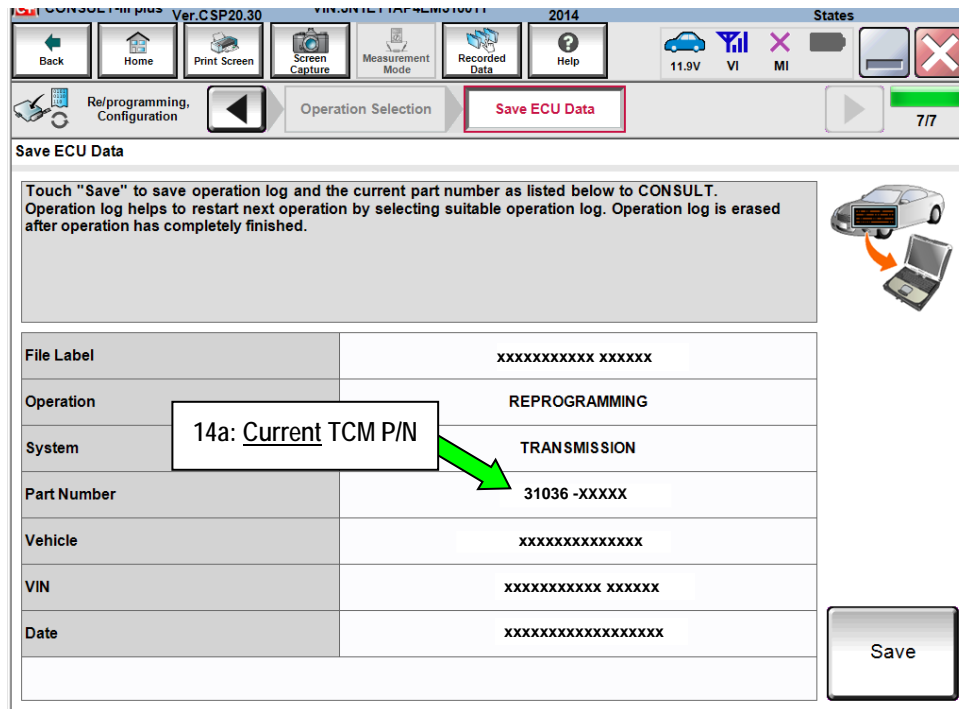
Figure 8A

14. When you get to the screen shown in Figure 8A, confirm this bulletin applies as follows.

- a. Find the TCM **Part Number** and write it on the repair order.

NOTE: This is the current TCM Part Number (P/N).

- b. Compare the P/N you wrote down to the numbers in the **Current TCM Part Number** column in **Table A** below.
 - If there is a match, continue with the reprogramming procedure.
 - If there is not a match, this bulletin does not apply. Refer to ASIST for further diagnosis.

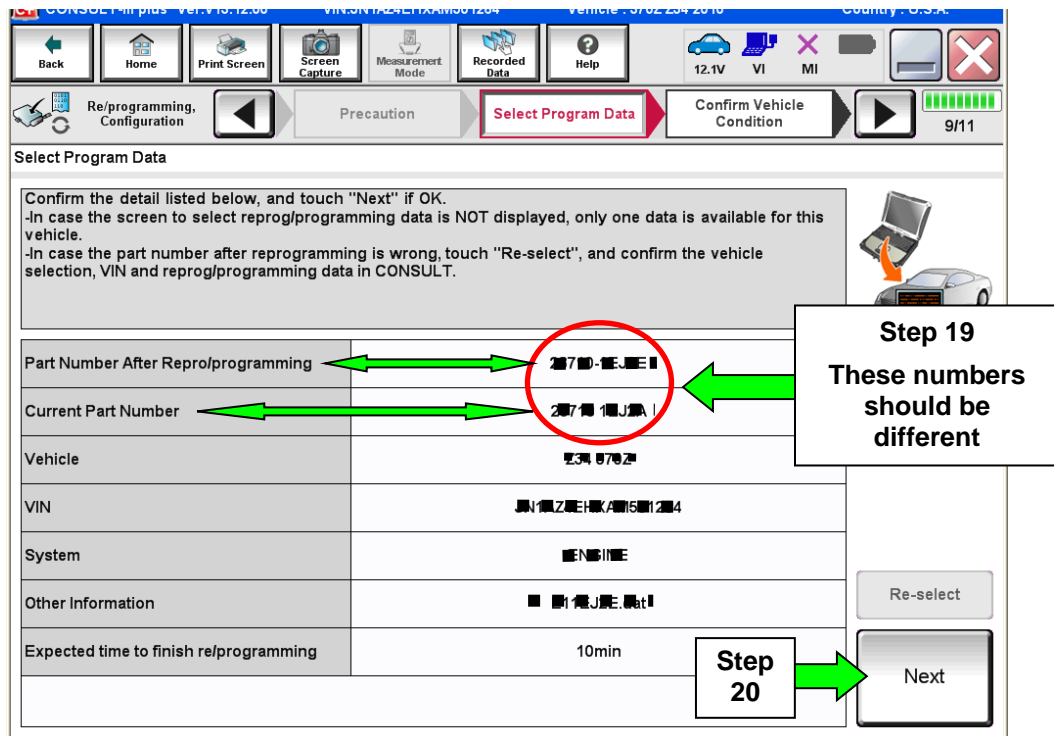
Figure 11A

19. Read the **Current Part Number** and **Part Number After Reprogramming**. They should be different.

20. Select **Next**.

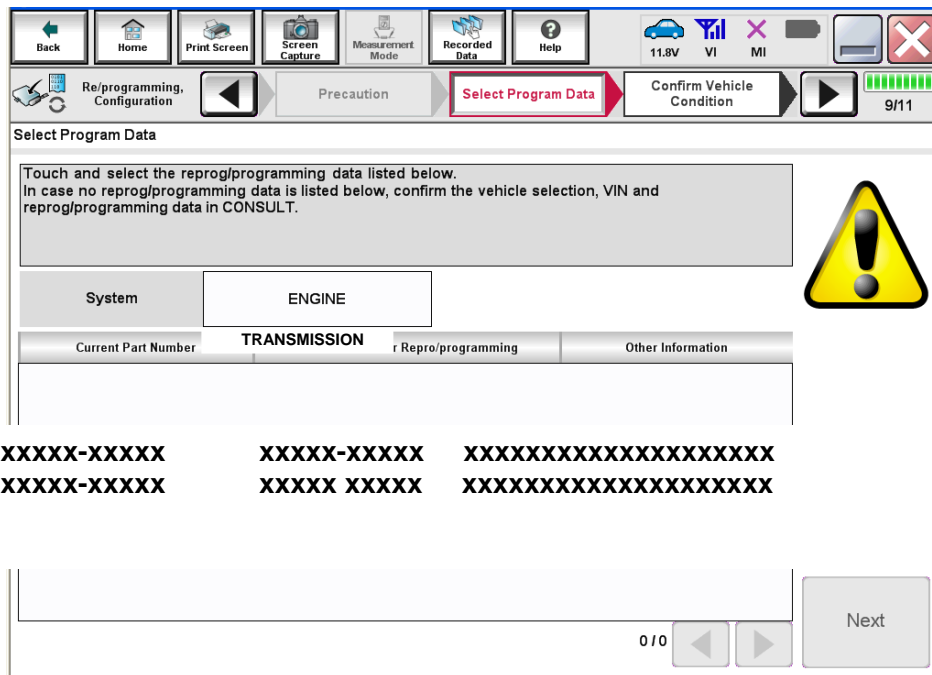
- In some cases, more than one new P/N for reprogramming is available.
 - If more than one new P/N is available, the screen in Figure 12A displays.
 - Select and use the reprogramming option that **does not** have the message “Caution! Use ONLY with NTBXX-XXX”.
- If you get this screen and it is blank (no reprogramming listed), it means there is no reprogramming available for this vehicle. Close C-III plus and refer back to ASIST for further diagnosis.

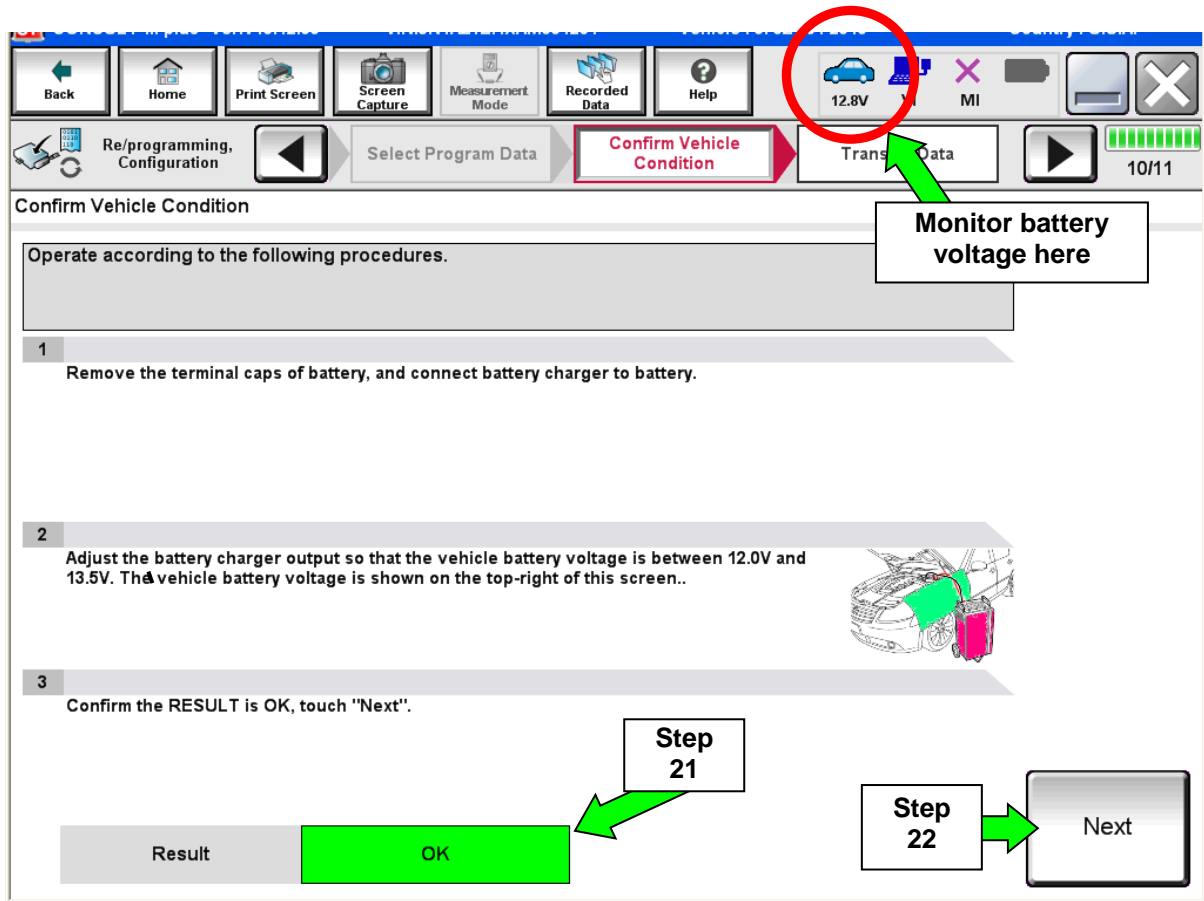
Figure 13A

21. Make sure **OK** is highlighted **green** (battery voltage must be between **12.0 and 15.5 Volts**).

22. Select **Next**.

IMPORTANT: Battery voltage must stay between **12.0 and 15.5 Volts** during reprogramming or ECM reprogramming may be interrupted and ECM may be damaged.

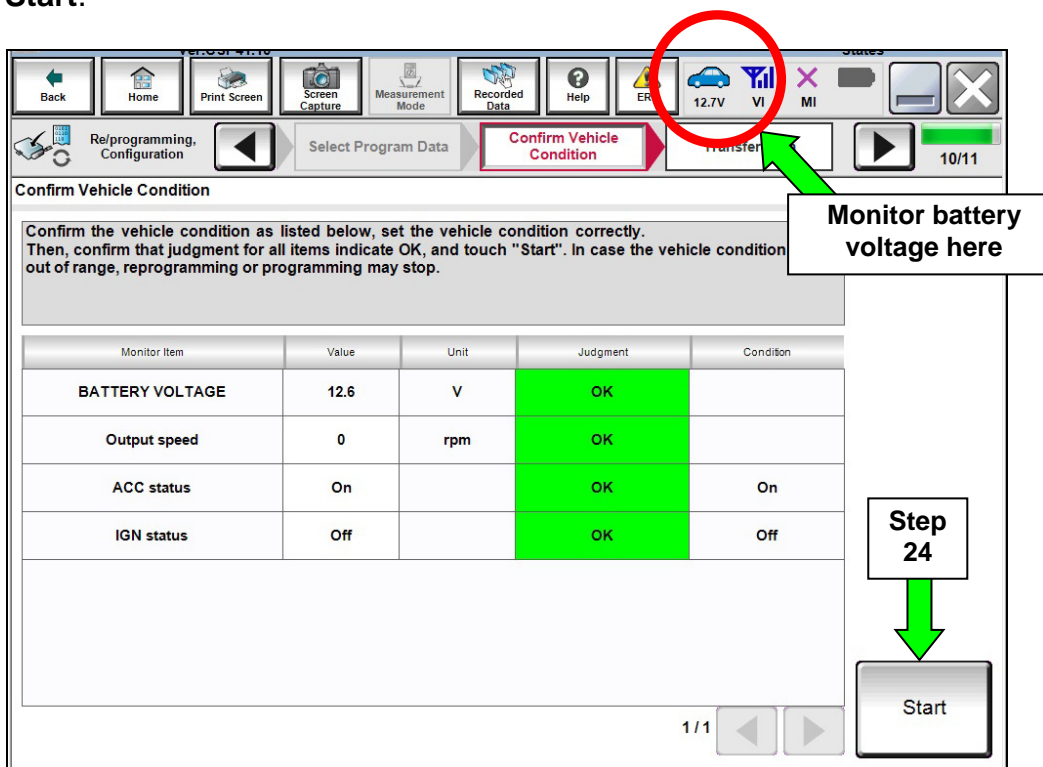
Figure 15A

NOTE: In the next step, the reprogramming process will begin when **Start** is selected.

24. Select **Start**.

- Make sure the IGN status judgement changes to **OK**. See Figure 15A.

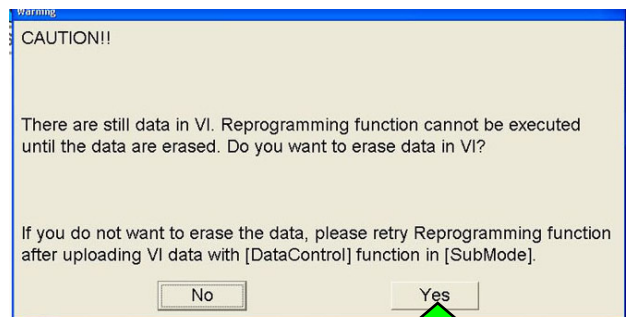
NOTE: If the message shown in Figure 17A appears, there is data stored in the plus VI. Select "Yes" to proceed with reprogramming.

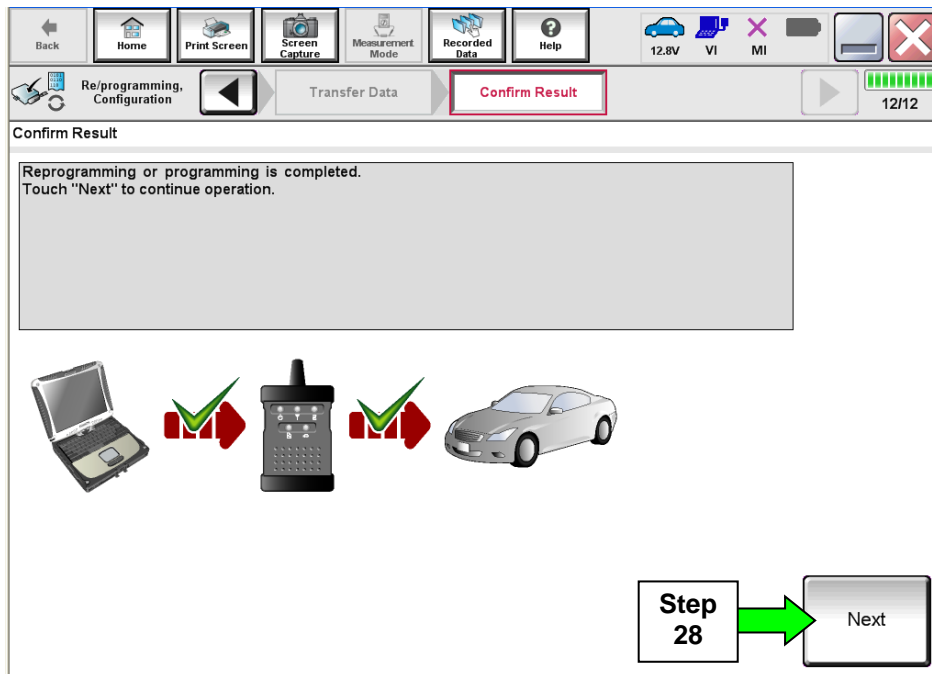
26. When the screen in Figure 18A displays, reprogramming is complete.

NOTE: If the screen in Figure 18A does not display (indicating that reprogramming did not complete), refer to ECM recovery on the next page.

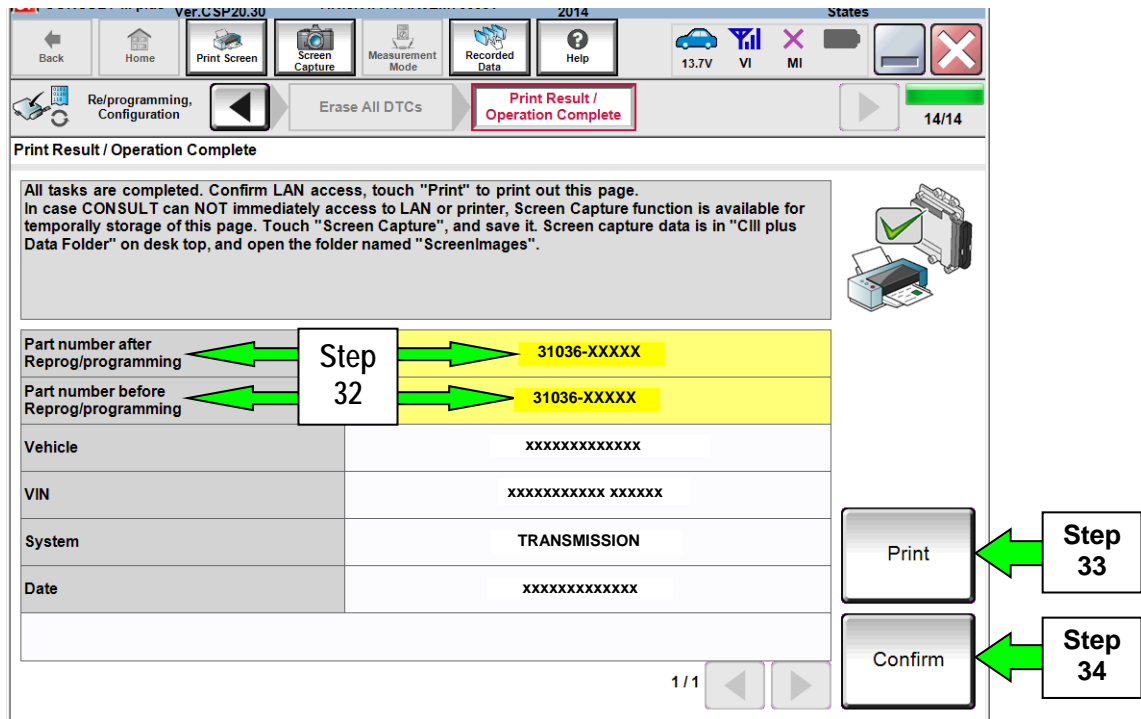
30. Follow the on-screen instructions to **Erase DTCs**.
31. When the entire reprogramming process is complete, the screen in Figure 22A will display.
32. Verify the before and after part numbers are different.
33. Print a copy of this screen (Figure 22A) and attach it to the repair order for warranty documentation.
34. Select **Confirm**.

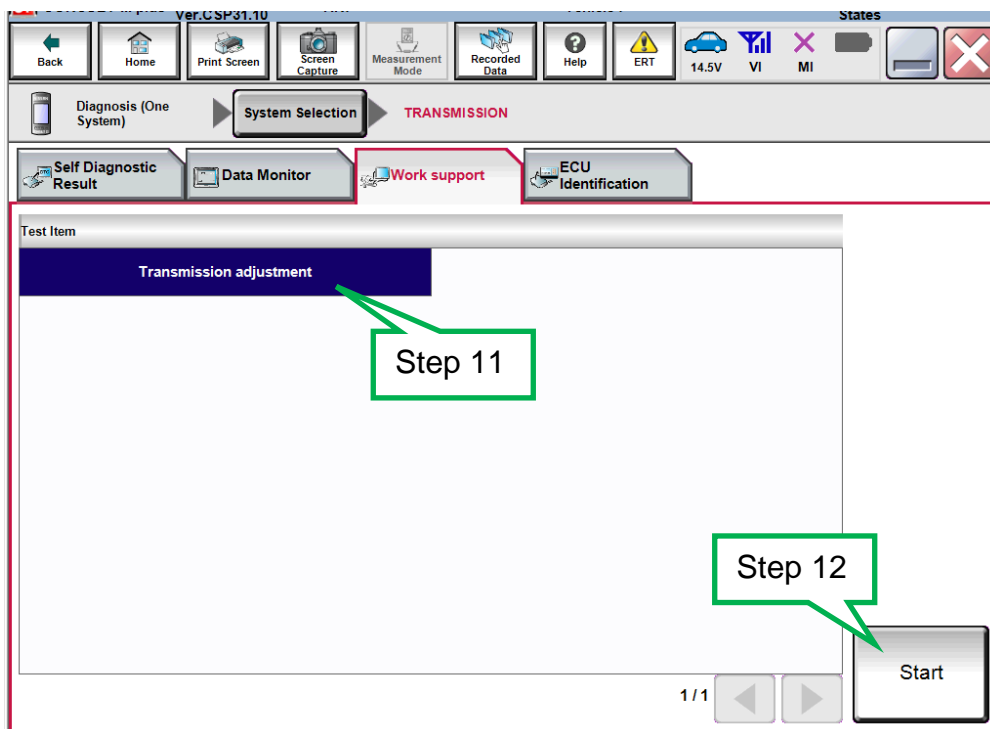
Figure 2B

10. Navigate C-III plus to **Transmission > Work support** (see Figure 2B).

11. Select **Transmission adjustment**.

12. Select **Start**.

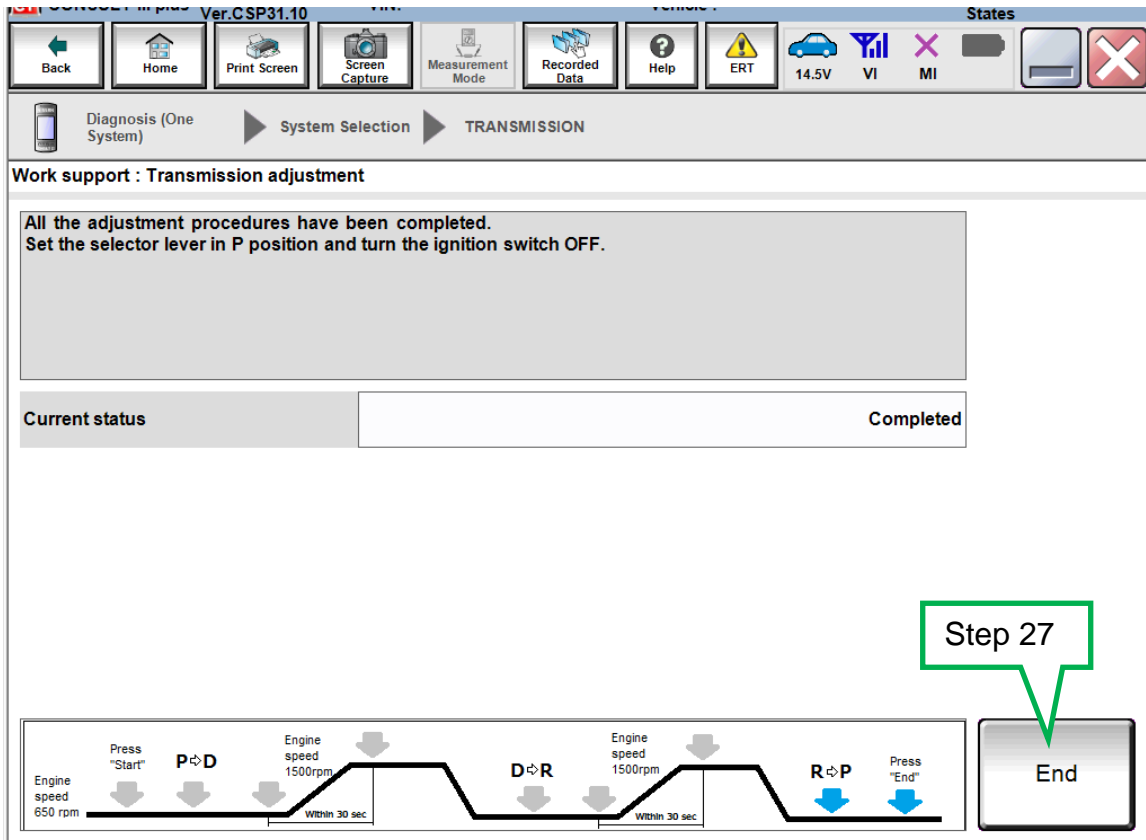
25. When the Transmission Adjustment has completed (see Figure 8B), shift the transmission to Park.

- When complete the screen in Figure 8B (next page) will display.
