Technical Service Bulletin

SUBJECT: TC-SST TRANSMISSION GEAR NOISE AFTER COLD ENGINE START (2009 – 2010 MODELS) – REVISED			No: TSB-16-22-002
			DATE: July, 2016
			MODEL: See below
CIRCULATE TO:	<input type="checkbox"/> GENERAL MANAGER	<input checked="" type="checkbox"/> PARTS MANAGER	<input checked="" type="checkbox"/> TECHNICIAN
<input checked="" type="checkbox"/> SERVICE ADVISOR	<input checked="" type="checkbox"/> SERVICE MANAGER	<input checked="" type="checkbox"/> WARRANTY PROCESSOR	<input type="checkbox"/> SALES MANAGER

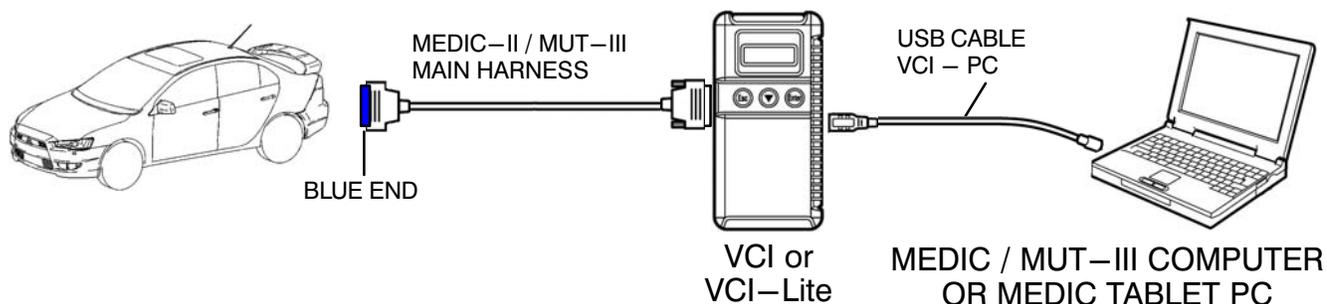
Connect the equipment as follows:

- Turn the computer on. If you're running on battery power and the charge indicator in the lower right hand corner of the screen does not show a full charge, it is recommended that either the PC battery be charged prior to beginning, or you should complete this procedure with the A/C power adaptor connected to the PC.
- Connect the USB cable to the VCI (or VCI-LITE).
- When the PC displays the MUT-III main screen, connect the USB cable to the PC.
- Connect the MUT-III main harness (blue DLC connector) to the VCI.
- Connect the blue connector of the MUT-III main harness to the vehicle's data link connector.
- Turn the VCI power switch ON. Verify the indicator lamp in the upper right corner of the screen is green.

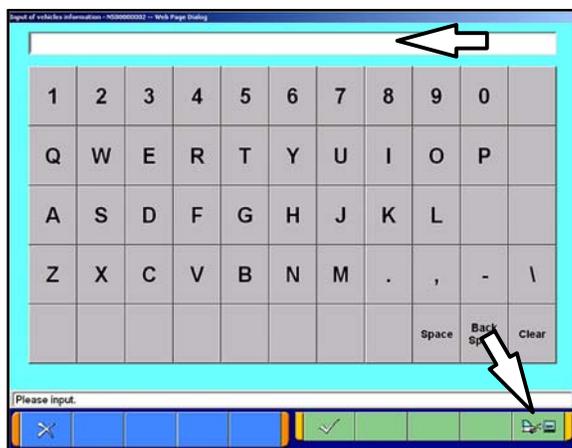
g. If the VIN or vehicle description displayed does not match the vehicle you are working on, click the eraser icon at the bottom of the page to erase vehicle data.
Then click the **VIN** button.

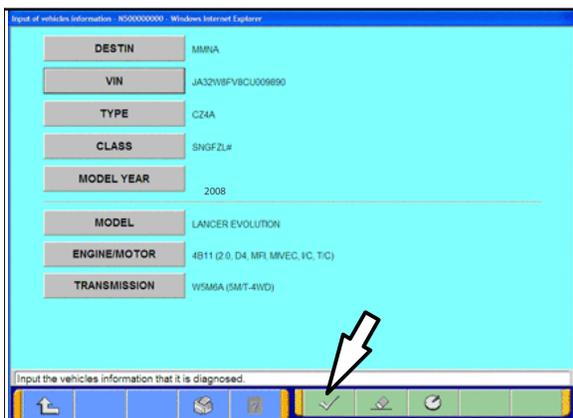
h. Click the icon in the lower RH corner of the screen to have MUT-III automatically read the VIN.
If a message appears saying the VIN cannot be input automatically, manually enter the 17 digit VIN into the VIN field at the top of the page.
Make sure the VIN is correct and click the check mark.

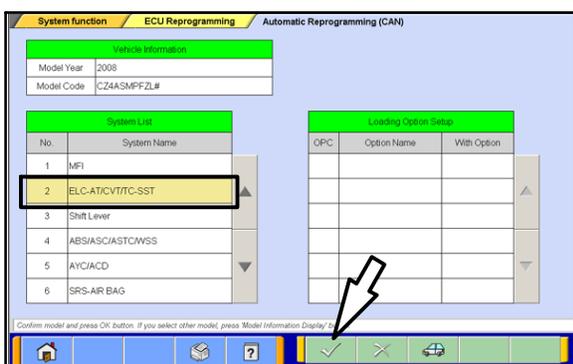
i. Confirm all data matches the vehicle and click the check mark at the bottom of the page.

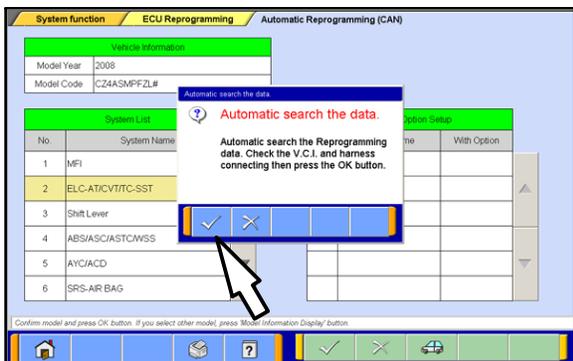
2. Select **ELC-AT/ CVT/ SST** and click the **check mark** to continue.

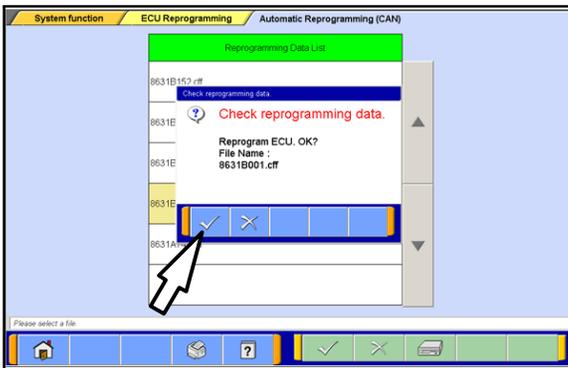
16. Select the correct Reprogramming Data file by model:

- 2009–10 Lancer Evolution – 8631B001.cff
- 2009–10 Lancer Ralliart Edition – 8631B002.cff

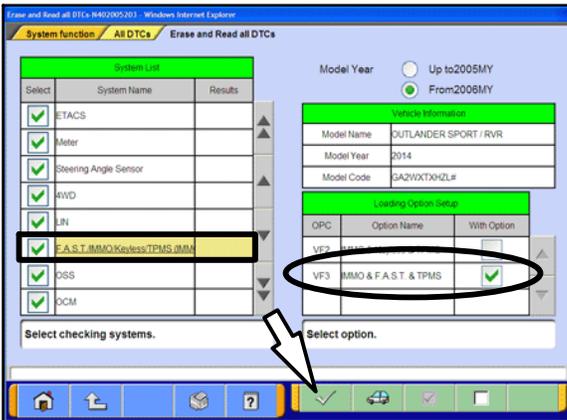
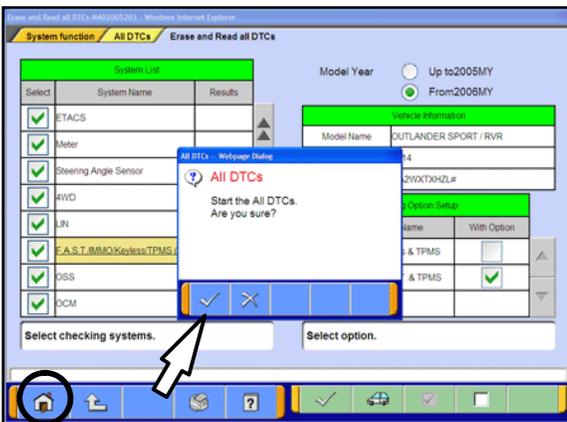
e. In the left column, scroll to and click FAST/IMMOB/KEYLESS/TPMS. In the right column, check the correct option code (VF#) from the Loading Options Setup list. This will activate the check mark at the bottom of the page.

- Vehicles with regular keyless entry (buttons on a multi-function key), select VF2.
 - Vehicles with F.A.S.T. Key, select VF3.
- Click the check mark to continue.
