# Technical Service Bulletin

SUBJECT: <b>ECM REPROGRAMMING FOR MIL ILLUMINATION WITH DTC P0139 OR P0171</b>			No: <b>TSB-16-13-002</b>
			DATE: <b>April, 2016</b>
			MODEL: <b>2014-16 Outlander</b>
CIRCULATE TO:	<input type="checkbox"/> GENERAL MANAGER	<input type="checkbox"/> PARTS MANAGER	<input checked="" type="checkbox"/> TECHNICIAN
<input checked="" type="checkbox"/> SERVICE ADVISOR	<input checked="" type="checkbox"/> SERVICE MANAGER	<input checked="" type="checkbox"/> WARRANTY PROCESSOR	<input type="checkbox"/> SALES MANAGER

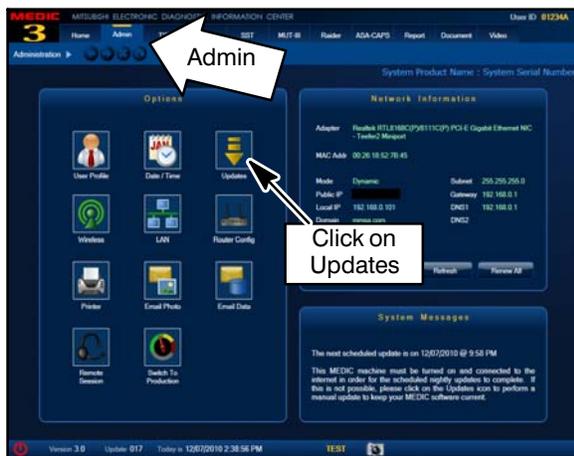
2. Verify the MEDIC 3/4 is at version 3.5 and at update **384** or higher.

If your **MEDIC 3/4 update is at least 384**, continue with the Reprogramming Procedure on page 4.

If your **MEDIC 3/4 update is below 384**, update your MEDIC as follows.

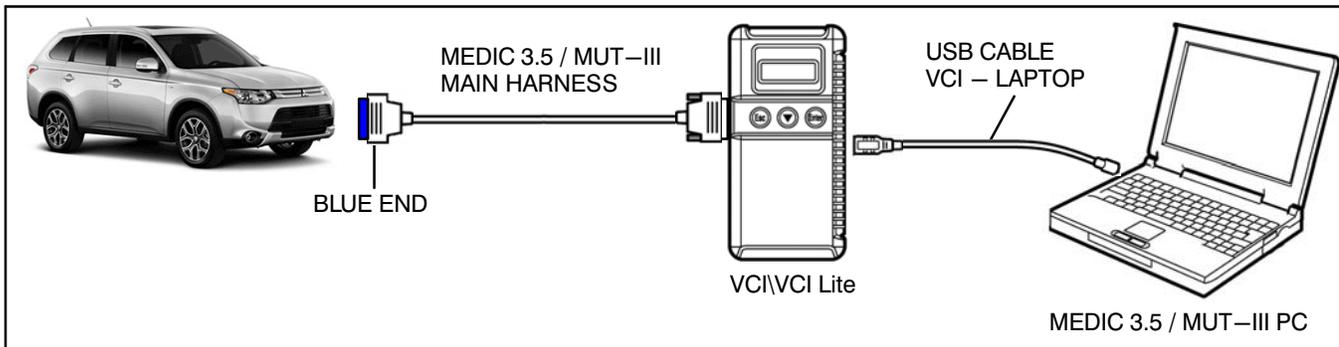
- Turn the MEDIC PC/tablet on. If the battery indicator in the lower right hand corner of the screen does not show a full charge, it is recommended that either the battery be charged prior to beginning, or be used with the A/C power adaptor connected.
- Connect the USB cable to the VCI/VCI Lite.
- When the laptop/tablet displays the MUT-III main screen, connect the USB cable to the device.
- Connect the MUT-III main harness with the blue DLC connection to the VCI/VCI Lite.
- Connect the blue connection of the MUT-III main harness to the vehicle's data link connector.
- Turn the VCI power switch ON . Verify that the indicator lamp in the upper right corner of the screen is green.

**NOTE:** VCI and MEDIC 3.5 Laptop shown for illustration purposes only.

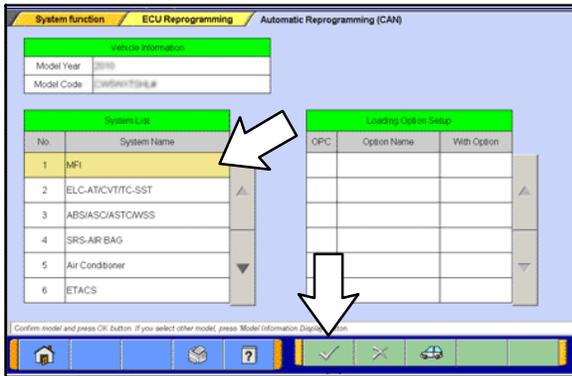
8. “MFI” should be highlighted by default. If not, click on it to highlight it. Click the **check mark** to continue.

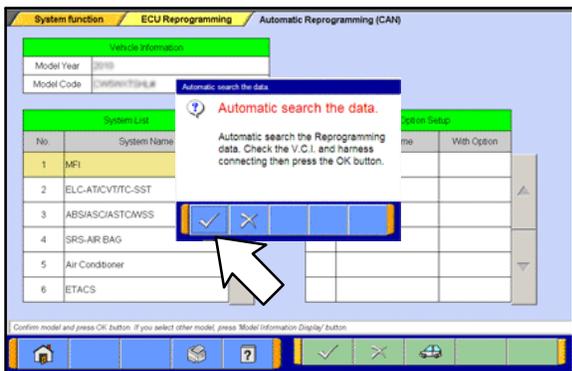
9. A message will advise the system will “Automatic search the data.”

Click the check mark to continue.

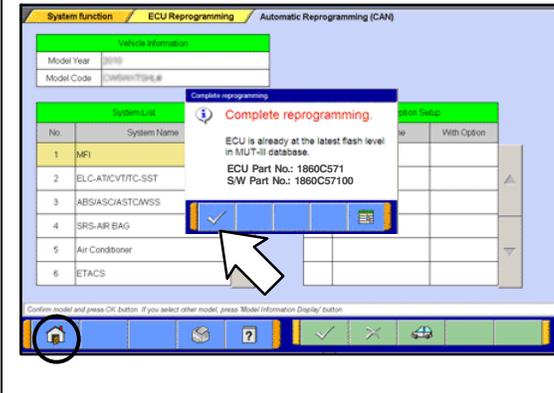
If the message seen at left is displayed, the ECU software is already at the most current level. Do not continue with the reprogramming procedure. This TSB does **not** apply.

Click the check mark to clear the window, then click the Home icon at the lower left corner of the screen to return to the System Select main page.

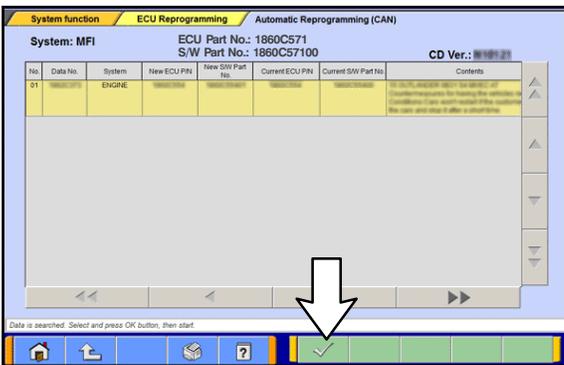
10. The Automatic Reprogramming (CAN) database screen will display.

- Verify that the new ECU and S/W part numbers are listed in the table.
- Confirm the database number at the top right of the table is N16031 or higher.
- If more than one row is displayed in the table, refer to the ECM Reprogramming Chart on page 2 to highlight and select the correct row.
- Click the check mark to continue.

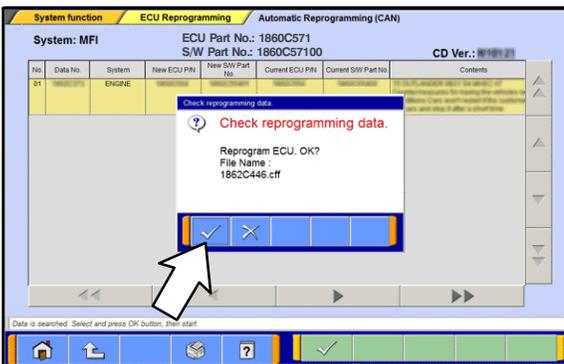
11. The "Check reprogramming data" window should appear with the new file name.

12. Click on the check mark in the pop-up box to initiate the reprogramming.

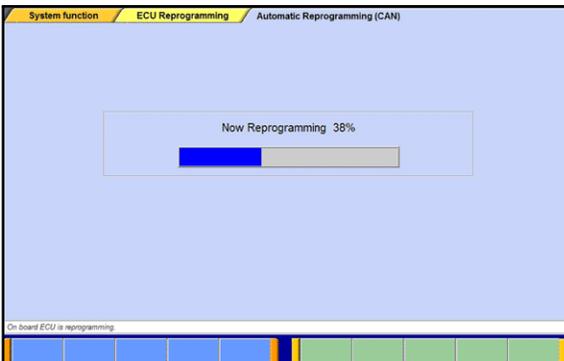
13. Once the reprogramming is initiated, the screen as shown will indicate the reprogramming progress.

**NOTE:** Do not disturb the cables or turn off the ignition during reprogramming.

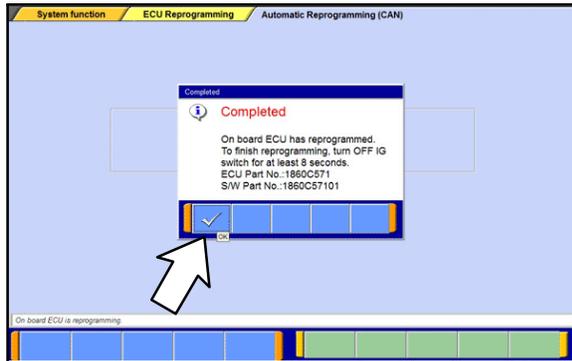
- 14. Reprogramming is completed.
  - a. Verify that the S/W Part No. Is correct.
  - b. Click on the check mark.
  - c. Turn OFF ignition switch for at least 8 seconds.
  - d. Turn ignition switch ON, then proceed to the next step.

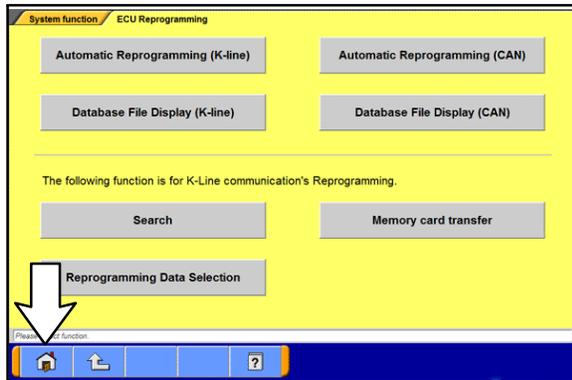
- 15. Click on the “home” button.

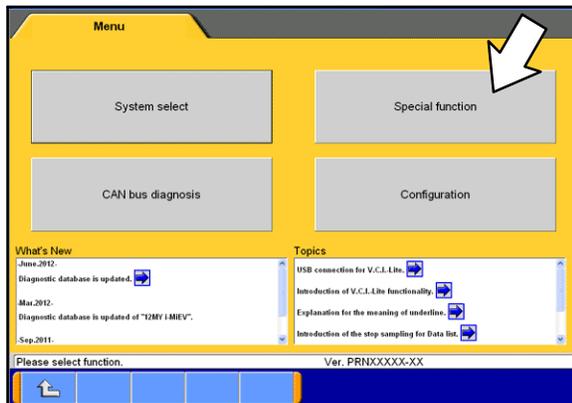
- 16. Perform an “Erase and Read all DTCs.”
  - a. Select “Special function.”

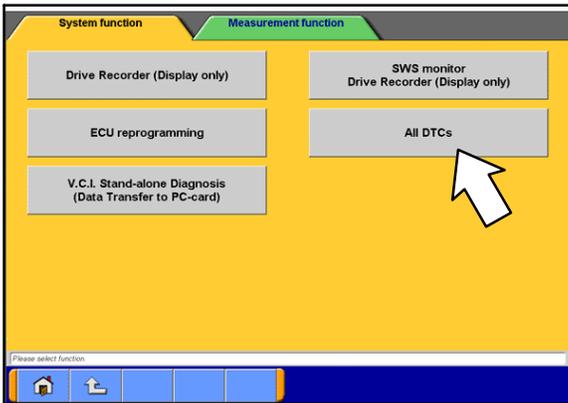
b. Select "All DTCs."

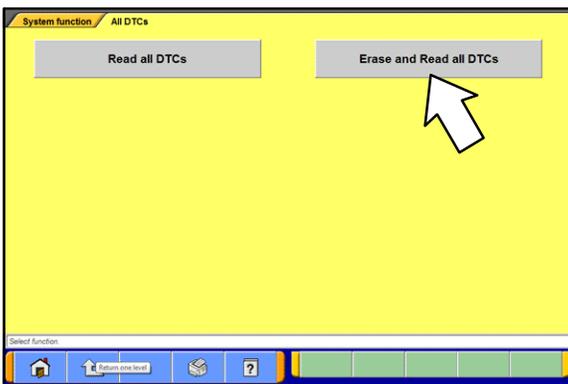
c. Select "Erase and Read All DTCs."

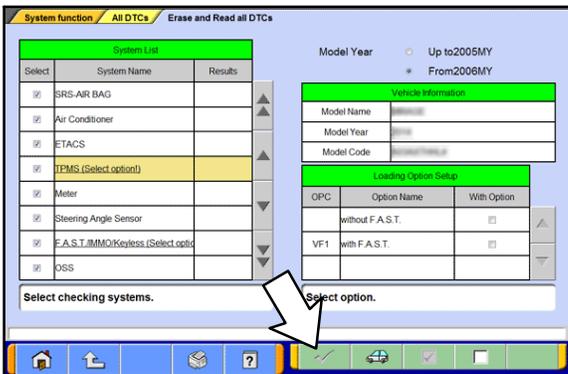
d. The "System List" on the left side of the screen will have all selections checked. Do not change these selections. DTCs may be set if the vehicle is equipped with options that are unchecked.

e. Click the check mark to continue.
