Electrical

2014MY Soul (PS)  
2014MY Sorento (XMa)  
2014MY Optima (TF/QF)  
2014MY Forte (YD)  
2014MY Sportage (SL)

## TECHNICAL SERVICE BULLETIN

SUBJECT: COMBINATION TSB / SERVICE ACTION: UVO SYSTEM  
UPGRADE (SA 222)

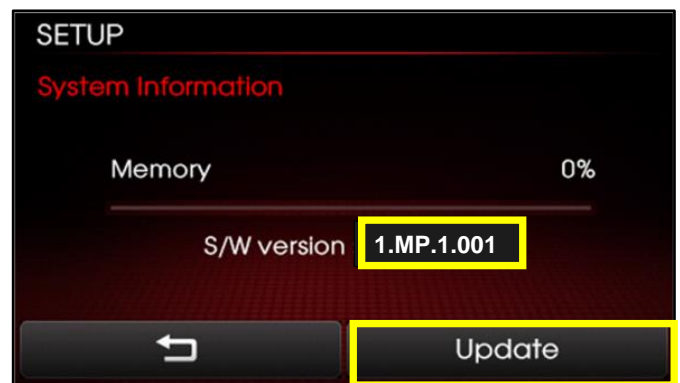
1. Start the vehicle or connect the Midtronics GR8-1299 charger.
2. Record the customer's radio presets before performing the upgrade.
3. Press **SETUP** > **System** > **System Information** and check to ensure the software version is at or above the level shown in the table below.

Original Software Version
1.MP.1.001 (or higher)

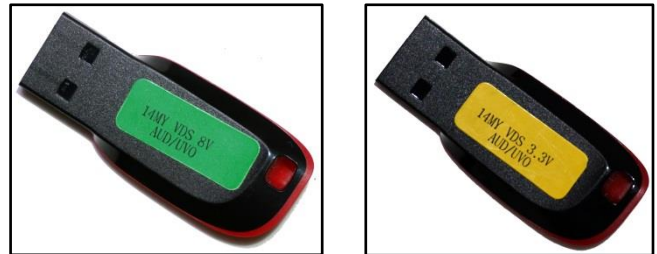
5. If performing the update using a USB stick, obtain the **14MY VDS AUD/UVO (3.3V or 8V)** upgrade USB stick (shown to the right) from your Service Manager and insert it in the vehicle's USB port.

Either USB stick can be used for this UVO upgrade regardless of the microphone voltage (3.3v or 8v).

Verify that the USB drive contains files and is <u>NOT</u> blank. If the USB is blank, order a replacement through Snap on Business Solutions at 888-542-1011

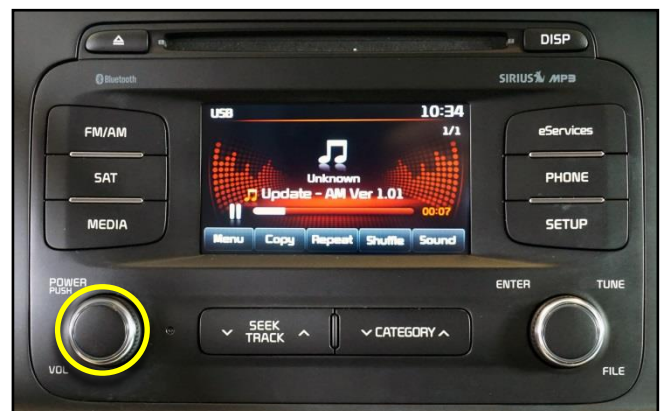
6. Allow the music files to play and then press the **POWER** button to turn the head unit OFF.

Do NOT turn the vehicle OFF while the update is in progress.

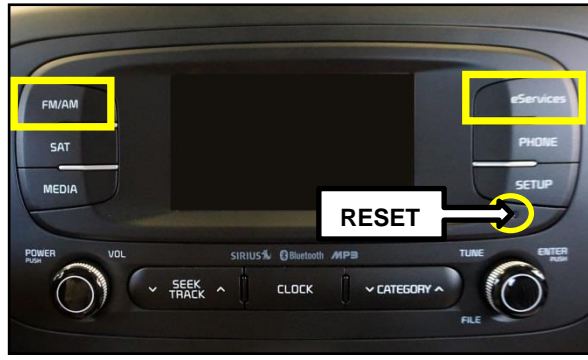
**\* NOTICE**  
 On Soul (PS) vehicles, **PRESS** and **HOLD** the, **FM/AM** and the **eServices** buttons, then, insert a ball point pen in the **RESET** button.

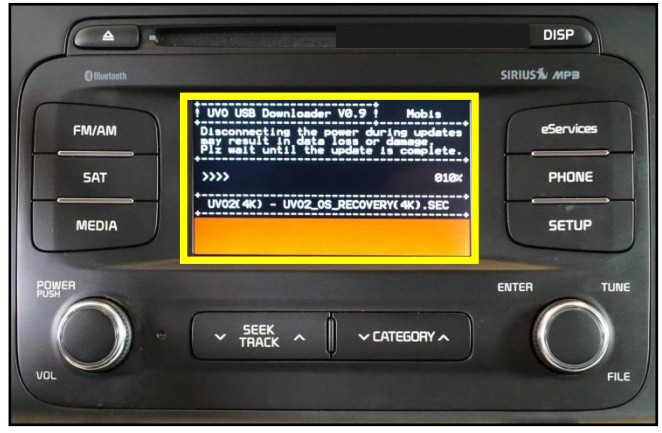
- The head unit will enter the UVO USB Downloader mode and begin downloading the upgrade from the USB stick or AUM.

**\* NOTICE**  
 If the **USB Downloader** fails to download the upgrade, press the **Reset** button and restart the procedure from step 3 or 4. If the upgrade download continues to fail, refer to the **Troubleshooting Matrix** on Page 8.

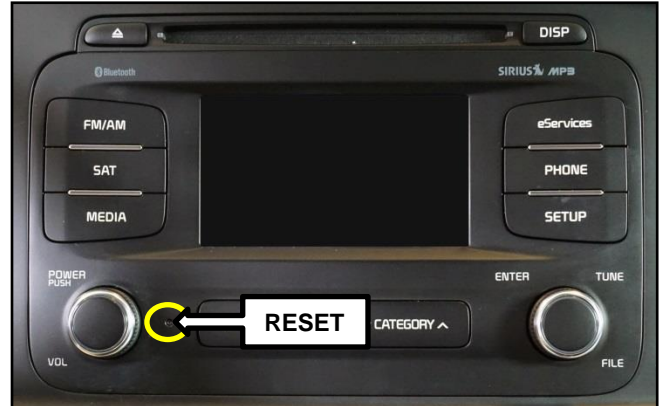
9. When the download shows 100% complete, press the **RESET** button, using a ball point pen to restart the system.

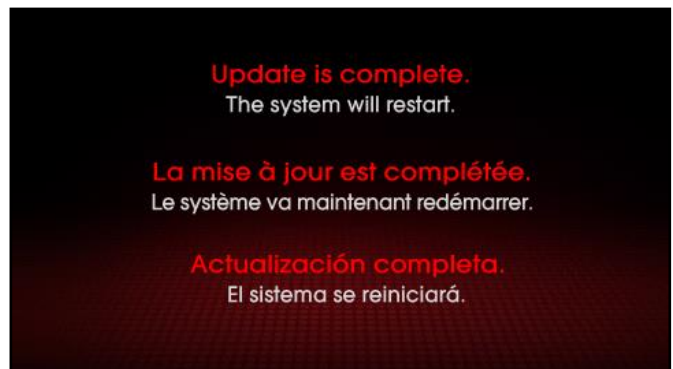
11. After update is complete, the display shown on the right will appear for a few moments; then the UVO system will be restarted again.

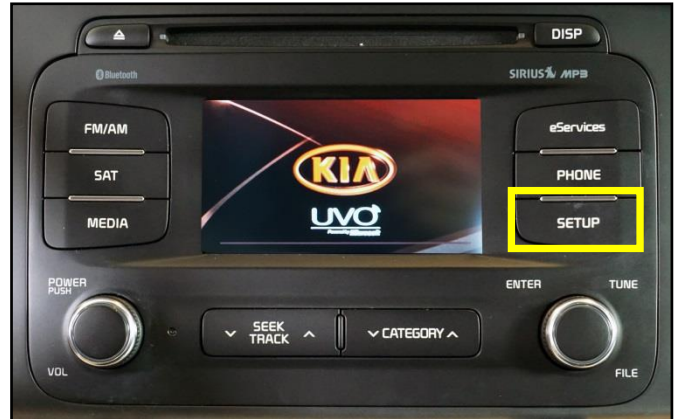
12. After the system has restarted, press the **SETUP** button on the head unit.

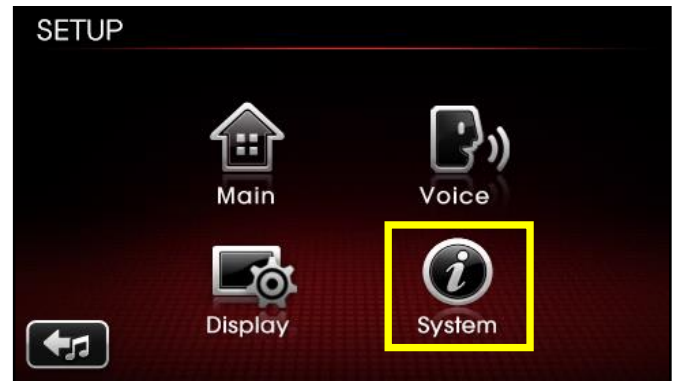
13. Touch **System icon** on the screen.

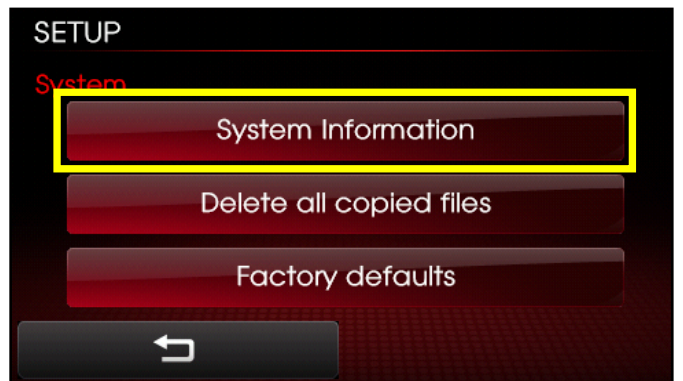
14. Touch **System Information** button on the screen.
