Subject: AUDIO, NAVIGATION AND PHONE CONCERNS WITH MAZDA CONNECT INFOTAINMENT SYSTEM	Bulletin No: 09-024/16
	Last Issued: 04/19/2016

DESCRIPTION

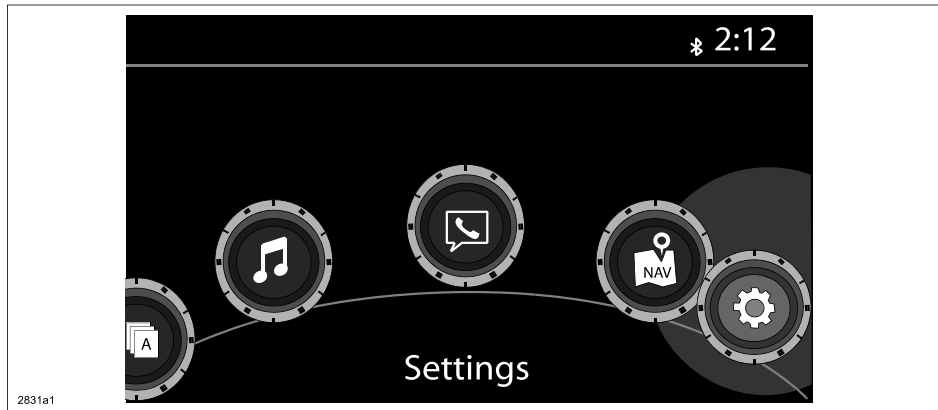
1. Select “Settings” from the Home screen to check the software version.

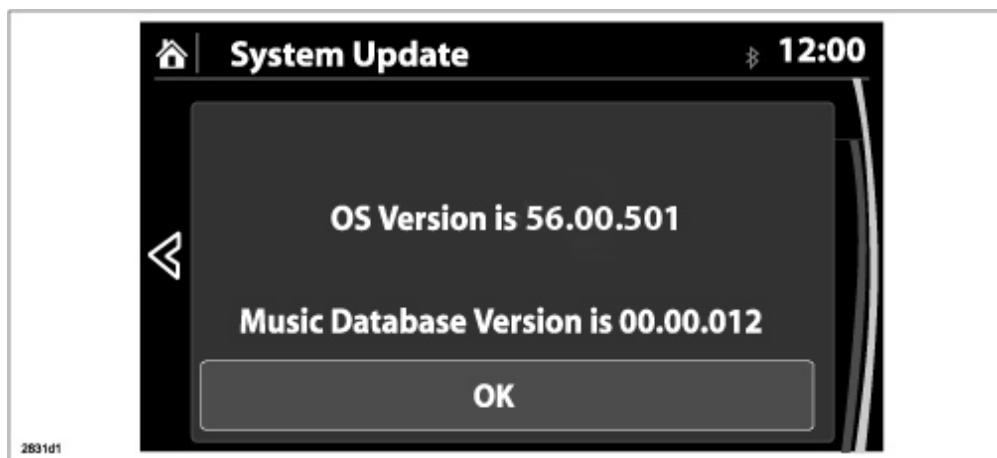
4. Make sure the software version is **56.00.760** or later, then select OK. If it is not **56.00.760** or later, update the system using a USB memory stick with the latest software according to the "Reflash Procedure." If needed, refer to "Downloading Update Software to a USB Memory Stick (for additional USB memory sticks)" below.

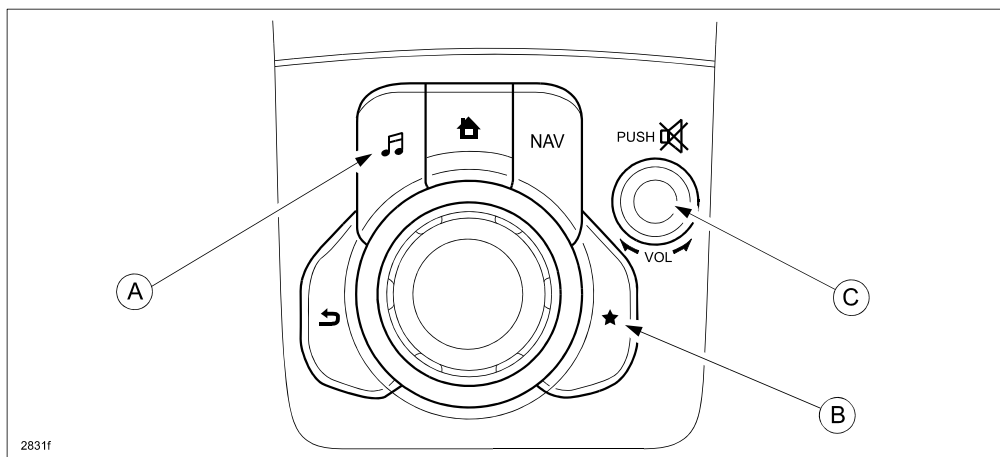
8. Press the three buttons (Music (A) + Favorites (B) + Volume Mute(C)) on the commander switch at the same time for 2-5 seconds and the Diagnostic Test Screen will appear.

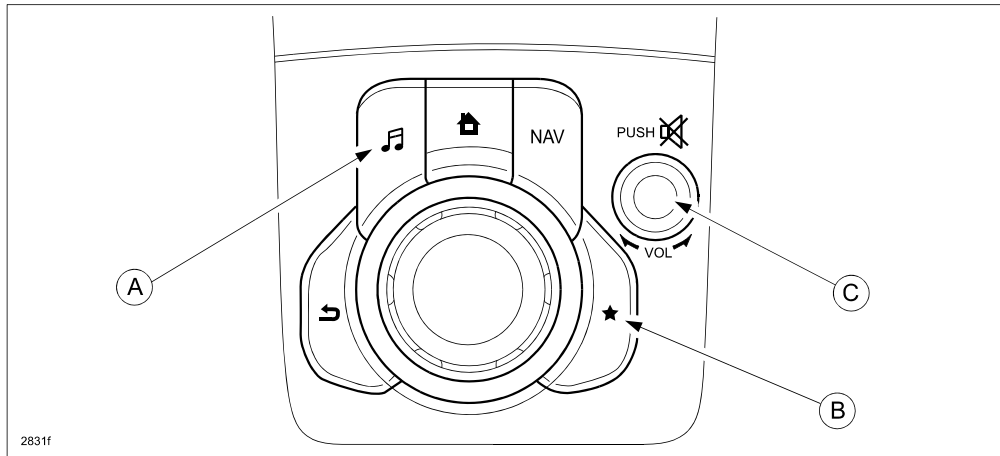
15. Press the three buttons (Music (A) + Favorites (B) + Volume Mute(C)) on the commander switch at the same time for 2-5 seconds.

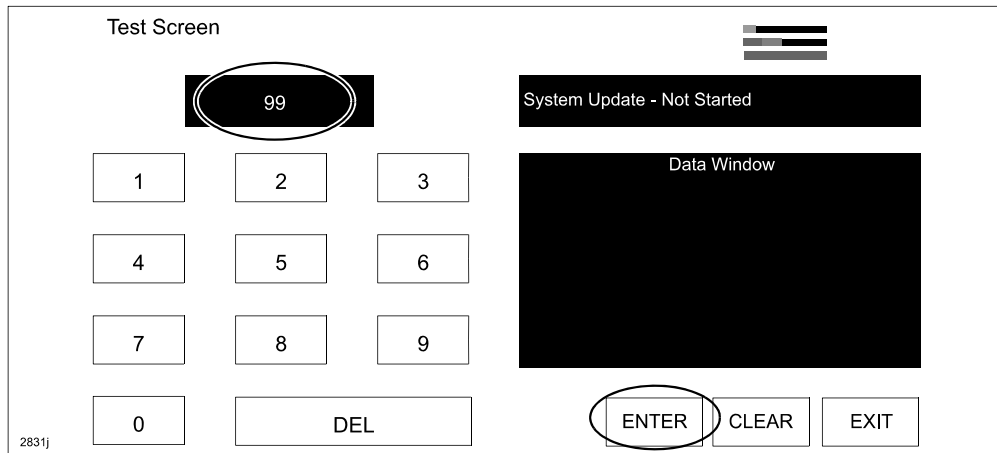
16. Use the touchscreen or the commander switch to input '99' and then select "ENTER" on the Test screen.

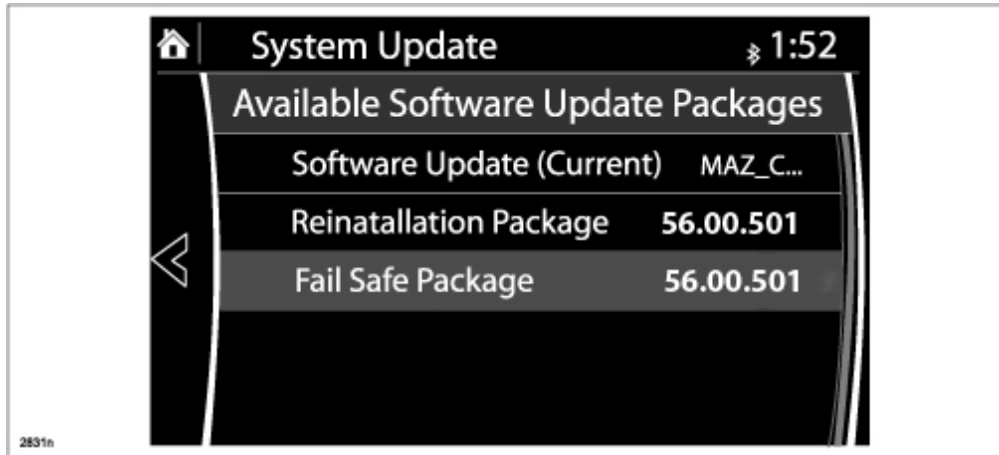
18. Select "Fail Safe Package" first using the touch screen.

CAUTION: Always do the "Fail Safe Package" first, followed by "Reinstallation Package".

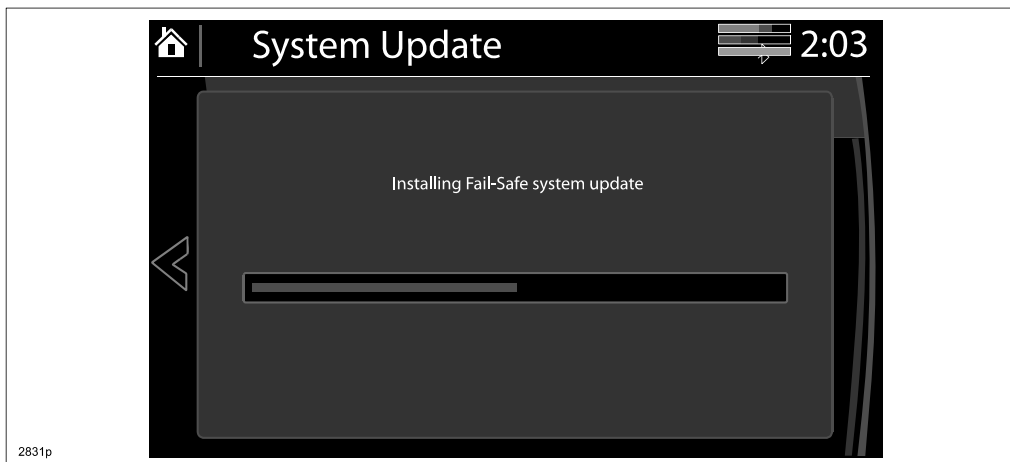
20. Failsafe installation process will start.

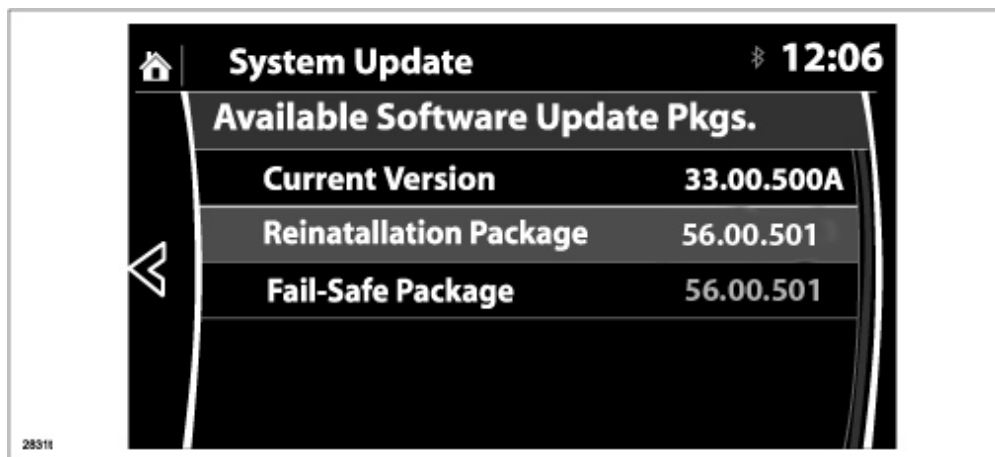
26. Select "Reinstallation Package" on the screen below.

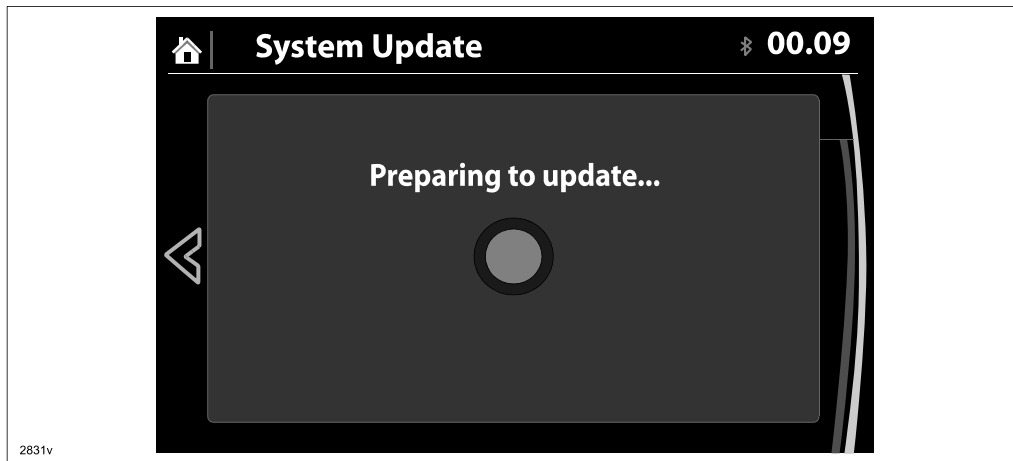
28. The screen below will be displayed.

NOTE: Blank screens (black and white) are displayed momentarily. It will take approx. 2 minutes before the reflashing process moves to the next screen.

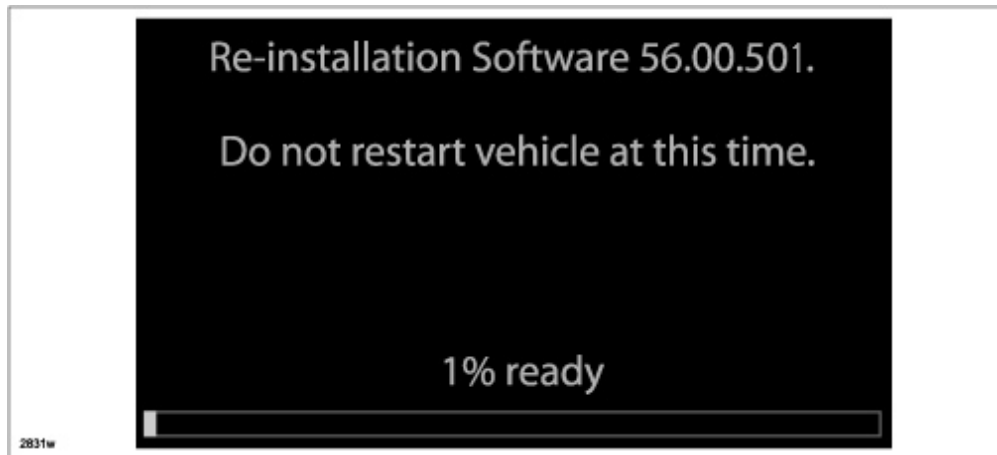
29. Reinstallation will start from 0% and as the reflashing process takes place, the progress bar will gradually increase to 100%.

NOTE: It may be difficult to read the display at times as it becomes dark, but “Do not restart vehicle at this time” is displayed.

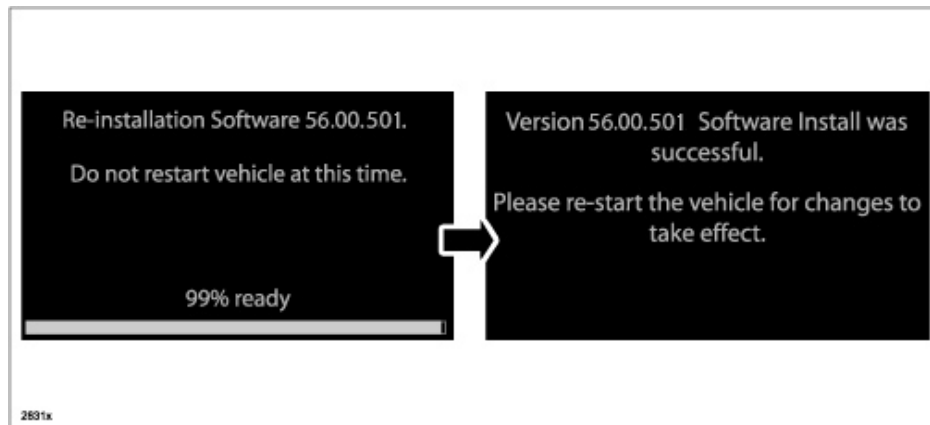
NOTE: It will take some time for the reflashing process to get from 98 % to “100%. After the installation, do not follow “re-start” message. Proceed to next step.

30. After the update is completed with the above right screen, confirm that the push button start indicator light is illuminated (amber) and the display in the instrument cluster is OFF (ignition is in "ACC"). If the ignition is "OFF" and the push button start indicator light is not illuminated (amber), turn the ignition to "ACC" and one of the following two screens will be displayed.

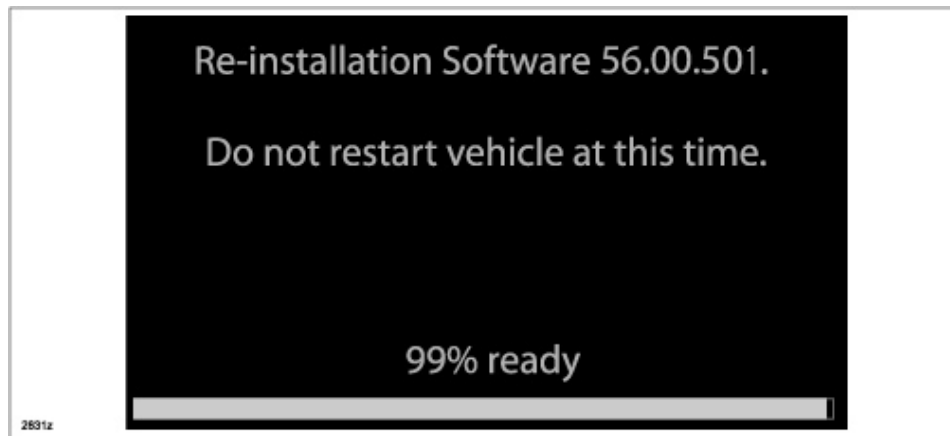
Type B: The ignition was turned "OFF" during the reflashing process. This screen will continue to be displayed until reflashing is completed. After the reflashing is completed, go to next step.

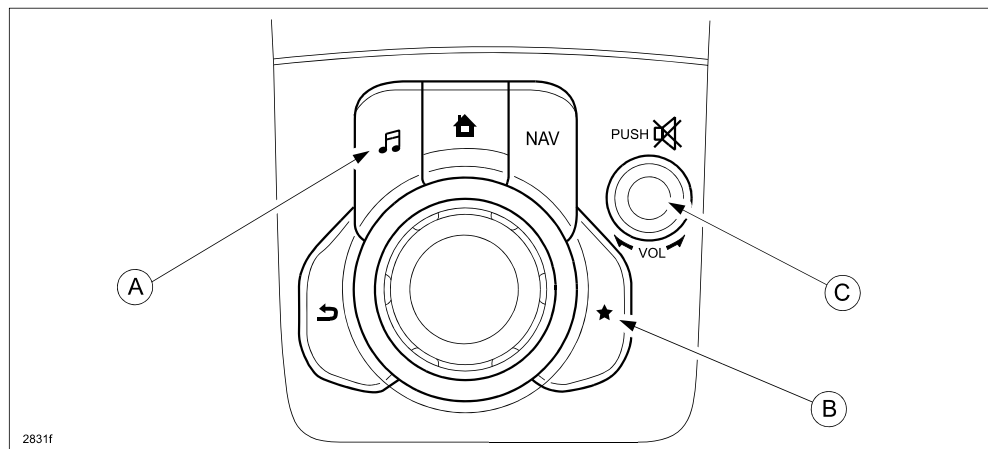
36. Press the three buttons (Music (A) + Favorites (B) + Volume Mute(C)) on the commander switch at the same time for 2-5 seconds to open the Diagnostics Test screen again.
