TECHNICAL BULLETIN
JTB00496NAS3
26 OCT 2016

InControl® Touch Pro™ Features May Not Function As Expected (Additional Updates)

XJ Range (X351)

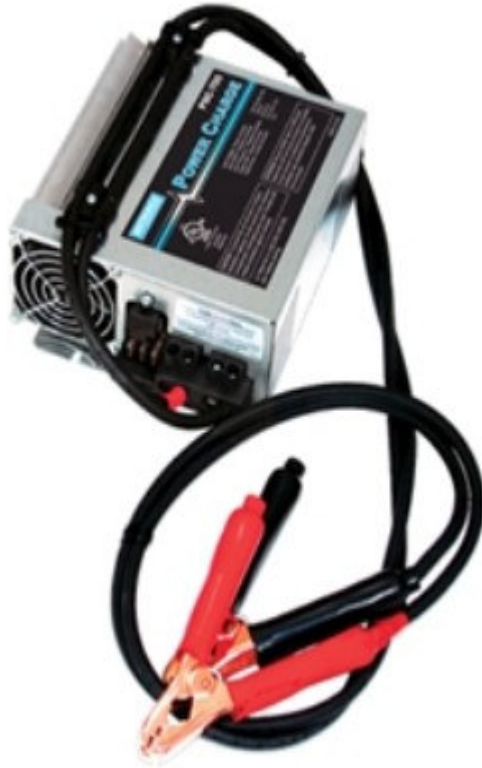
E192494

Jaguar Land Rover-approved Midtronics battery power supply

CAUTION: Battery support unit - It is extremely critical to use a battery support unit and have a vehicle with a battery that has a good state of health to start. The battery support unit must also be in proper working condition to be able to supply 13v consistently. If the voltage is compromised during the installation of software, the IMC may switch off.
