November 5, 2016

05080 Version 1

MIL Comes On with DTC P14A0 and/or P1DFD

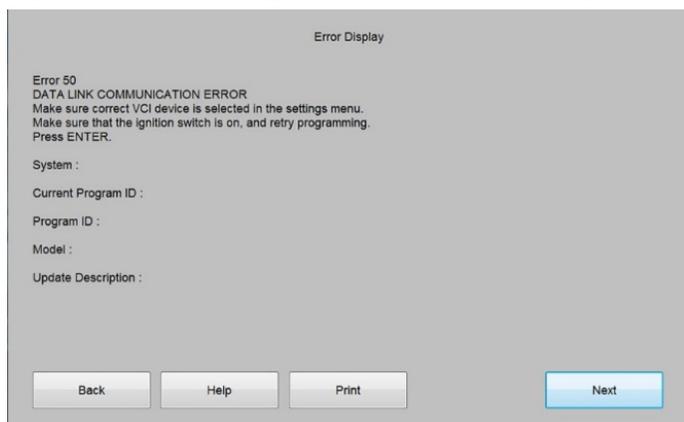
- You can't update the vehicle using the MVCI as a standalone tool.
- **Do not** use the MongoosePro VCI tool.
- Make sure the 12 volt battery is fully charged before starting an update.
- Connect a fully charged jumper battery to the vehicle and leave it connected during the entire procedure to maintain steady voltage.
- Never turn the ignition to OFF or ACCESSORY during the update. If there is a problem with the update, leave the ignition turned to ON.
- To prevent powertrain control module damage, do not operate anything electrical (headlights, audio system, brakes, A/C, power windows, door locks, etc.) during the update.
- If you see the following Error Display, check that you are using the correct tool (MVCI or DST-i) with the i-HDS.

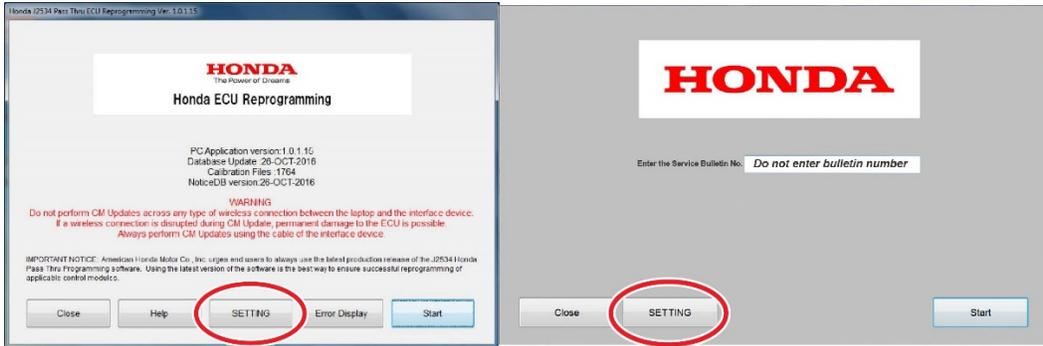
To change this, click on either of the SETTING selection buttons at the bottom of the J2534 initial screens as shown.

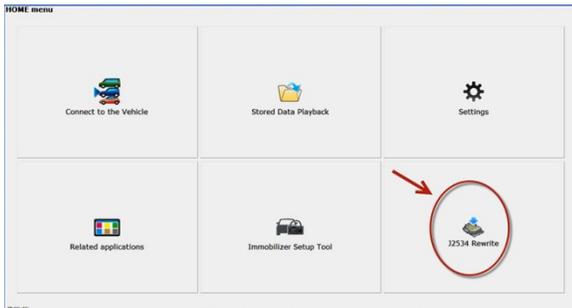
3. Select **J2534 Rewrite**.

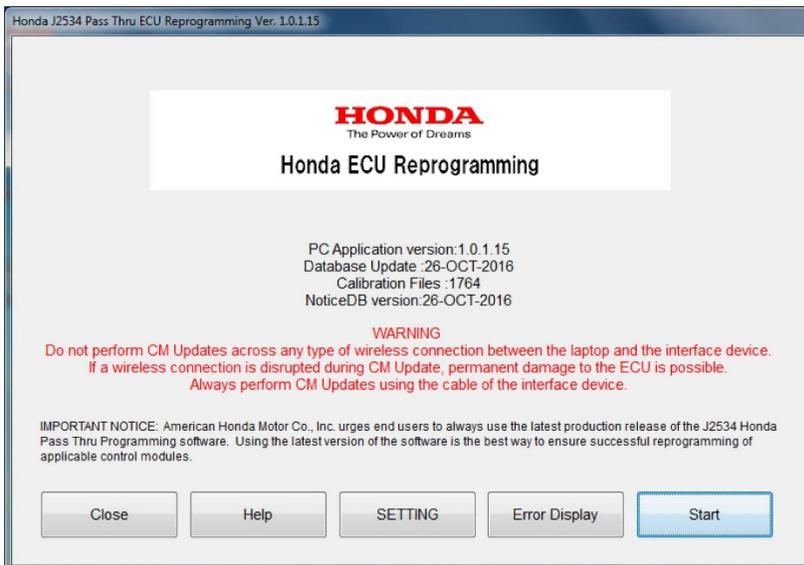
4. Confirm the software is the same **or later** as listed in SOFTWARE INFORMATION.

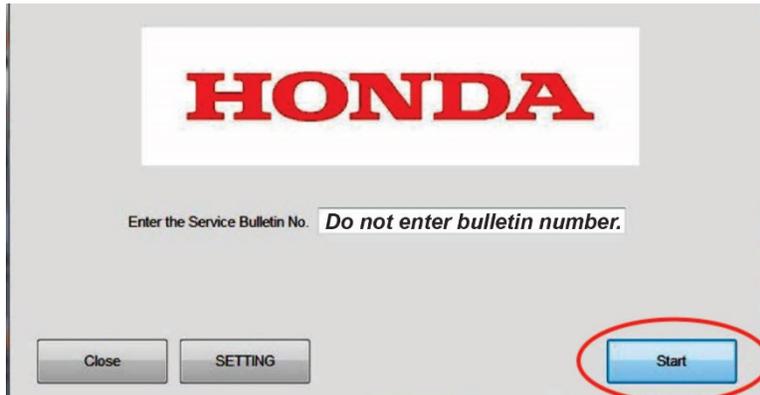
- **Don't enter a bulletin number.**
- If you receive a message that the vehicle has been already updated or that no update is available, check the engine data list. The header should indicate one of the following numbers (or later).

37805-5K1-A58	37805-5K1-A68	37805-5K0-A14
---------------	---------------	---------------

- If the program part numbers do not match those listed above, the i-HDS software needs to be reinstalled. Contact the Special Tools Hotline at **800-346-6327** for assistance.
