05047 Version 1

## Audio-Navigation System Update for Upper Screen Going Blank

### AFFECTED VEHICLES

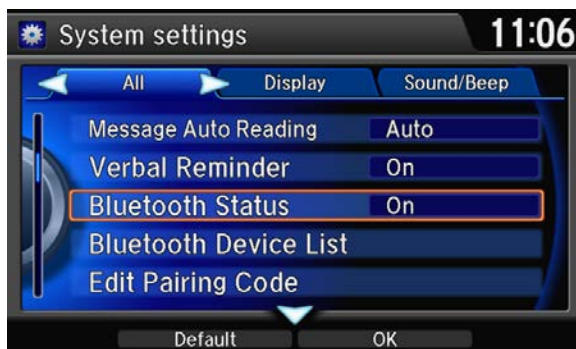
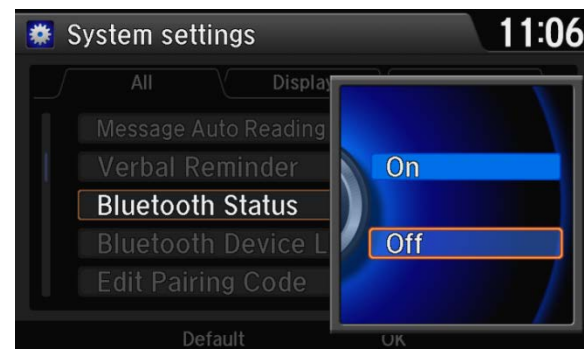
3. Scroll down to **Bluetooth Status**, and select **Off** to turn off *Bluetooth* connectivity.

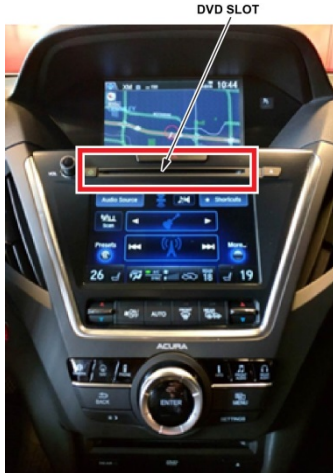
4. Insert the DVD update disc into the upper slot in the center console. The DVD contains an auto-run program that launches the software update automatically after the DVD is inserted. Go to TOOL INFORMATION for additional information about the DVD.

When the DVD is inserted, the navigation (upper display) will show **Disc Reading...** and then **Disc No Data**. The ODMD (lower display) will display a **No Data** message. It may take up to 1 minute to begin the update; **do not eject the disc**. If the unit does not go to the next screen after 1 minute, go to step 12 because the unit may already have the latest software version.

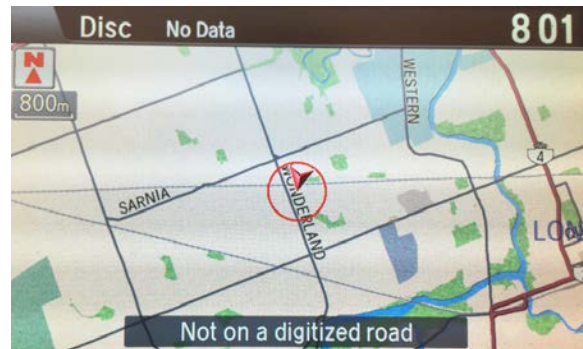
Upper screen

The software update will begin after the upper and lower screen shuts off for a few seconds and reboot. The upper screen will show **Program update started** and the lower screen will display 4 updates with a progress bar.

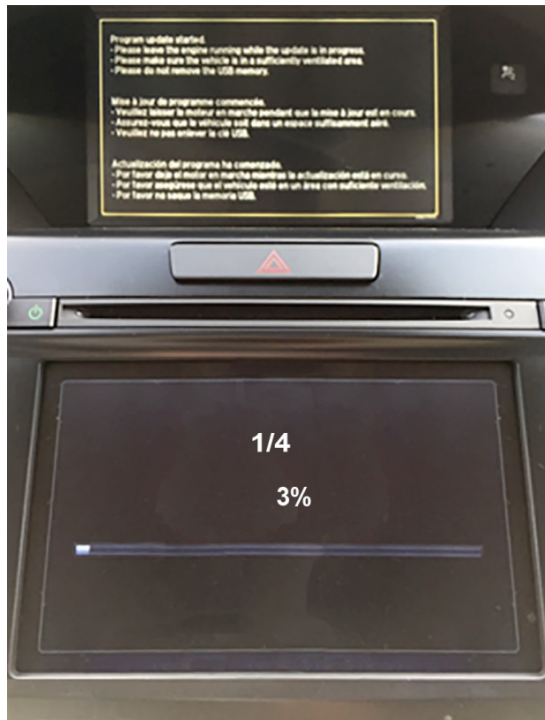
When the update has completed, the system will reboot a couple of times. Wait until the **Enter code** message appears on both the upper and lower display screens before doing the next step. There will also be a keypad on the lower screen.

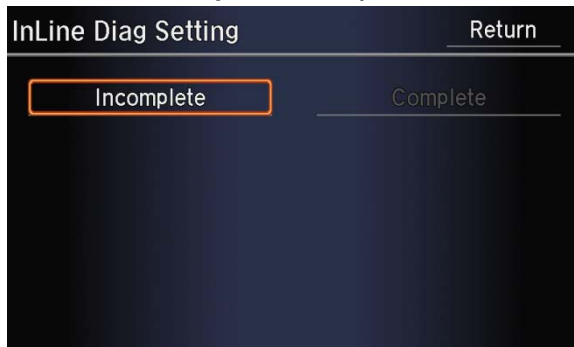
- Press and hold the NAVI button.
- Select **Incomplete**. The system will restart.

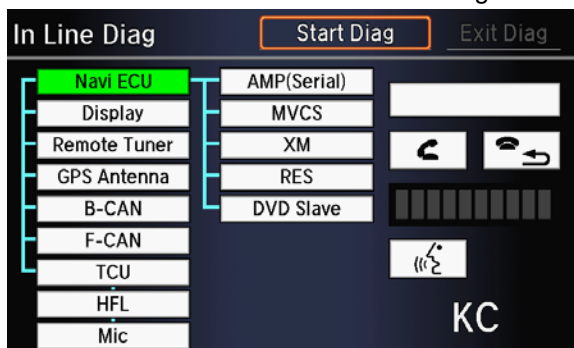
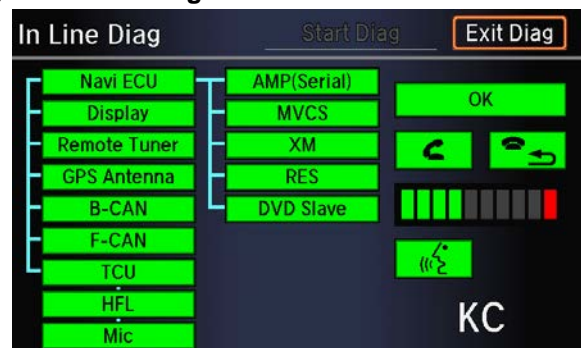
- When the **InLine Diag** screen appears, select **Start Diag**.
- Make sure all function icons turn to green. Then, select **Exit Diag**.

NOTE: To get all of the icons to turn green, do the following:

- Press the Pick-up button on the steering wheel.
- Press the Hang-up button on the steering wheel.
- Press the Talk button on the steering wheel.
- Make some noise in front of the microphone located by the roof console module to complete the test.
- Turn the ignition to OFF, then back to ON. Make sure the **InLine Diag** screen does not reappear.

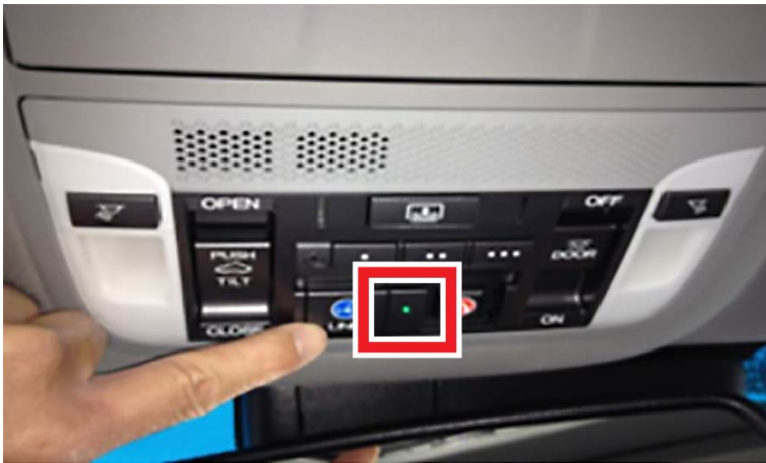
Turn the ignition to the ON in an open and uncovered area to ensure good GPS and cellular signal reception for at least 10 minutes. Wait until the LED on the roof console panel is lit and turns solid green. If the LED does not turn solid green after 30 minutes, contact Tech Line for further help.

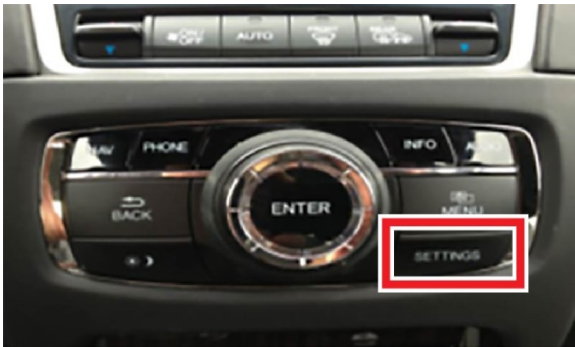
15. Press **SETTINGS** on the dial interface control panel.

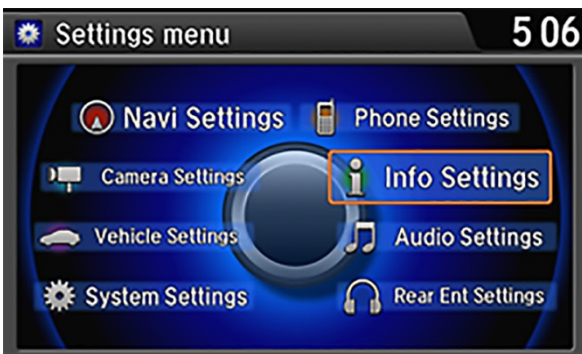
16. Select **Info Settings**.

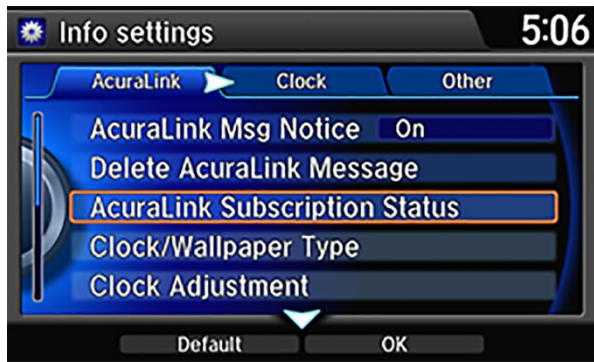
17. Select **AcuraLink Subscription Status**.

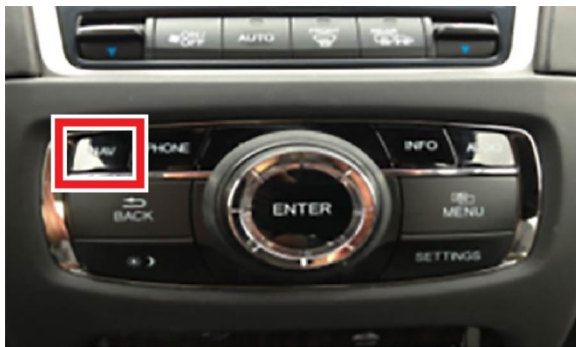
19. Press the NAVI button on the center switch panel.

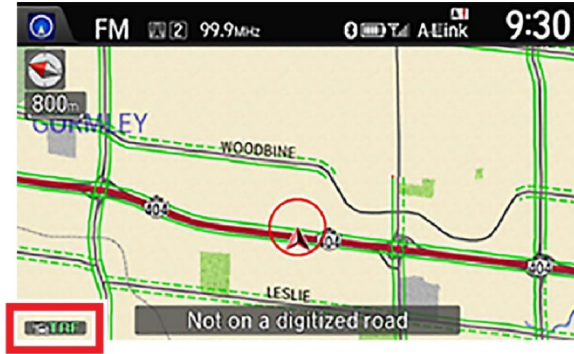
20. Check if the AcuraLink Real-Time traffic appears on the navigation screen (i.e. the TRF icon and green/orange/red traffic lines on the upper display). If the contract on the vehicle is Premium, go to step 21. Otherwise, the software update is complete. Go to step 24.

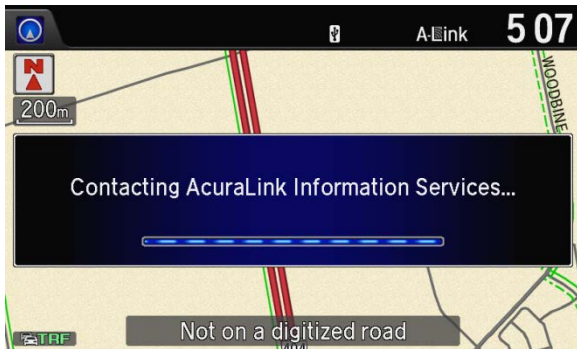
21. Press the **Link** button on the roof console panel to connect an AcuraLink call.

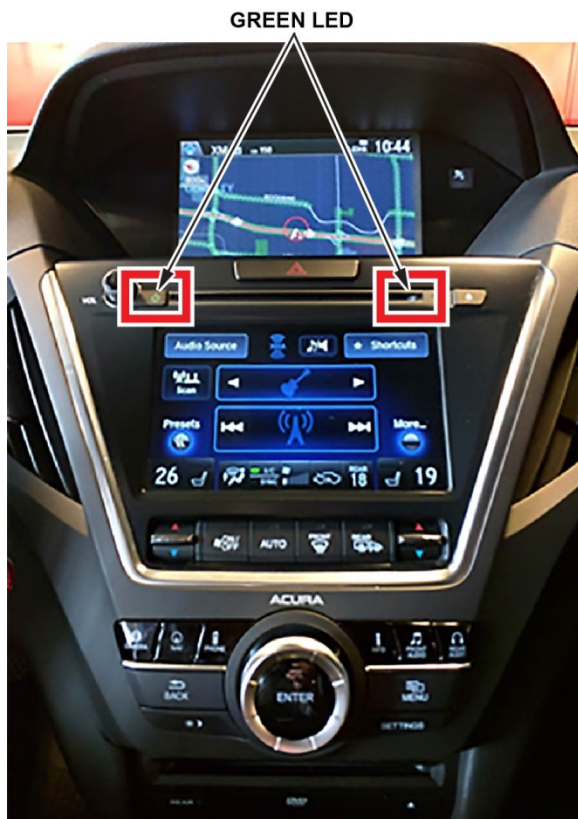
5. Turn the ignition to ON. **Do not start the vehicle** because doing so interrupts the steady battery power needed to update the audio-navigation unit.
6. Make sure the green LEDs on either side of the upper CD slot are blinking. This indicates the recovery process is working. Repeat the RECOVERY PROCEDURE FOR LOCKED UNIT step 1 if the LEDs are not blinking.

NOTE: The recovery process and software update reload takes about 15 to 30 minutes, depending on when the update process was interrupted. The screens may stay blank during this time.
