October 2016  
FL718A-D  
NHTSA #16V-634  
Transport Canada #16-419

## **Subject: Front Axle Hub Rating**

**Models Affected: Specific Freightliner 108SD, 114SD, Business Class M2, Cascadia, and Coronado vehicles; and Western Star 4700, 4800, and 5700 vehicles manufactured April 29, 2013, through July 29, 2016.**

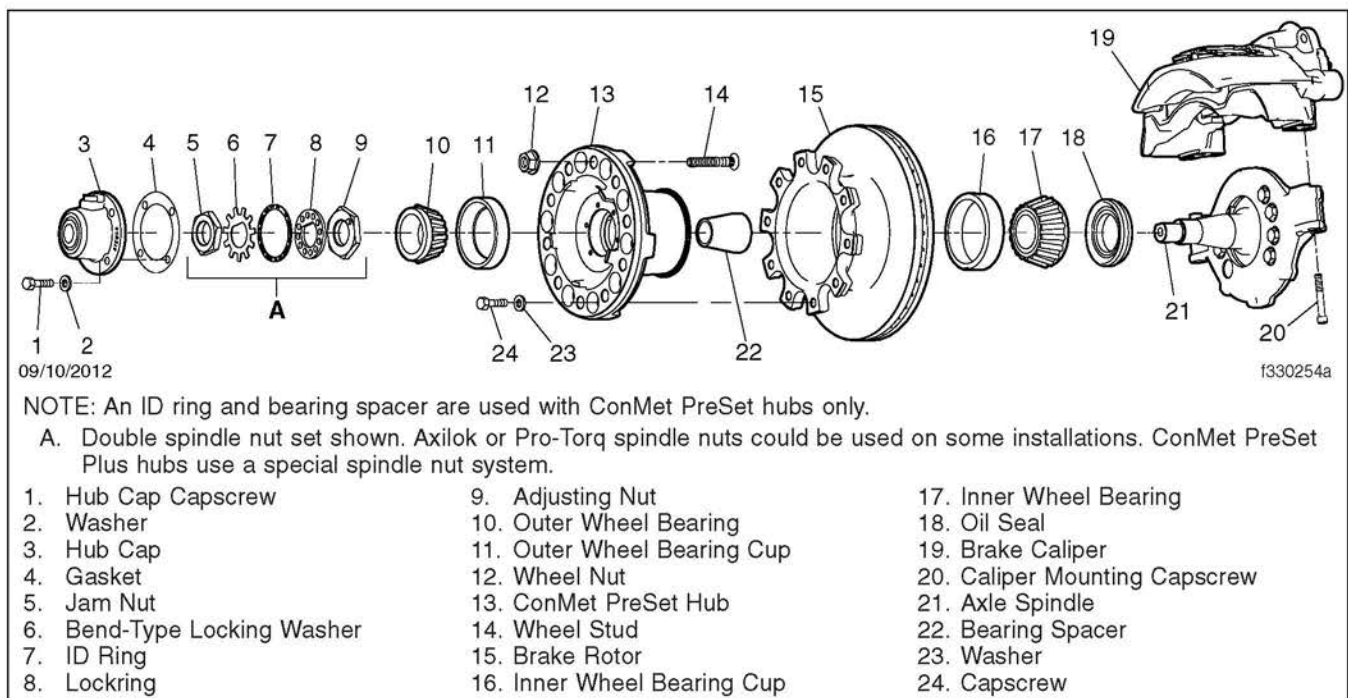
Fig. 1, Typical Wheel End Assembly, Front Axle with Disc Brakes

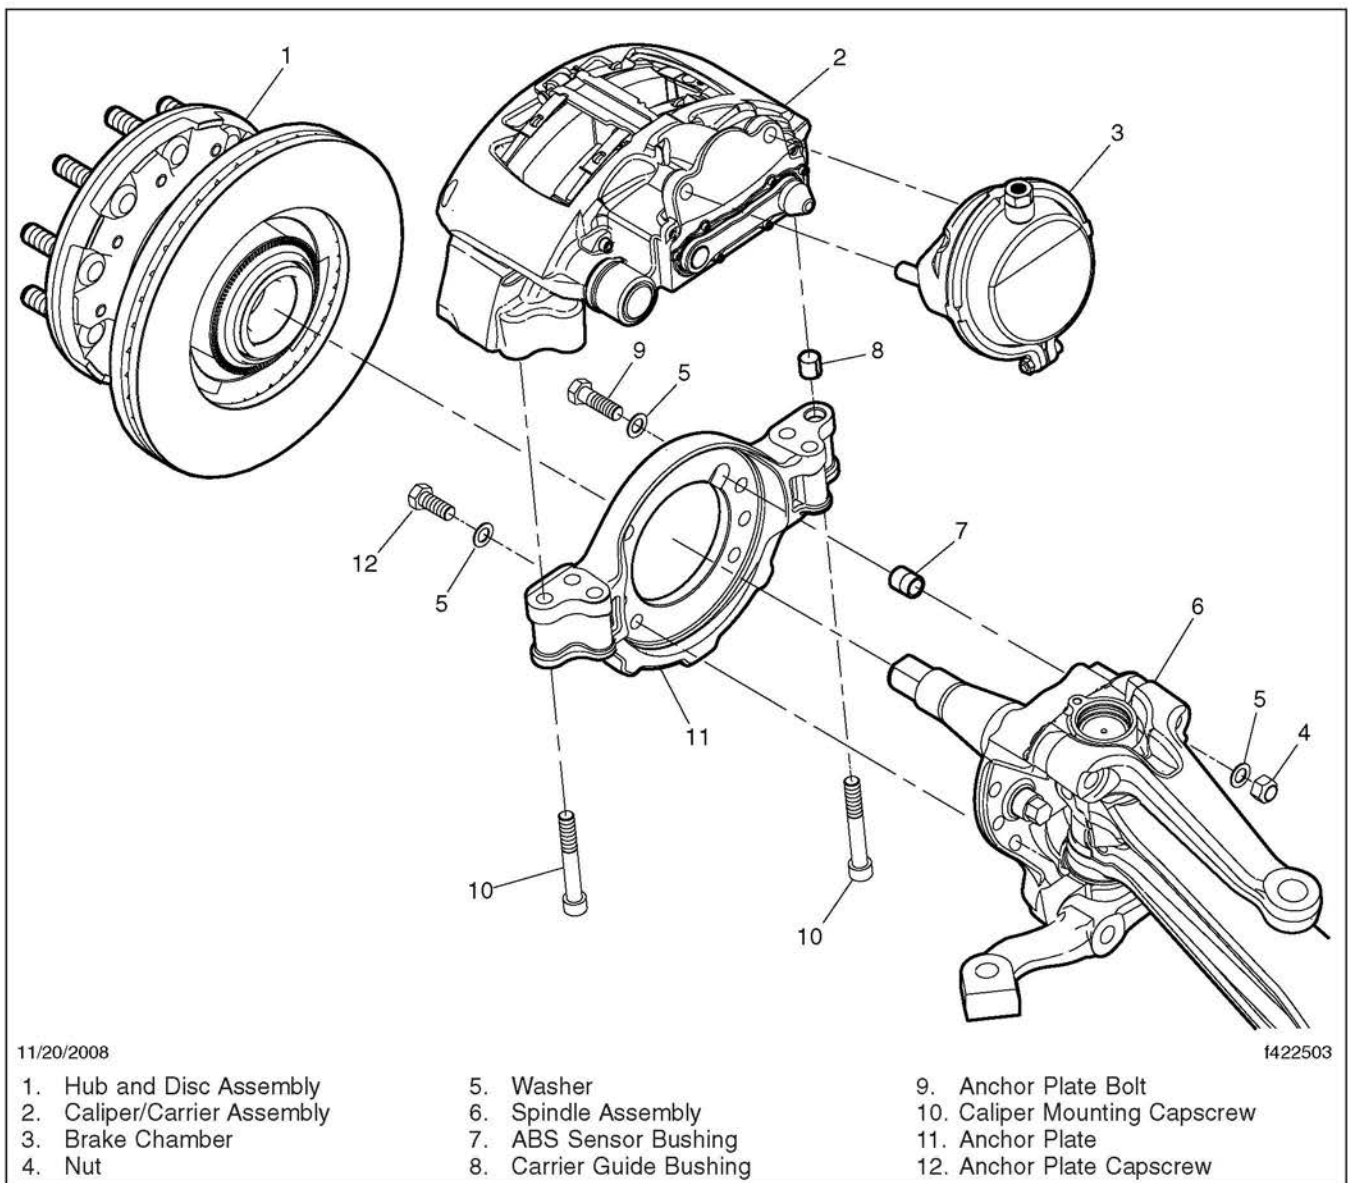
**Fig. 2, Front Caliper and Carrier Assembly Installation**

4. Remove the wheel and tire assembly.
5. Remove the brake caliper as follows. Refer to **Fig. 2** for front caliper/carrier removal and installation.
  - 5.1 Drain the air from the air brake system.
  - 5.2 Disconnect the supply and return lines from the brake chamber.
  - 5.3 Cut the zip ties holding the ABS harness to the brake hose as needed.
  - 5.4 Back off the manual brake adjuster 1/4 turn.
  - 5.5 Remove the six brake caliper/carrier assembly retaining bolts, and discard the bolts.

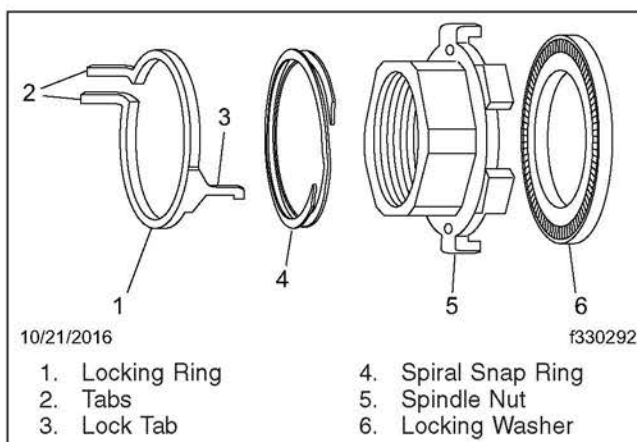
**Fig. 3, PreSet Plus Spindle Nut System**

7. ConMet PreSet Plus hubs use a special integrated spindle nut designed specifically for PreSet Plus hubs. See **Fig. 3**. Remove the axle nut as follows.

- 18.1 If the red locking snap ring is locked into the spindle nut, compress the tabs and pivot the ring to remove it from the nut. See [Fig. 3](#).
- 18.2 If needed, install the PreSet Plus spindle nut components as shown in [Fig. 3](#).  
Ensure that the spiral snap ring fully seats into the groove in the hub. See [Fig. 5](#) and [Fig. 6](#).
- 18.3 Tighten the spindle nut 300 lbf-ft (407 N·m) while rotating the hub. Do not back off the spindle nut.

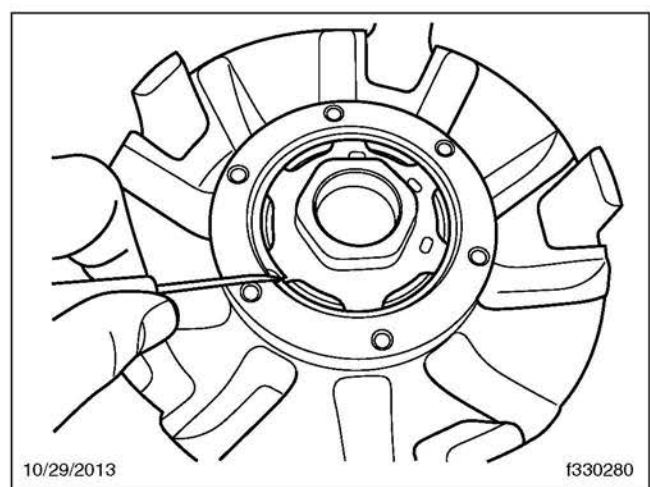
**Fig. 4, Removing a Spiral Snap Ring**

- 7.2 Loosen the spindle nut. As the spindle nut is loosened, it can act as a hub puller. However, if the hub will not come off of the spindle without exceeding 50 lbf·ft (68 N·m) of torque, remove the spiral snap ring (see **Fig. 4**) and then the spindle nut assembly.

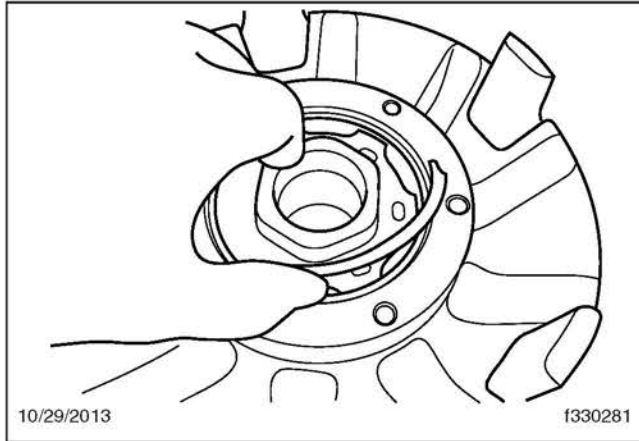
Fig. 5, Installing a Spiral Snap Ring

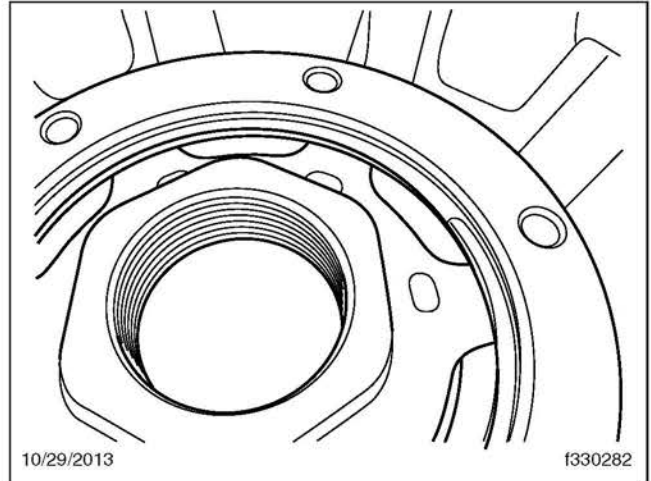
Fig. 6, Fully Seated Spiral Snap Ring

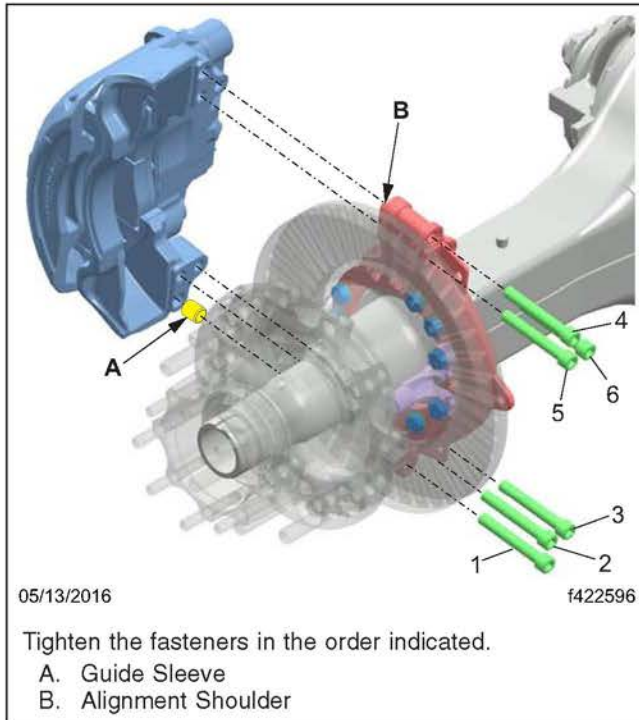
**Fig. 7, Tightening Pattern**

- NOTE: The tightening pattern will always start on the short (floating) pin side, with the bolt that passes through the shear sleeve.
- 22.2 Tighten the carrier mounting bolts in two steps, using the pattern shown in [Fig. 7](#). Initially tighten all six bolts 40 to 50 lbf-ft (54 to 68 N-m). Perform the final torque spec of 180 to 200 lbf-ft (244 to 271 N-m).

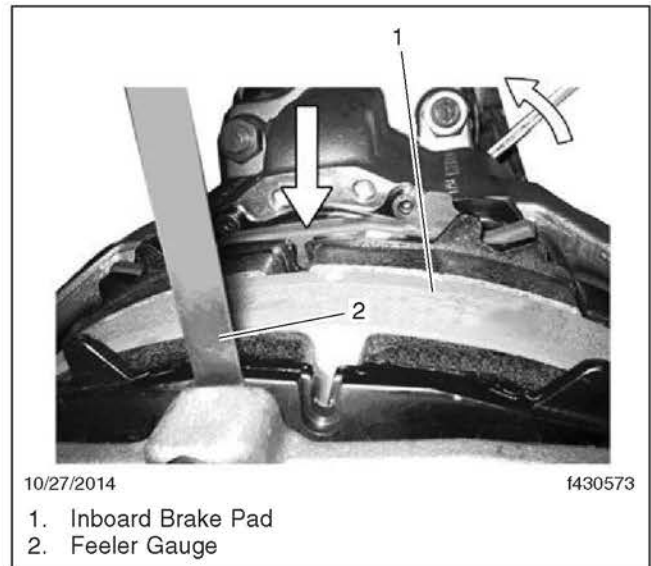
**Fig. 8, Adjusting the Clearance**

- 22.4 Install the brake pads.
- 22.5 Using a 0.047 inch (1.2 mm) feeler gauge, adjust the clearance. See the arrow in [Fig. 8](#). Insert the feeler gauge between the brake pad of the rim side and the brake caliper.
