SERVICE CAMPAIGN BULLETIN

SUBJECT: ECM REPROGRAMMING FOR ENGINE KNOCKING NOISE – SERVICE CAMPAIGN			No: SC-16-001
			DATE: February, 2016
			MODEL: 2014–15 Mirage
CIRCULATE TO:	<input checked="" type="checkbox"/> GENERAL MANAGER	<input checked="" type="checkbox"/> PARTS MANAGER	<input checked="" type="checkbox"/> TECHNICIAN
<input checked="" type="checkbox"/> SERVICE ADVISOR	<input checked="" type="checkbox"/> SERVICE MANAGER	<input checked="" type="checkbox"/> WARRANTY PROCESSOR	<input checked="" type="checkbox"/> SALES MANAGER

During cold start, the engine ECU may order inappropriate fuel amounts which may cause engine noise. This campaign bulletin instructs dealers to reprogram the ECM with new software on all affected vehicles. In rare cases, if the vehicle exhibits an engine knocking noise, the engine may need to be replaced.

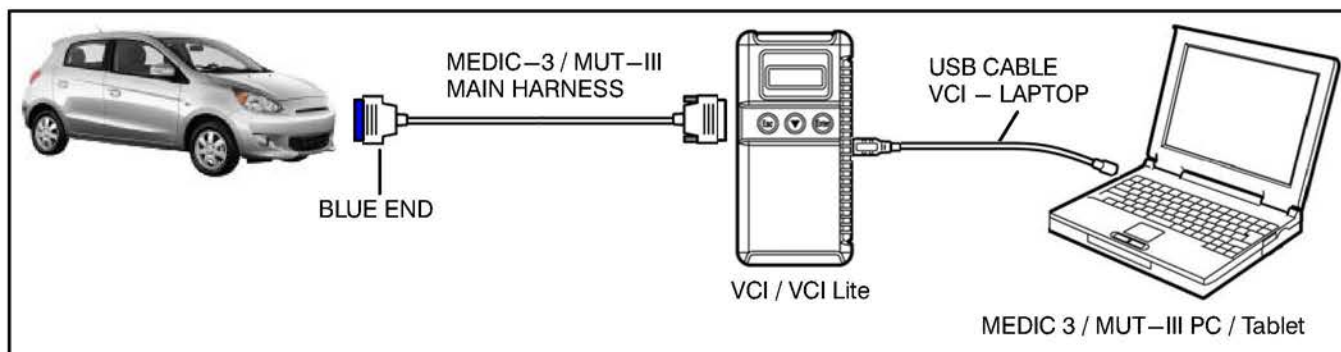
1. Connect the equipment as follows:

- Turn the MEDIC PC/tablet on. If the battery indicator in the lower right hand corner of the screen does not show a full charge, it is recommended that either the battery be charged prior to beginning, or be used with the A/C power adaptor connected.
- Connect the USB cable to the VCI/VCI Lite.
- When the laptop/tablet displays the MUT-III main screen, connect the USB cable to the device.
- Connect the MUT-III main harness with the blue DLC connection to the VCI/VCI Lite.
- Connect the blue connection of the MUT-III main harness to the vehicle's data link connector.
- Turn the VCI power switch ON . Verify that the indicator lamp in the upper right corner of the screen is green.

NOTE: VCI and MEDIC 3.5 Laptop shown for illustration purposes only.

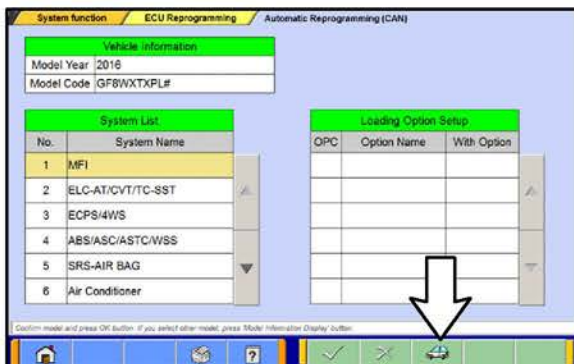
6. In ECU reprogramming, select "Automatic Reprogramming (CAN)."

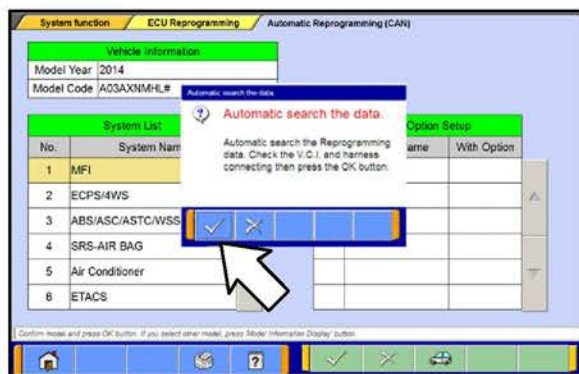
8. "MF" should be highlighted by default. If not, click on it to highlight it. Click the **check mark** to continue.

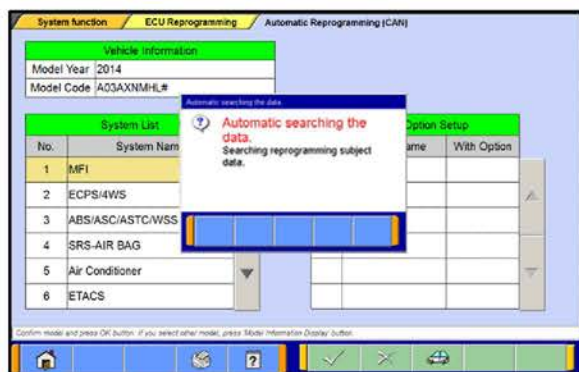
9. A message will advise the system will “Automatic search the data.”

Click the check mark to continue.

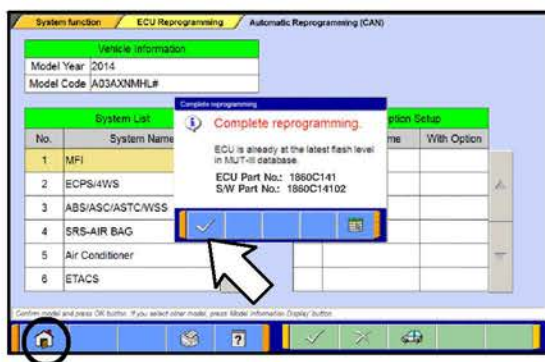
IF ECU IS ALREADY AT LATEST VERSION

If the message seen at left is displayed, the ECU software is already at the most current level. Do not continue with the reprogramming procedure. This TSB does **not** apply.

Click the check mark to clear the window, then click the Home icon at the lower left corner of the screen to return to the System Select main page.

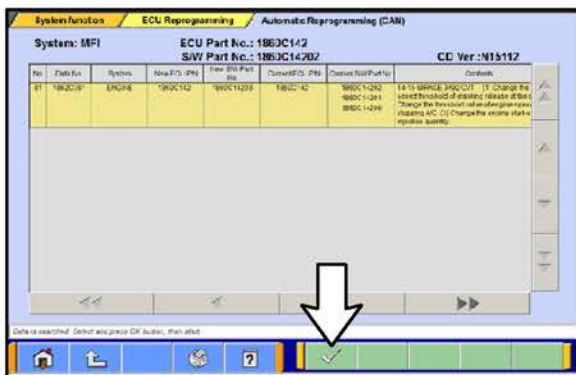
10. The Automatic Reprogramming (CAN) database screen will display.

- Verify that the new ECU and S/W part numbers are listed in the table.
- Confirm the database number at the top right of the table is N15112 or higher.
- If more than one row is displayed in the table, refer to the ECM Reprogramming Chart on page 2 to highlight and select the correct row.
- Click the check mark to continue.

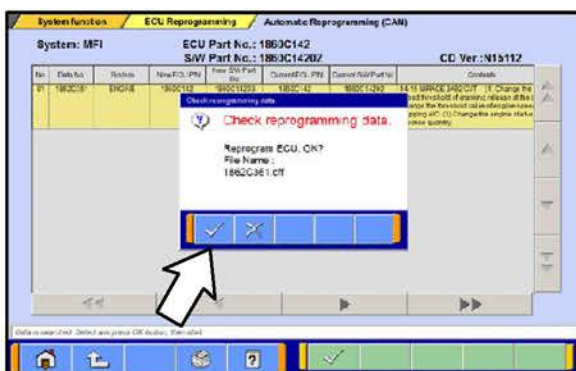
11. The "Check reprogramming data" window should appear with the new file name.

NOTE: Refer to the ECM Reprogramming Chart on page 2 for the new file names.

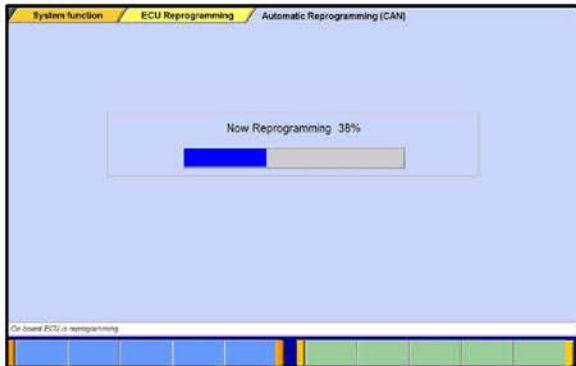
13. Once the reprogramming is initiated, the screen as shown will indicate the reprogramming progress.

NOTE: Do not disturb the cables or turn off the ignition during reprogramming.

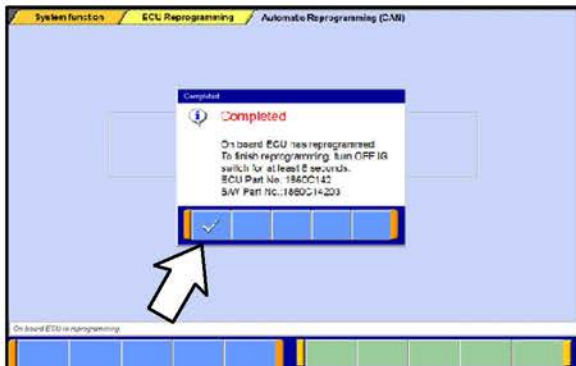
14. Reprogramming is completed.

- Verify that the S/W Part No. Is correct.
- Click on the check mark.
- Turn OFF ignition switch for at least 8 seconds.
- Turn ignition switch ON, then proceed to the next step.

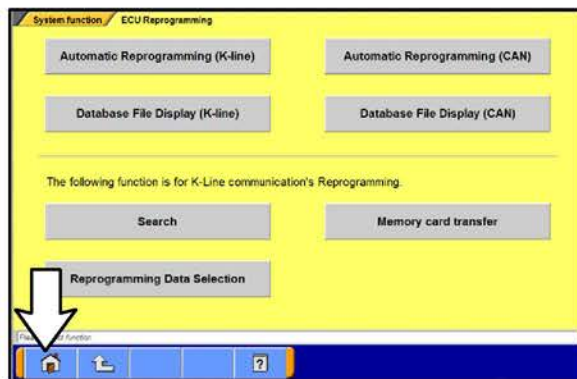
15. Click on the "home" button.

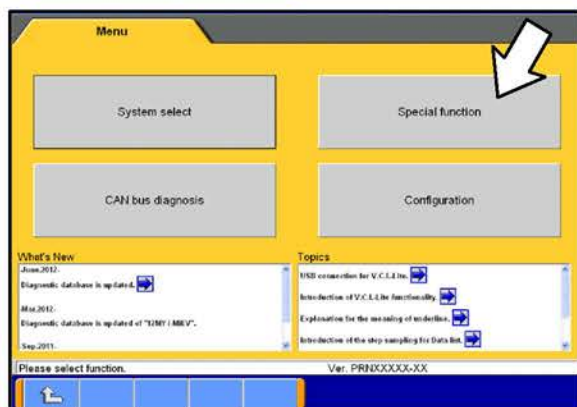
16. Perform an "Erase and Read all DTCs."

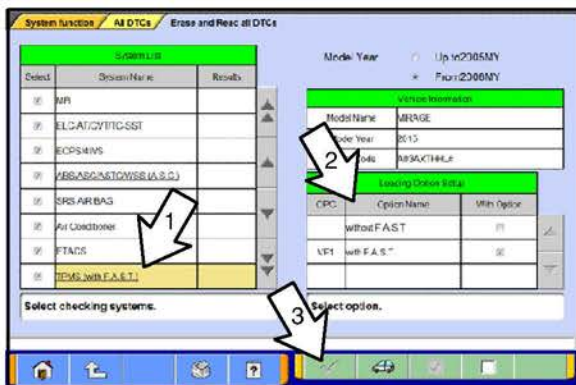
- d. The "System List" on the left side of the screen will have all selections checked. Do not change these selections. DTCs may be set if the vehicle is equipped with options that are unchecked.
- e. Click the check mark to continue.

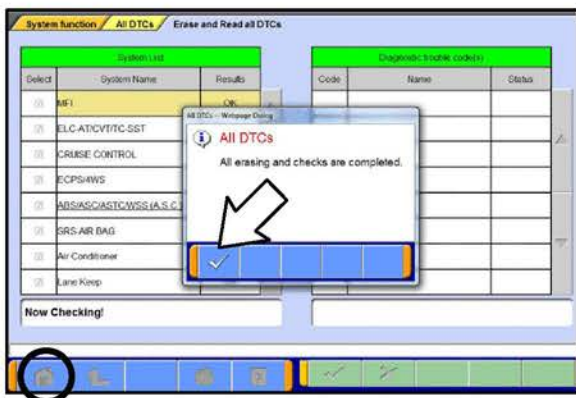
NOTE: If, in some cases, the check mark button at the bottom is not active, perform the following:

- 1) Select the System name that is underlined (for example, TPMS, as shown on left).
- 2) Select the appropriate option for the vehicle. Repeat steps 1 and 2 for all underlined systems.
- 3) Click on the check mark. Wait until MUT-III is finished and click the check mark again to confirm.
