Technical Service Bulletin

SUBJECT:			No: TSB-16-13-001REV
ECM REPROGRAMMING FOR HARD TO RE-START ENGINE WITH LOW COOLANT TEMPERATURE			DATE: March, 2016
			MODEL: 2014-16 Outlander
CIRCULATE TO:	<input type="checkbox"/> GENERAL MANAGER	<input type="checkbox"/> PARTS MANAGER	<input checked="" type="checkbox"/> TECHNICIAN
<input checked="" type="checkbox"/> SERVICE ADVISOR	<input checked="" type="checkbox"/> SERVICE MANAGER	<input checked="" type="checkbox"/> WARRANTY PROCESSOR	<input type="checkbox"/> SALES MANAGER

Affected vehicles may exhibit a condition where the engine is hard to re-start if engine coolant temperature is low. Due to inappropriate programming in the engine ECM, if the coolant temperature is between 32 – 68 °F (0 – 20 °C), a hard to re-start condition may occur.

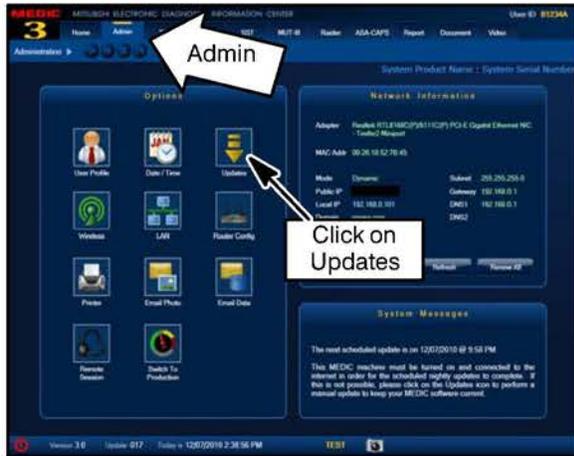
3. Select the MEDIC 3/4 Admin tab and click on “Updates.”

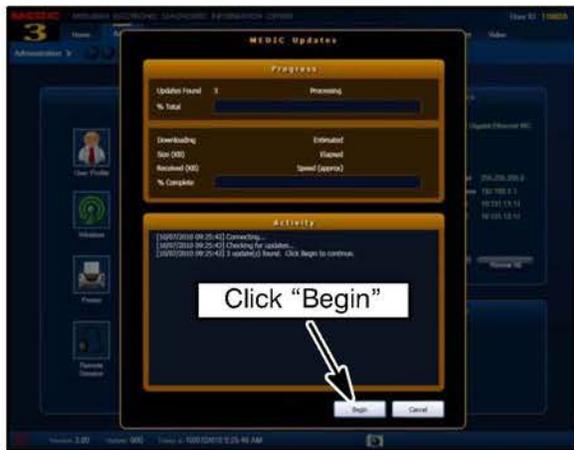
4. If the MEDIC update screen advises updates are available, click the “Begin” button. After all updates are complete, **GO TO THE REPROGRAMMING PROCEDURE.**

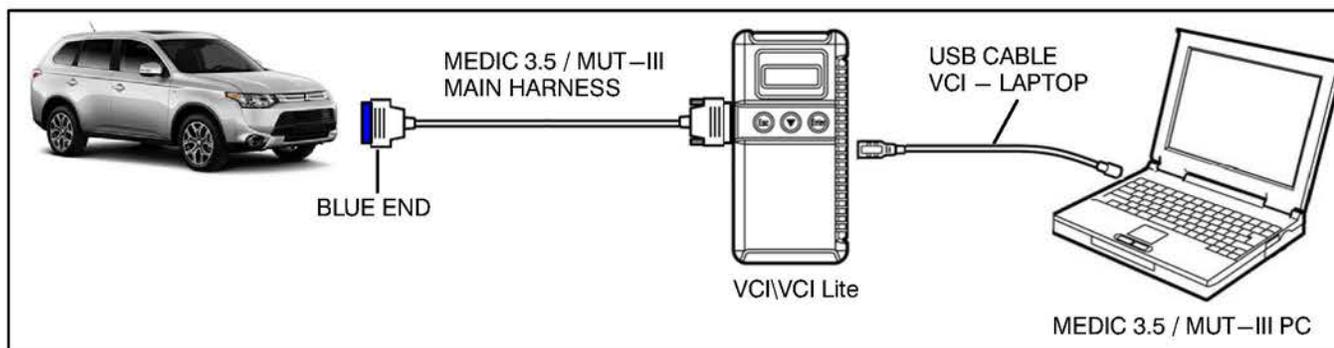
1. Connect the equipment as follows:

- Turn the MEDIC PC/tablet on. If the battery indicator in the lower right hand corner of the screen does not show a full charge, it is recommended that either the battery be charged prior to beginning, or be used with the A/C power adaptor connected.
- Connect the USB cable to the VCI/VCI Lite.
- When the laptop/tablet displays the MUT-III main screen, connect the USB cable to the device.
- Connect the MUT-III main harness with the blue DLC connection to the VCI/VCI Lite.
- Connect the blue connection of the MUT-III main harness to the vehicle's data link connector.
- Turn the VCI power switch ON . Verify that the indicator lamp in the upper right corner of the screen is green.

NOTE: VCI and MEDIC 3.5 Laptop shown for illustration purposes only.

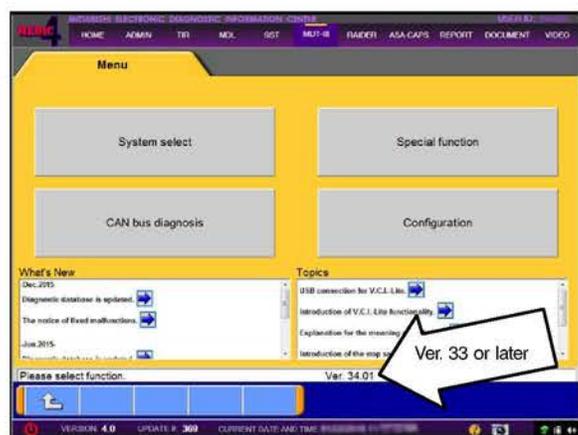
- #### 3. If using MEDIC, from the main page, click the MUT-III STV icon at the top center of the screen to open MUT-III.

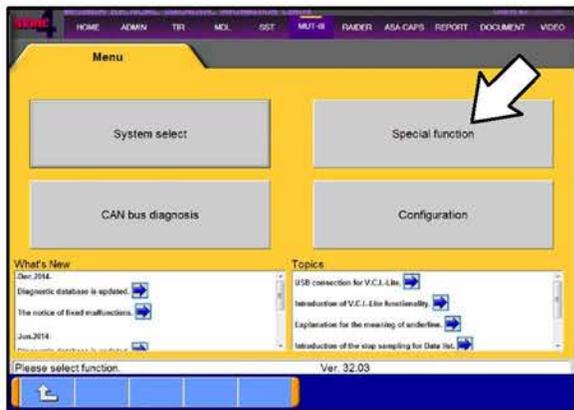
4. Go to the MUT-III home screen and click on “Special function.”

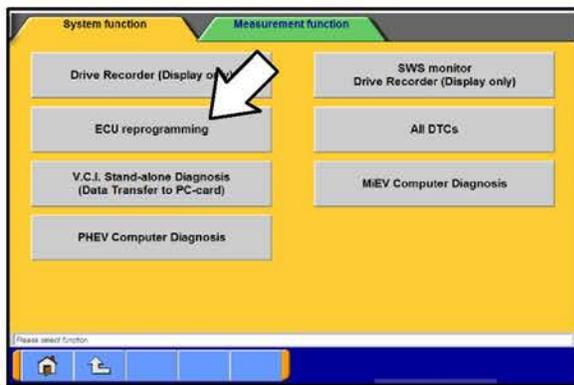
5. Select “ECU reprogramming.”

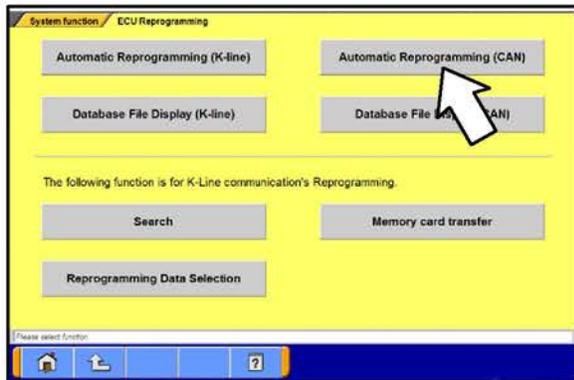
6. In ECU reprogramming, select “Automatic Reprogramming (CAN).”

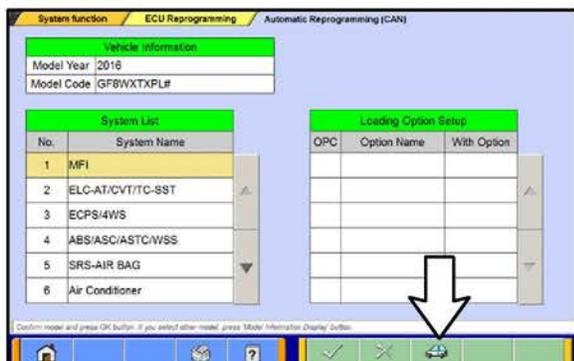
7. Press the model information display button (car icon) and verify that all vehicle information is correct.

- If vehicle information is NOT correct, follow steps a – c below.
- If vehicle information is correct, click the check mark at the bottom of the page, then go to step 8.

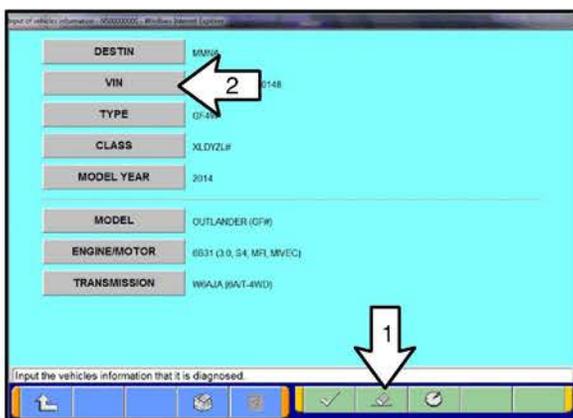
- a. If the VIN or vehicle description displayed does not match the vehicle you are working on, click the eraser icon at the bottom of the page to erase vehicle data. Then click the “VIN” button.

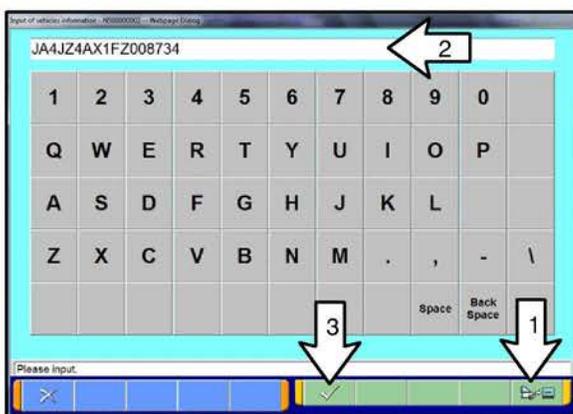
- b. Click the icon in the lower RH corner of the screen to have MUT—III automatically read the VIN.

If a message appears saying the VIN cannot be input automatically, manually enter the 17 digit VIN into the VIN field at the top of the page.

Make sure the VIN is correct and click the check mark.

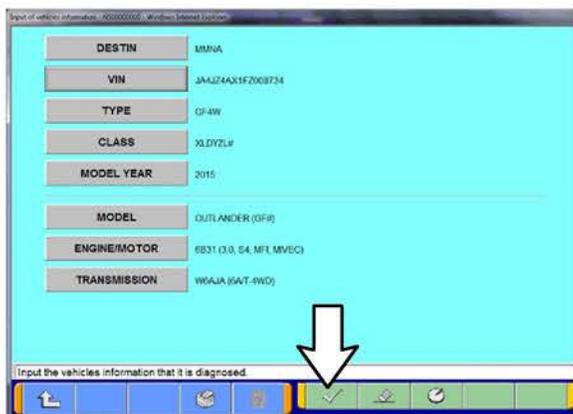
- c. Confirm all data matches the vehicle, then click the check mark at the bottom of the page.

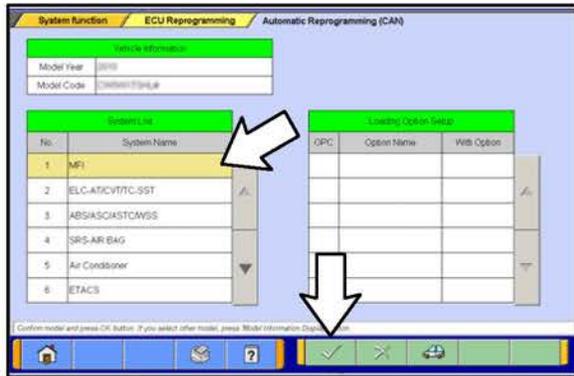
8. “MFI” should be highlighted by default. If not, click on it to highlight it. Click the **check mark** to continue.

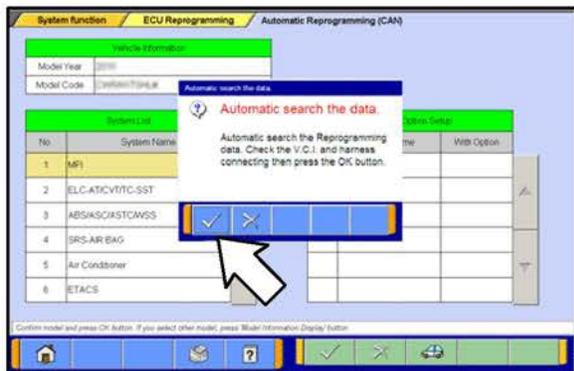
9. A message will advise the system will “Automatic search the data.”

Click the check mark to continue.

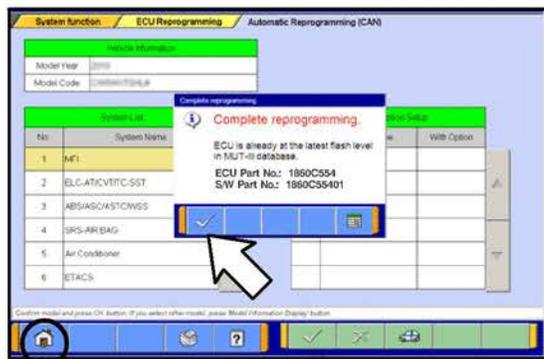
IF ECU IS ALREADY AT LATEST VERSION

If the message seen at left is displayed, the ECU software is already at the most current level. Do not continue with the reprogramming procedure. This TSB does **not** apply.

Click the check mark to clear the window, then click the Home icon at the lower left corner of the screen to return to the System Select main page.

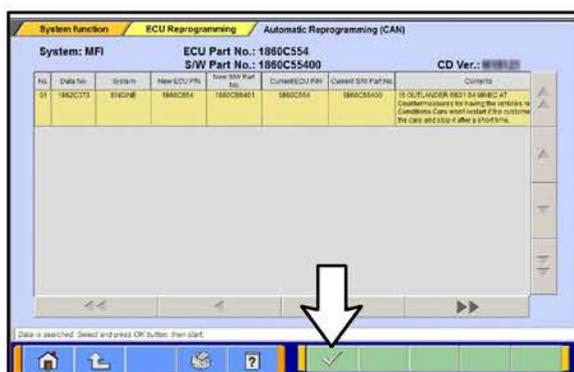
10. The Automatic Reprogramming (CAN) database screen will display.

- Verify that the new ECU and S/W part numbers are listed in the table.
- Confirm the database number at the top right of the table is *N16031* or higher.
- If more than one row is displayed in the table, refer to the ECM Reprogramming Chart on page 2 to highlight and select the correct row.
- Click the check mark to continue.

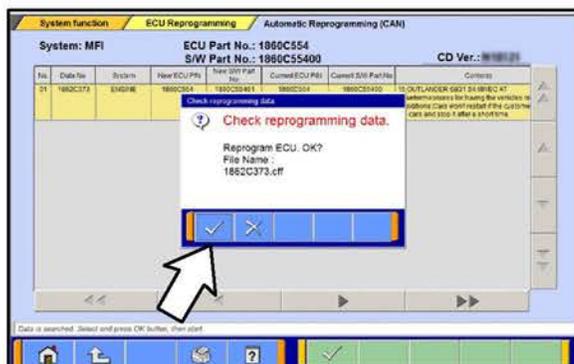
11. The "Check reprogramming data" window should appear with the new file name.

12. Click on the check mark in the pop-up box to initiate the reprogramming.

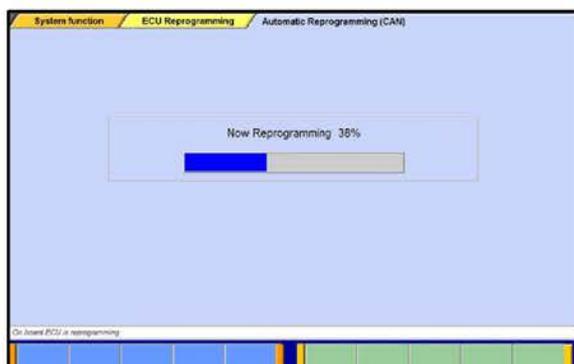
13. Once the reprogramming is initiated, the screen as shown will indicate the reprogramming progress.

NOTE: Do not disturb the cables or turn off the ignition during reprogramming.

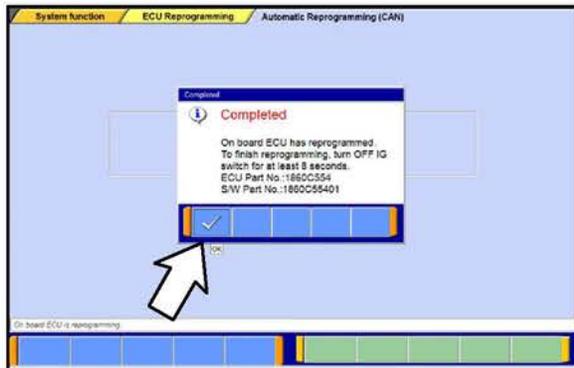
14. Reprogramming is completed.
 - a. Verify that the S/W Part No. Is correct.
 - b. Click on the check mark.
 - c. Turn OFF ignition switch for at least 8 seconds.
 - d. Turn ignition switch ON, then proceed to the next step.

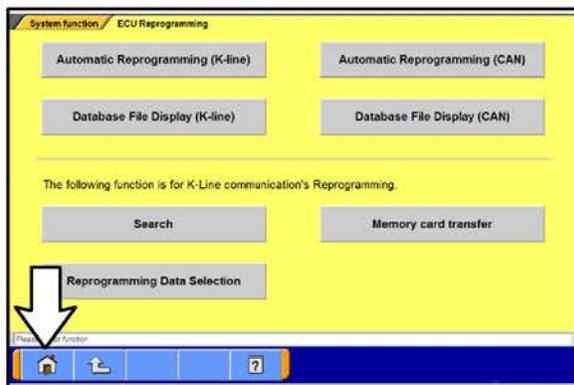
15. Click on the "home" button.

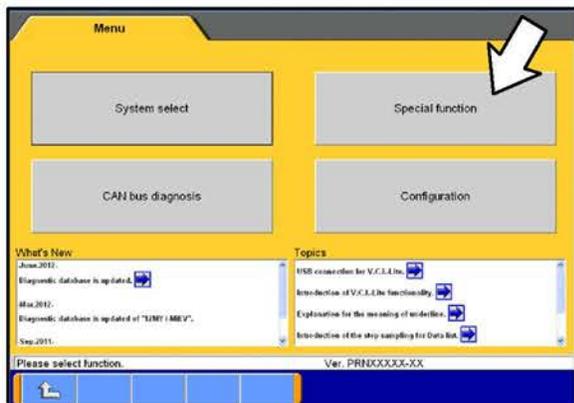
16. Perform an "Erase and Read all DTCs."
 - a. Select "Special function."

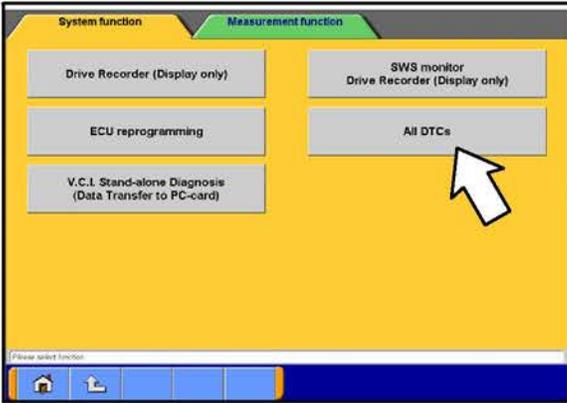
b. Select "All DTCs."

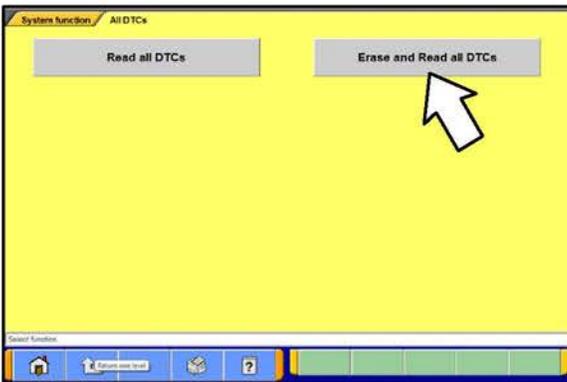
c. Select "Erase and Read All DTCs."

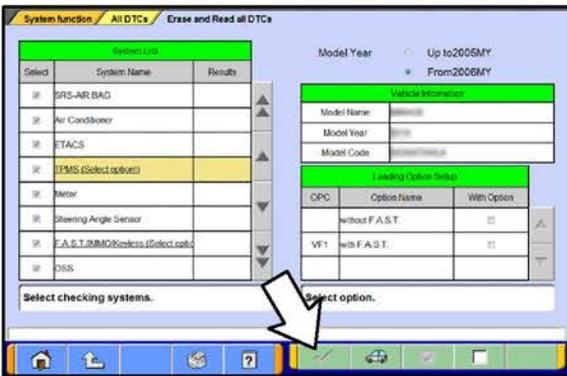
d. The "System List" on the left side of the screen will have all selections checked. Do not change these selections. DTCs may be set if the vehicle is equipped with options that are unchecked.

e. Click the check mark to continue.

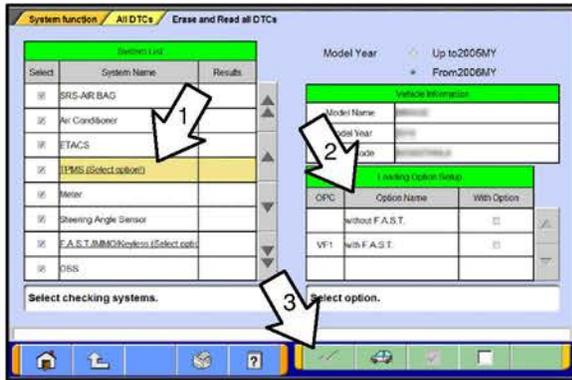
NOTE: If, in some cases, the check mark button at the bottom is not active, perform the following:

- 1) Select the System name that is underlined (for example, TPMS, as shown on left).
- 2) Select the appropriate option for the vehicle. Repeat steps 1 and 2 for all underlined systems.
- 3) Click on the check mark. Wait until MUT-III is finished and click the check mark again to confirm.

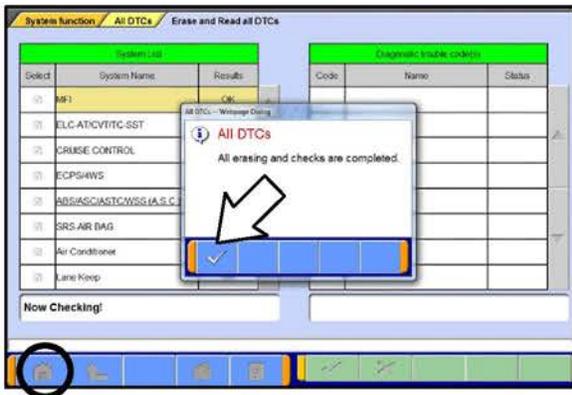
f. A window will pop up asking you to confirm DTC erasing. Click the check mark for DTC erasing and reading to begin.
