05403 Version 1

## Audio Unit and Navigation Unit Software Update

Year	Model	Trim	VIN Range
2016	Accord	EX, EX-L, Touring	ALL

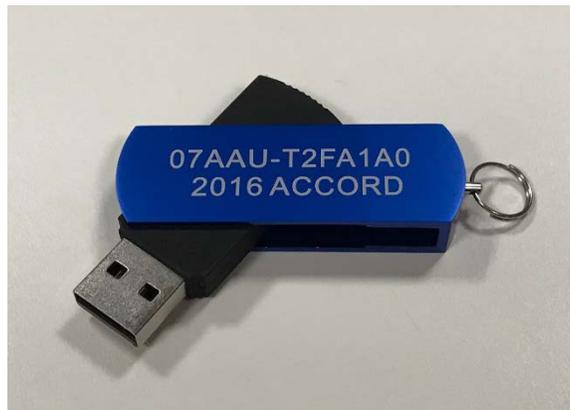
Tool Name	Part Number
Audio-Navigation System Update Device (blue USB Drive)	07AAU-T2FA1A0

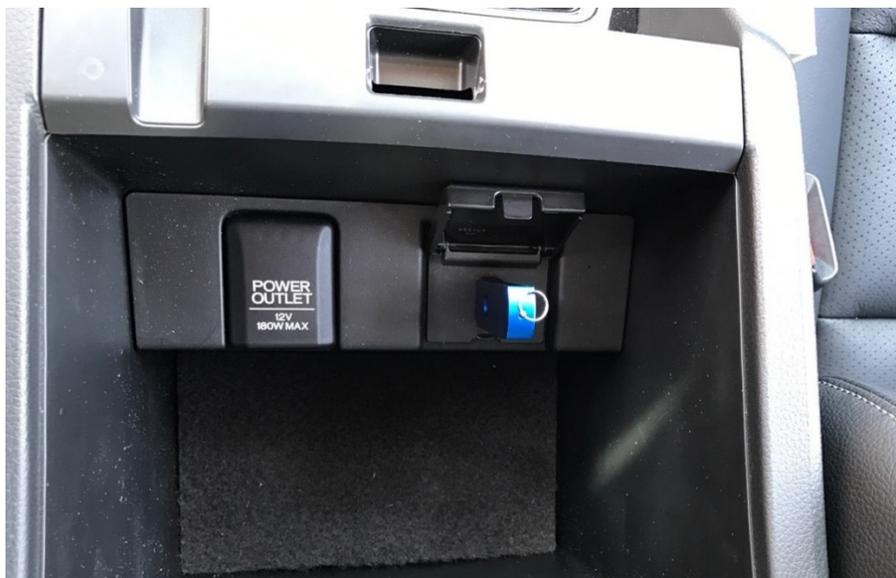
1. Prepare the vehicle for the update.
  - If the engine will be running, park the vehicle outside in a well ventilated area or attach an appropriate exhaust vent. Go to step 2.
  - If the engine will not be running, connect an active charger to the battery. Go to step 3.
2. Start the engine, and leave it running throughout the entire software update process. Go to step 4.
3. Push the Engine Start button twice to turn the Ignition to ON (not Accessory mode).
4. Plug the USB update device into the USB port in the center console.

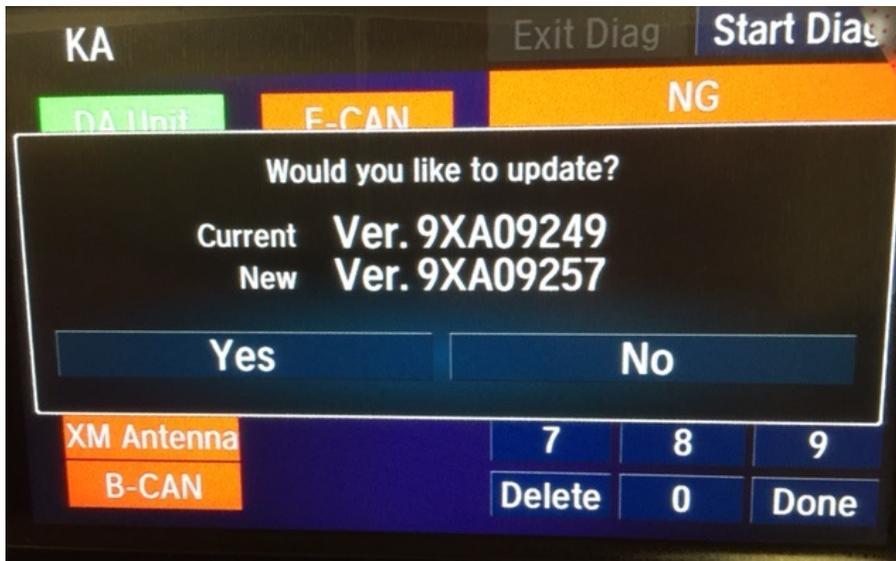
5. When the **Would you like to update?** message appears, select **YES**.

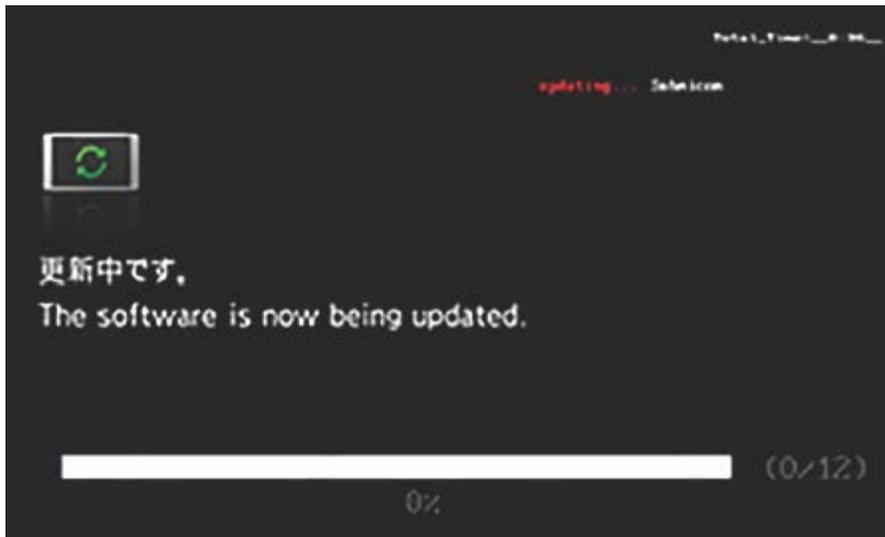
After 1 to 2 minutes, this screen will appear.

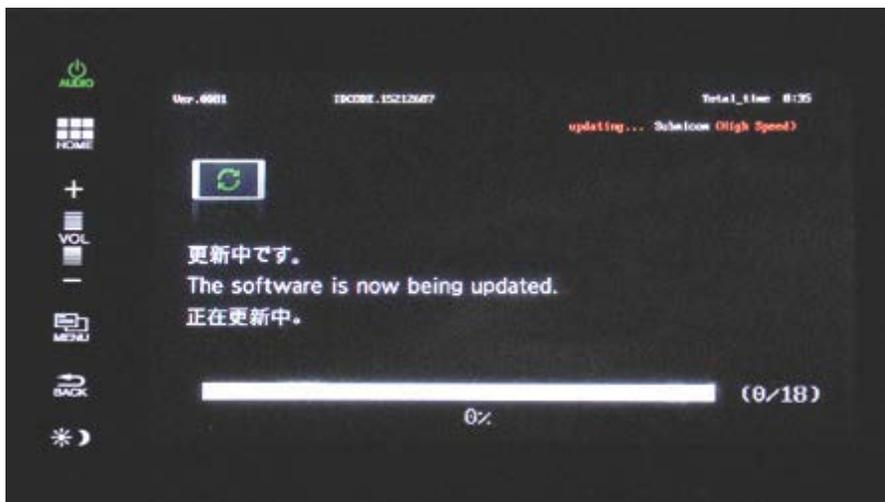
The progress bar will show 0% for about 20 to 25 minutes without updating, however, the update is still working. Once you start the update, you do not have to stay with the vehicle.

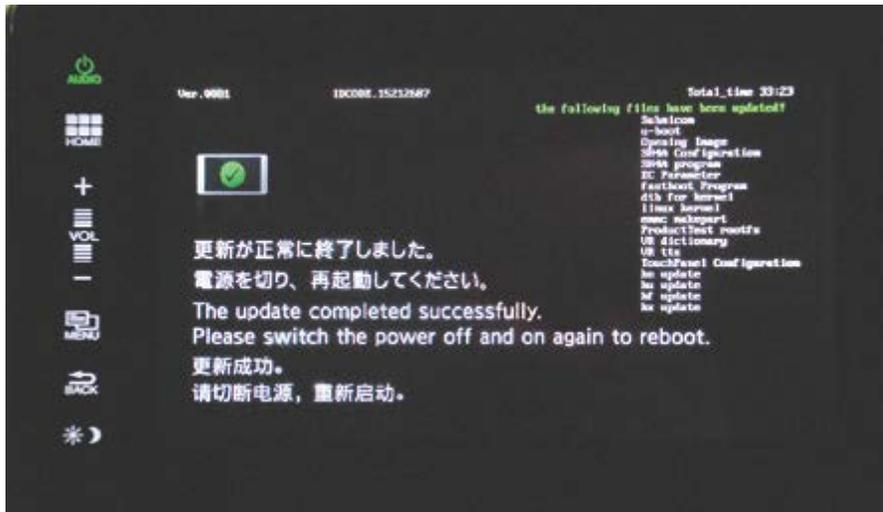
- When the **The update completed successfully** message appears, turn the ignition to OFF and remove the USB update device.

NOTE: You may hear a pop when the USB update device is removed.

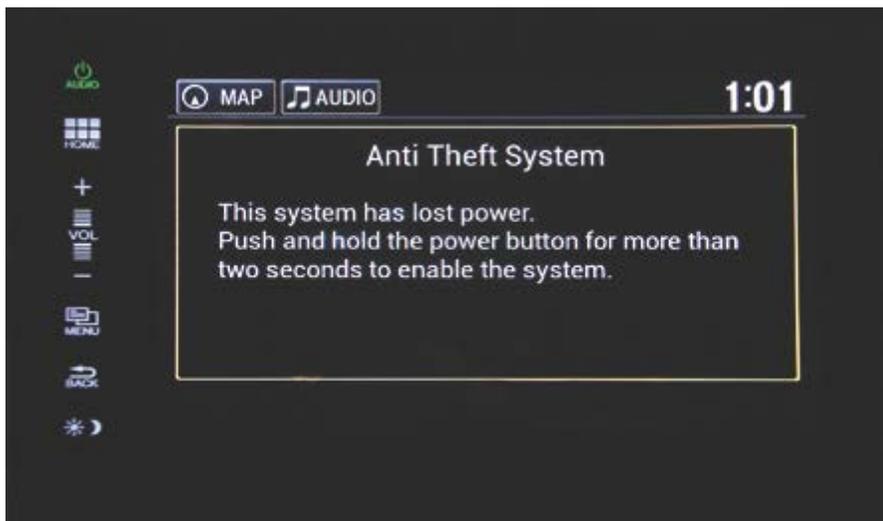
- After the engine start and the system has rebooted on its own, the **Anti Theft System** screen will appear. Press and hold the **AUDIO** button for more than 5 seconds. The update is now complete.

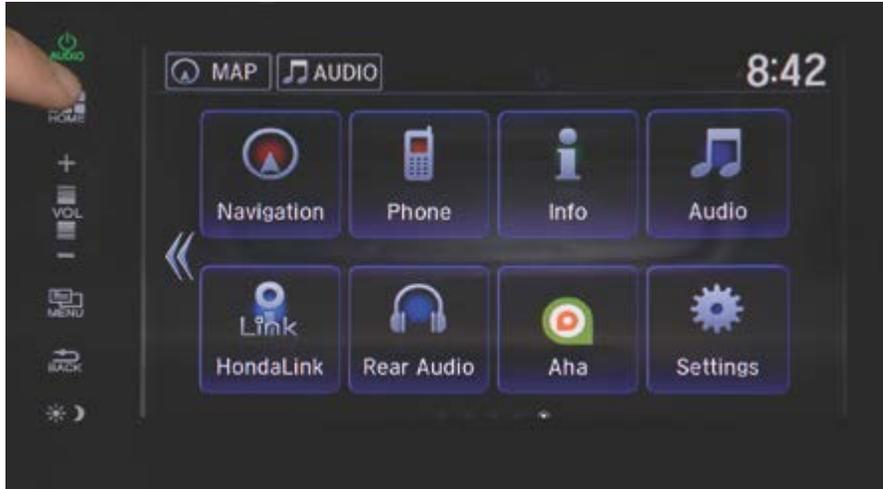
1. Select **HOME**.

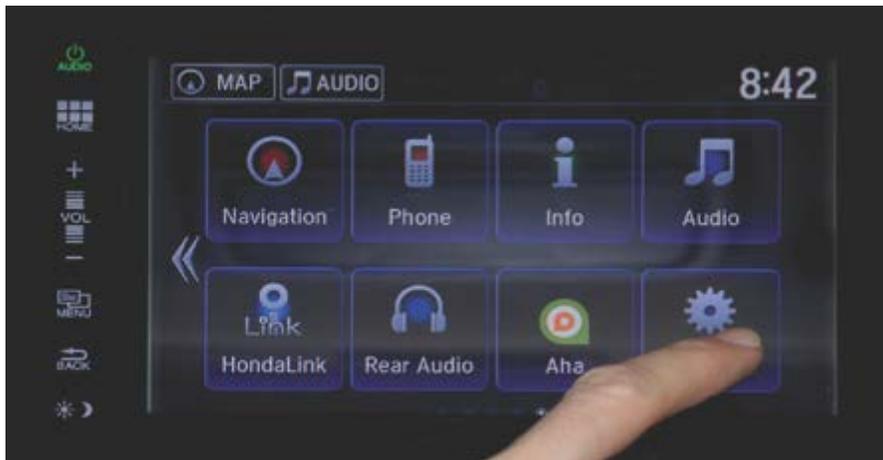
2. Select **Settings**.

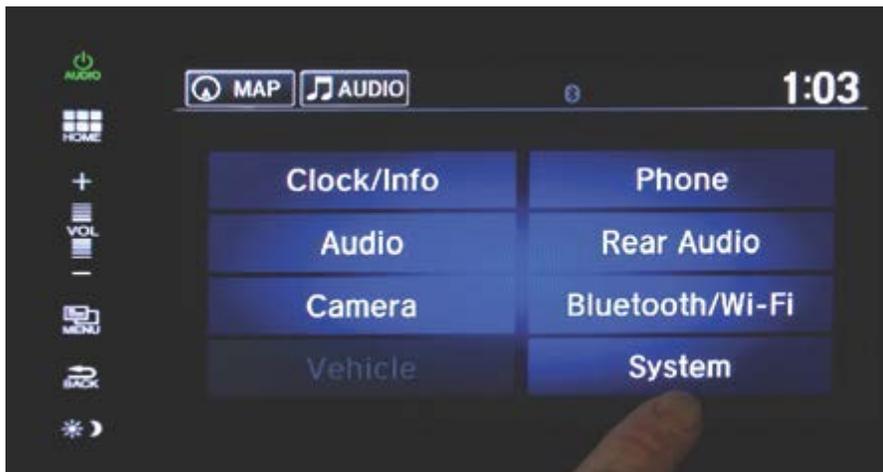
3. Select **System**.

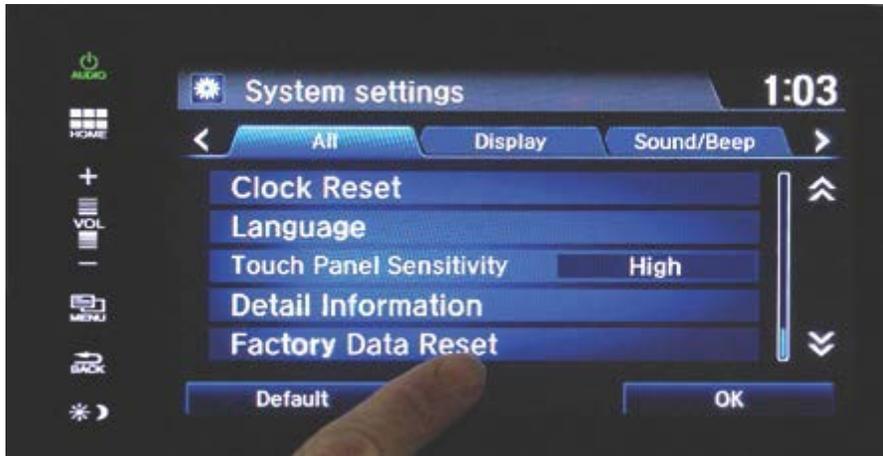
4. Scroll down and select **Factory Data Reset**.

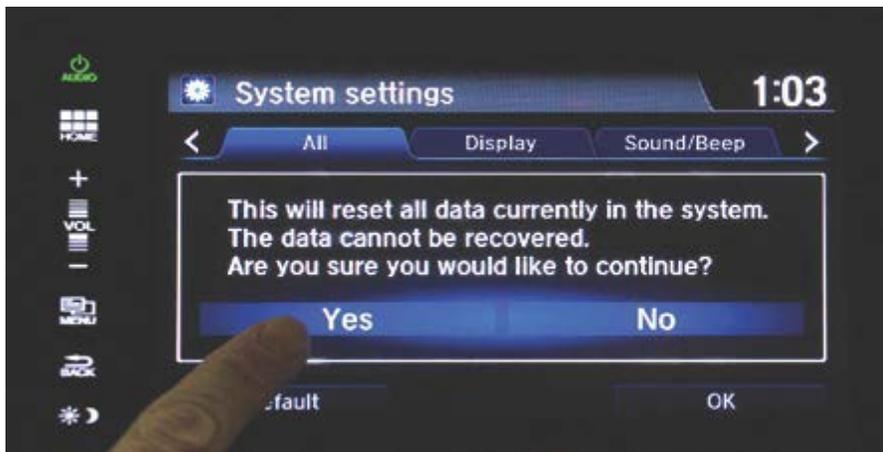
5. When the pop-up screen appears select **Yes**. The system will reboot and return to normal. The phone can now be paired using the Phone Setup in the owner's manual.

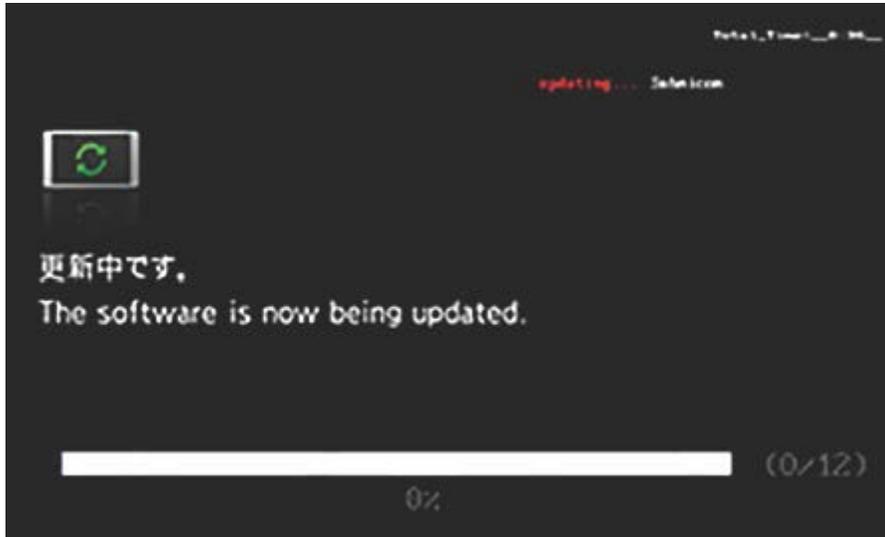
6. Insert the USB update device into the USB port. The display screen may continue to be blank for up to 10 minutes. The display will show the update screen start again at 0%.

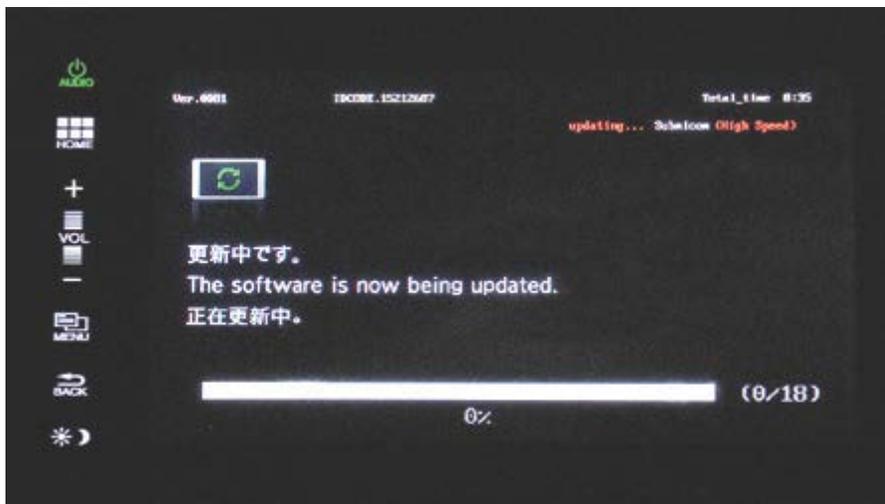
The progress bar will show 0% for about 20 to 25 minutes without updating; however, the update is still working. Once you start the update, you do not have to stay with the vehicle.

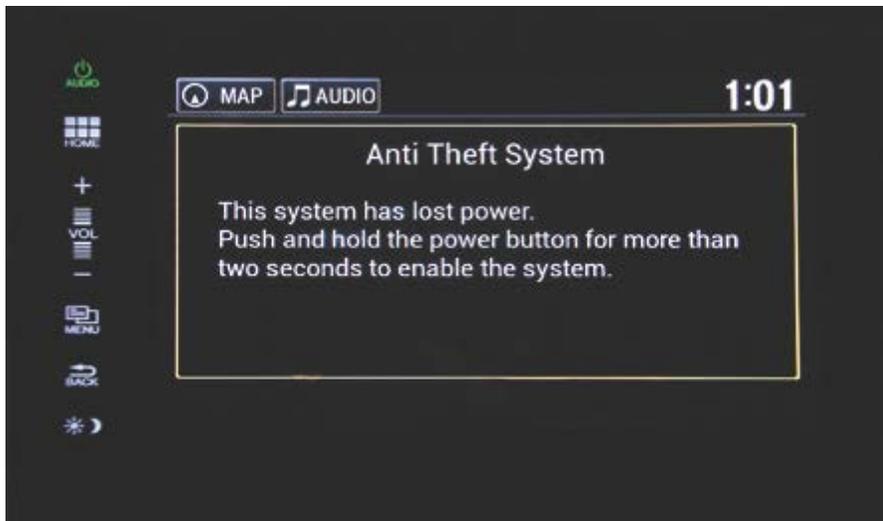
9. Start the engine. When the **Anti Theft System** screen appears, press and hold the **AUDIO** button for more than 5 seconds. The update is complete.
