06438 Version 4

**Vibration While Driving Under Light Acceleration**Supersedes 15-086, dated August 18, 2016, to revise the information highlighted in **yellow**.**AFFECTED VEHICLES**

Year	Model	Trim	VIN Range
2012-14	CR-V	ALL	ALL

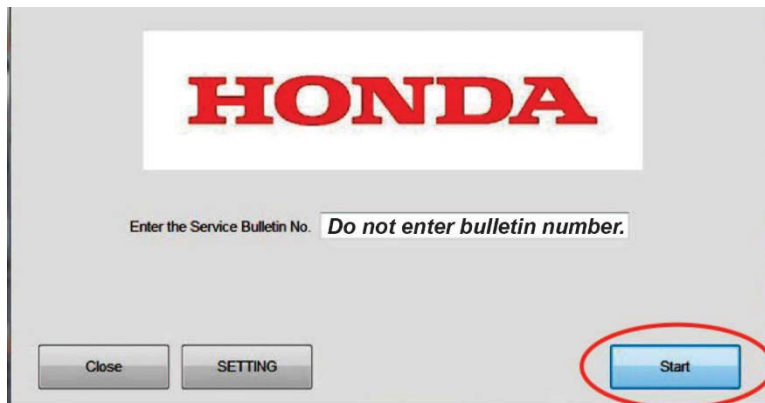
4. Select **Start**, then follow the screen prompts. NOTE: **Do not enter a bulletin number.**
