05199 Version 1

## Audio Unit Display Beeps or Changes Screens by Itself

### AFFECTED VEHICLES

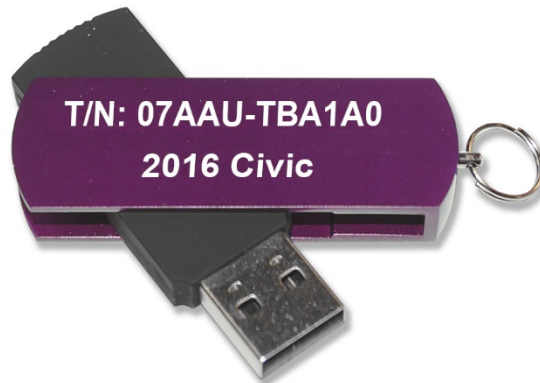
| Tool Name | Part Number |
|---|---|
| Audio-Navigation System Update Device (purple USB update tool) | 07AAU-TBA1A0 |

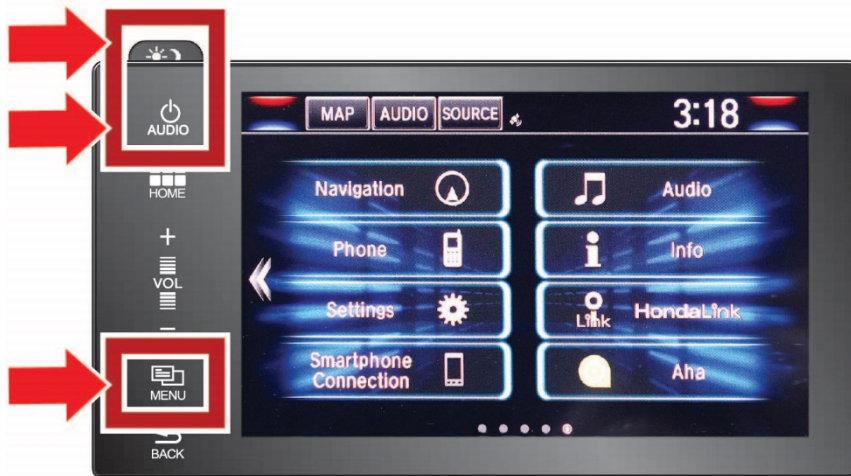
1. Prepare the vehicle for the update.
  - If the engine will be running, park the vehicle outside in a well ventilated area or attach an appropriate exhaust vent. Go to step 2.
  - If the engine will not be running, connect an active charger to the battery. Go to step 3.
2. Start the engine and leave it running throughout the entire software update process. Go to step 4.
3. Push the Engine Start button twice to turn the power mode to ON (not Accessory mode).
4. Press and hold the **Day/Night**, **Audio Power**, and **MENU** buttons at the same time.

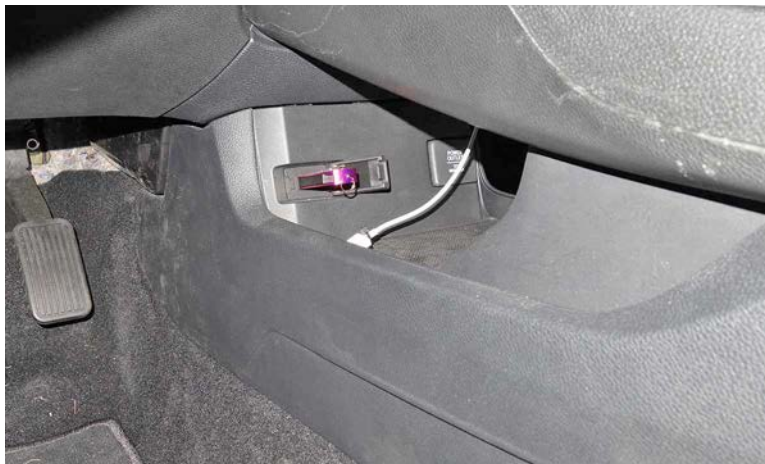
12. Plug the purple USB update device into the USB port below and behind the audio unit near the driver's knee area.

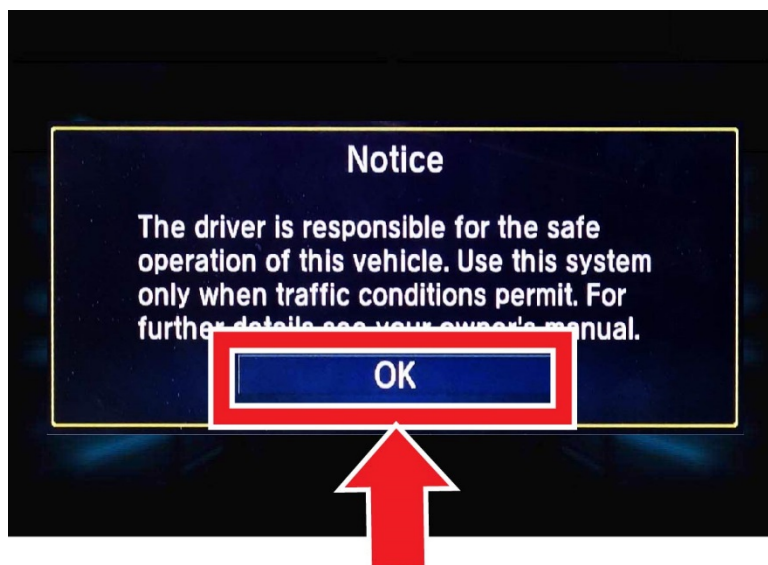
After the system reboots, click **OK** or wait for the safety notice to disappear.

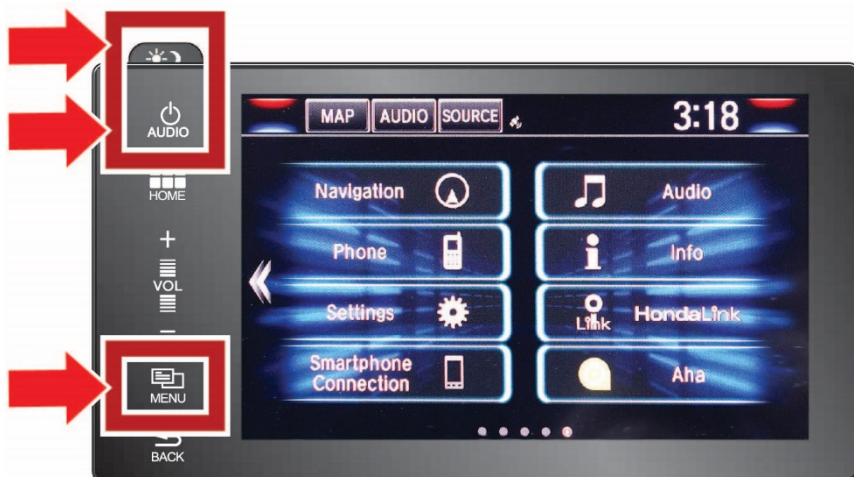
17. Press and hold the **Day/Night**, **Audio Power**, and **MENU** buttons at the same time.
