**June 20, 2017**

06539 Version 1

## 2013–15 Crosstour V6: Judder from the Torque Converter Lock-Up Clutch

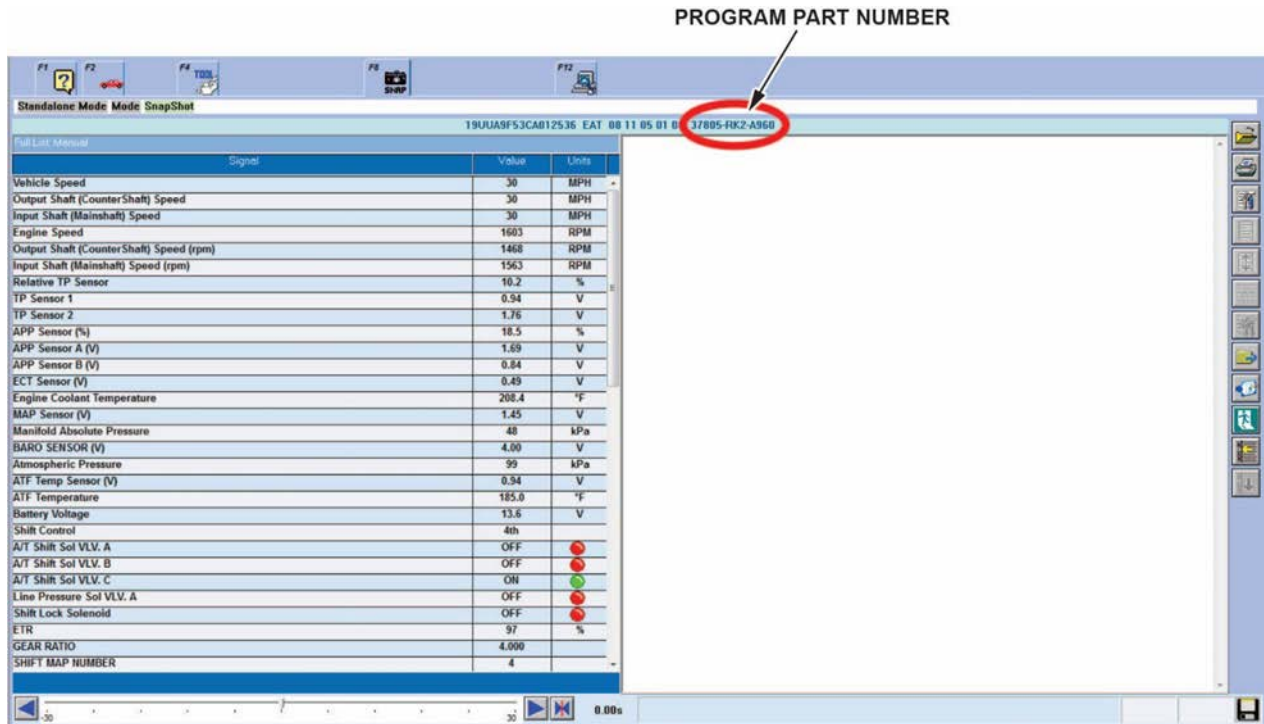
1. Connect the i-HDS, and go to the **A/T Data List**. Check to see if the software has been updated by comparing the program P/N against the table below.

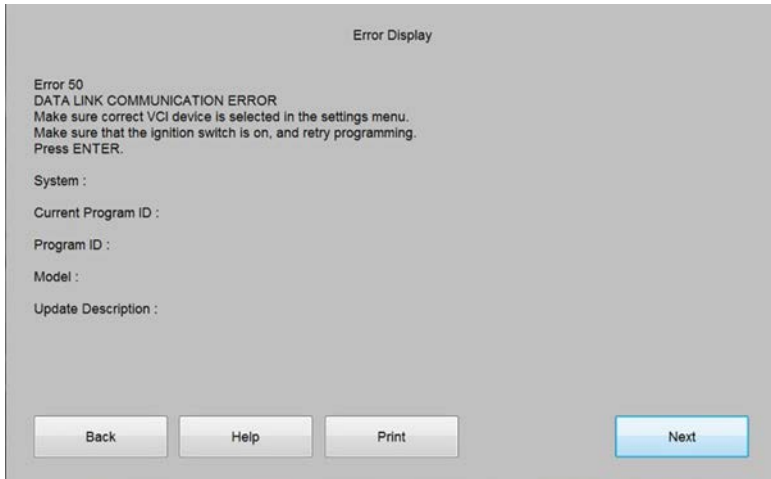
- You cannot update the vehicle using the MVCI as a standalone tool.
- Do not use the MongoosePro VCI tool.
- Make sure the 12-volt battery is fully charged before starting an update.
- Connect a fully charged jumper battery to the vehicle, and leave it connected during the entire procedure to maintain steady voltage.
- Never turn the ignition to OFF or ACCESSORY during the update. If there is a problem with the update, leave the ignition turned to ON.
- To prevent VSA modulator control unit damage, do not operate anything electrical (headlights, audio system, brakes, A/C, power windows, door locks, etc.) during the update.
- If you see the following **Error Display**, check that you are using the correct tool (MVCI or DST-i) with the i-HDS.

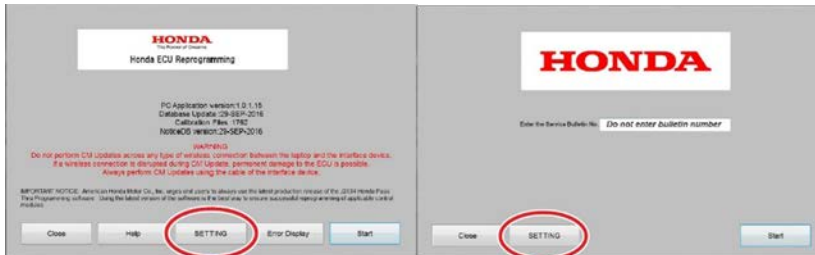
To change this, click on either of the **SETTING** selection buttons at the bottom of the J2534 initial screens as shown.

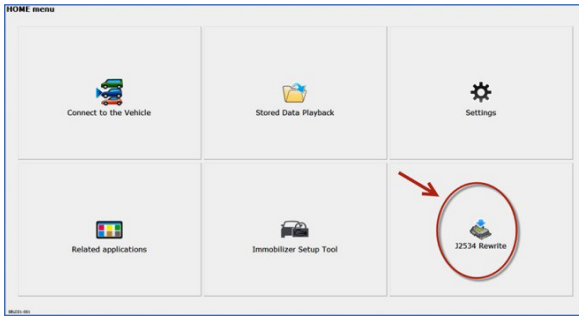
2. Select **J2534 Rewrite**.

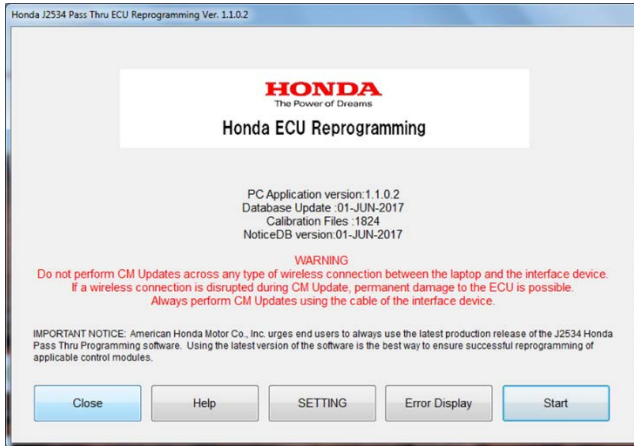
3. Confirm the software is the same **or later** as listed in SOFTWARE INFORMATION.

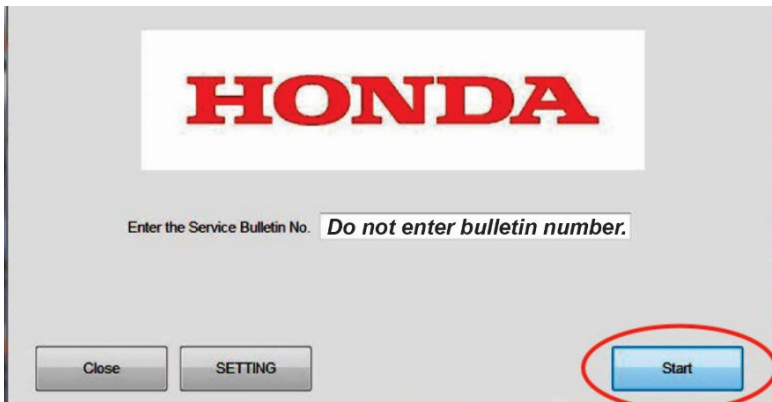
- Do not enter a bulletin number.
- If you receive a message that the vehicle has been already updated or that no update is available, check the **AT Data List**. The header should indicate one of the following numbers (or later).
