June 20, 2017

06917 Version 2

Audio Unit Display Beeps or Changes Screens by Itself

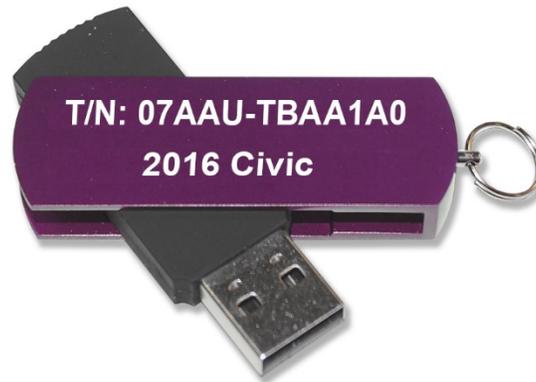
Tool Name	Part Number
Audio-Navigation System Update Device (purple USB update tool)	07AAU-TBAA1A0

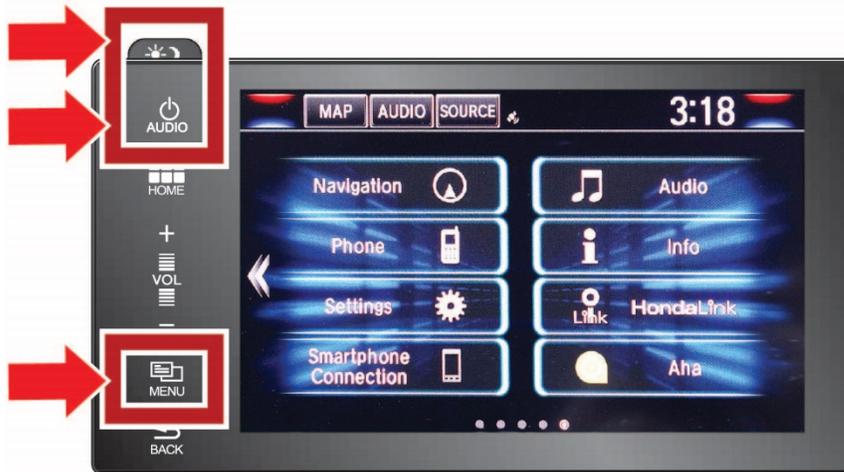
1. Prepare the vehicle for the update.
 - If the engine will be running, park the vehicle outside in a well ventilated area or attach an appropriate exhaust vent. Go to step 2.
 - If the engine will not be running, connect an active charger to the battery. Go to step 3.
2. Start the engine and leave it running throughout the entire software update process. Go to step 4.
3. Push the Engine Start button twice to turn the power mode to ON (not Accessory mode).
4. Press and hold the **Day/Night**, **Audio Power**, and **MENU** buttons at the same time.

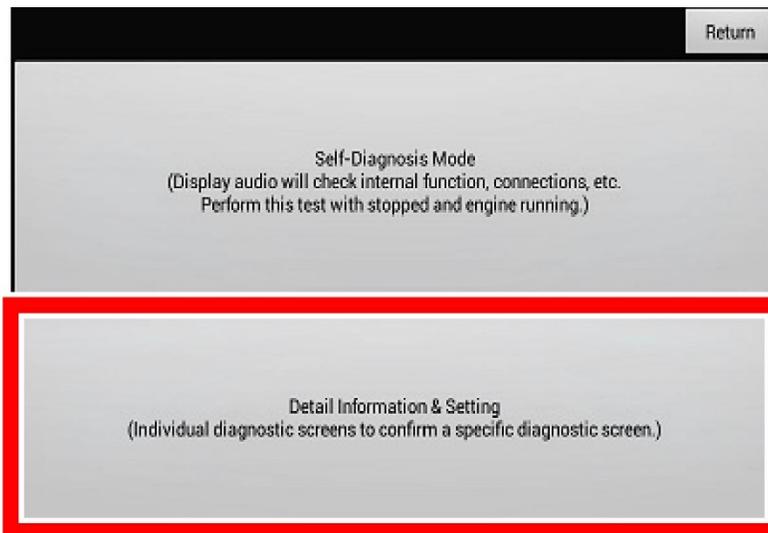
5. Select **Detail Information & Setting**.

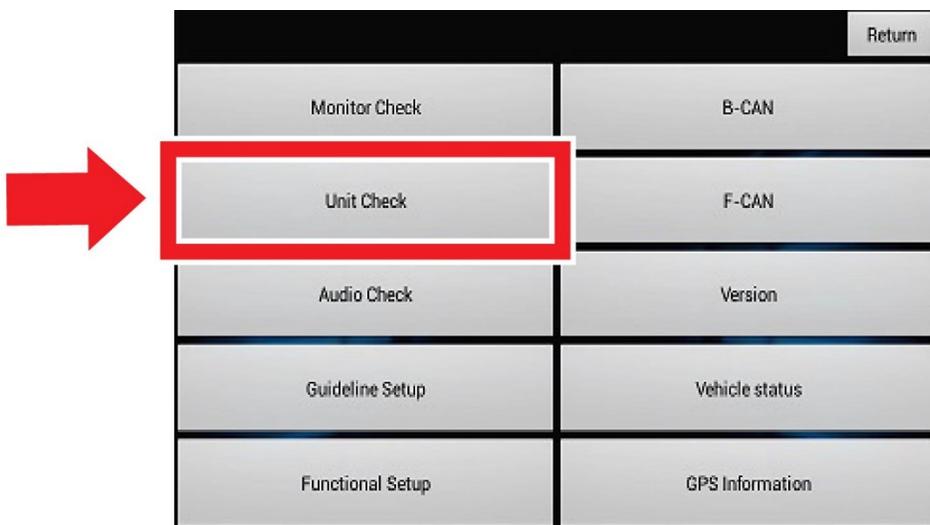
Select **Unit Check**.

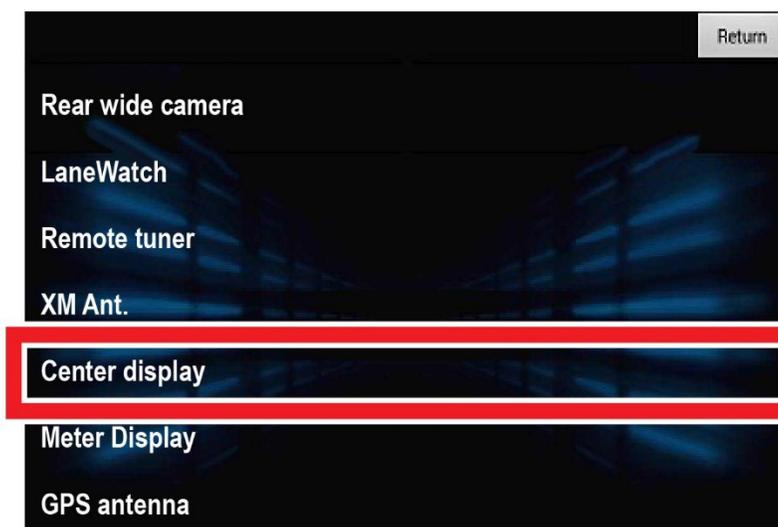
6. Scroll down and then select: **Center display**.

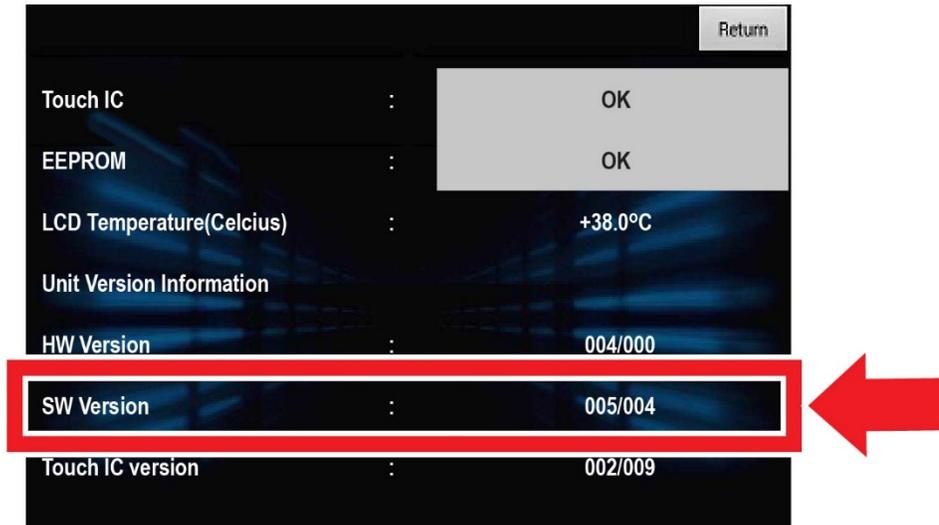
7. Scroll down to **SW Version**, and check what software version is indicated.

- If **005/004** is indicated, the software is already the latest version. This bulletin does not apply. Continue with normal troubleshooting.
- If the software version indicated is not **005/004**, continue with the update. Go to step 10.

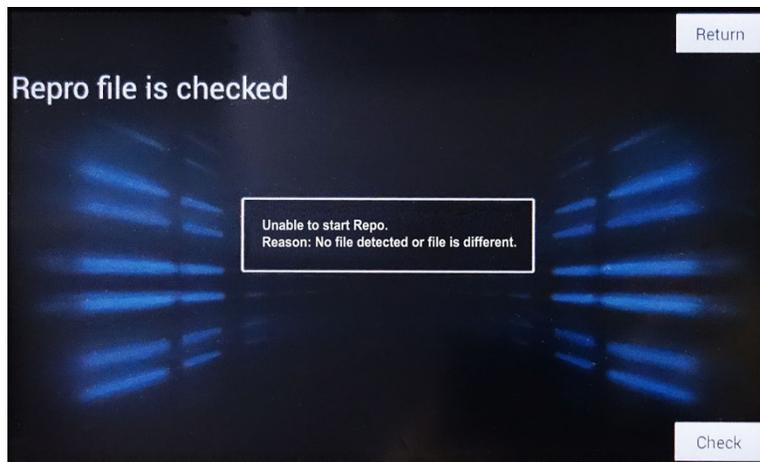
NOTE: If the “**Unable to start Repo. Reason: No files detected or file is different**” message appears, the display is already updated to the latest software version. This bulletin does not apply.

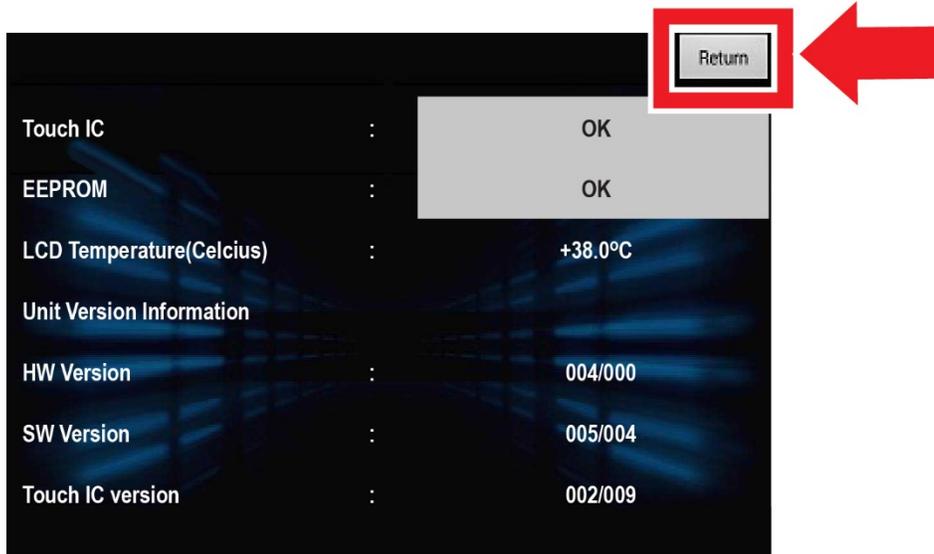
8. Select **Return** to return to the **Unit Check** menu screen.

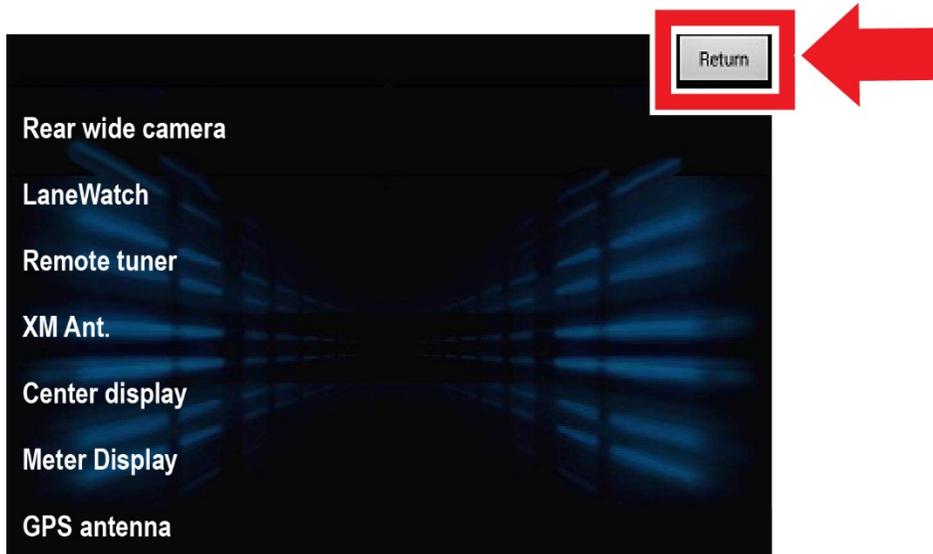
9. Select **Return** to return to the **Detail & Information Setting** menu screen.

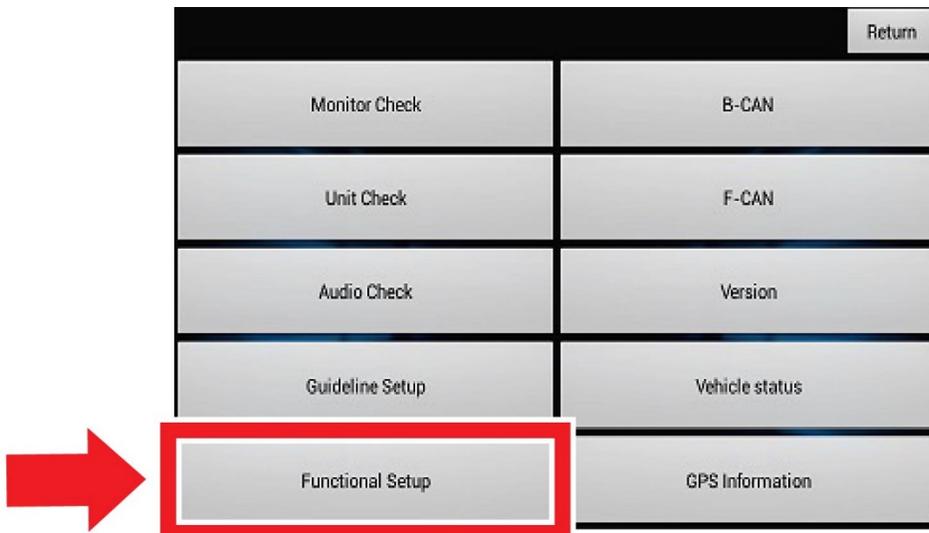
10. Select **Functional Setup**.

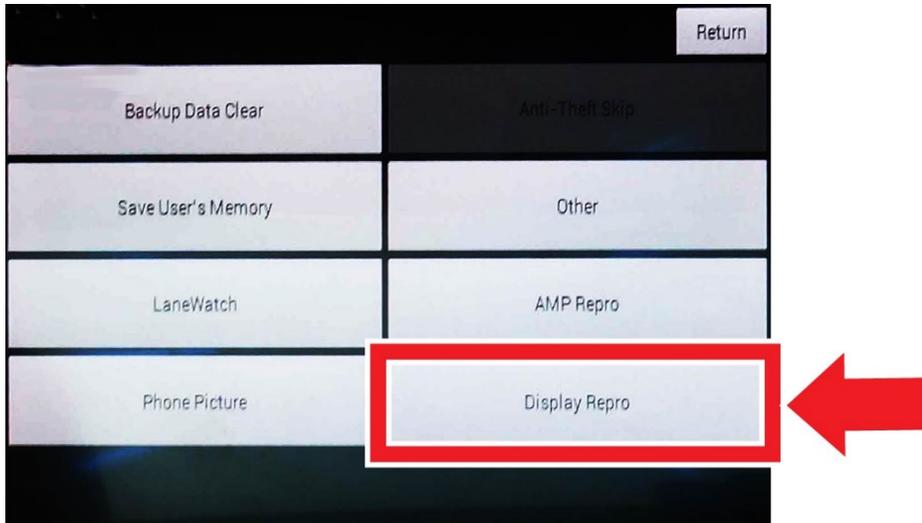
11. Select **Display Repro**.

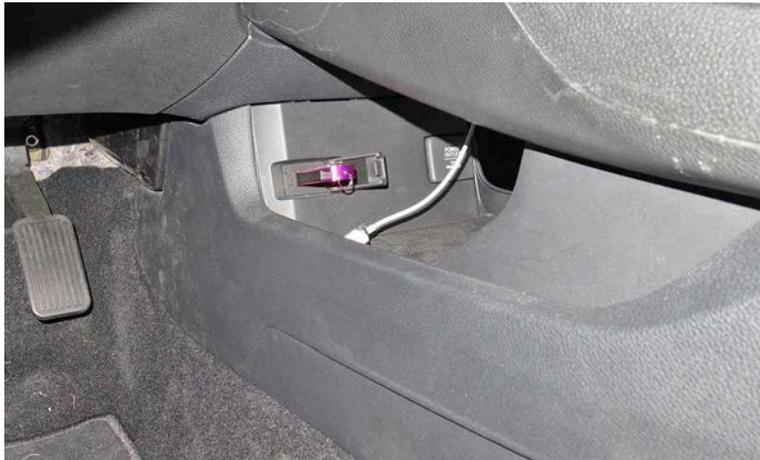
12. Plug the purple USB update device into the USB port below and behind the audio unit near the driver's knee area.

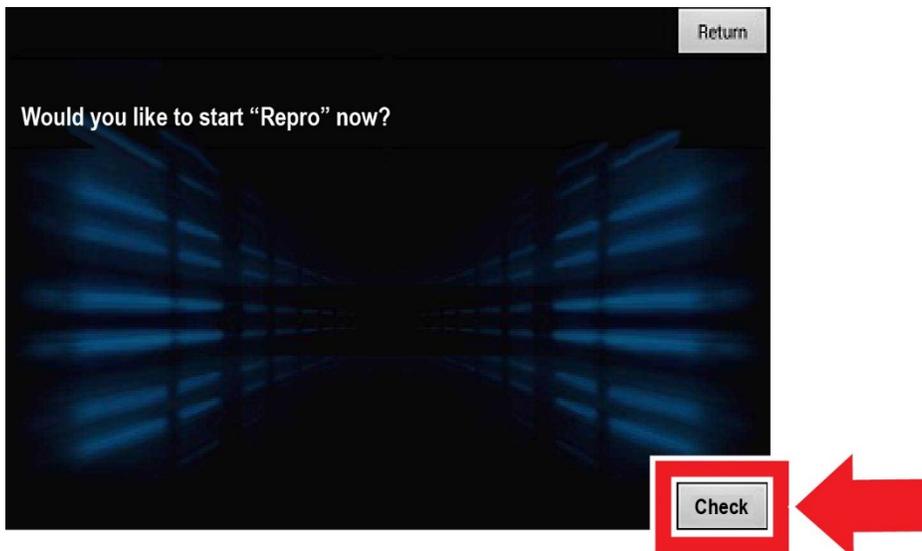
13. When the “Would you like to start “Repro” now?” message appears, select **Check**.

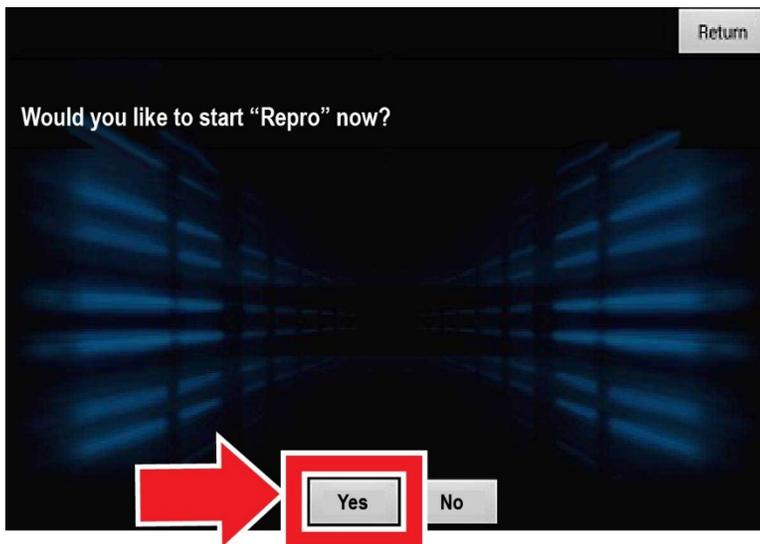
14. After checking the “Would you like to start “Repro” now?” message, select **Yes**.

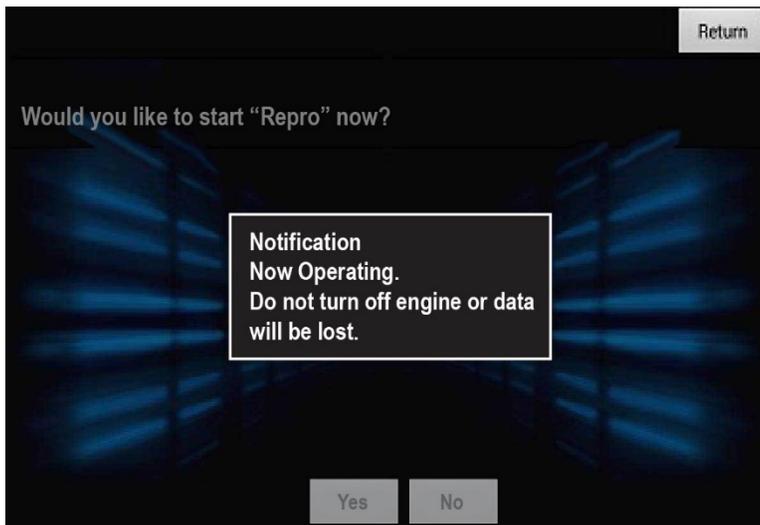
The software update should start. It takes up to 3 minutes to complete the update. Once you start the update, you do not have to stay with the vehicle.

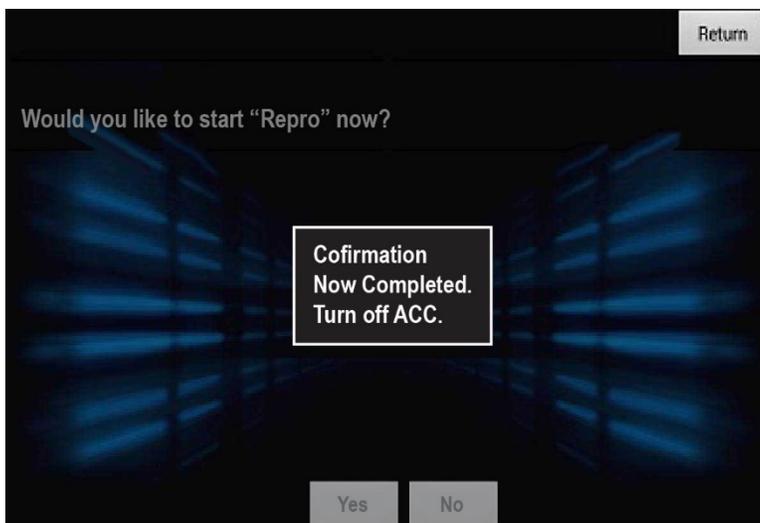
15. If the update operation completes normally, it will automatically reboot the display. If the “**Confirmation Now completed. Turn off ACC**” message appears, reboot the head unit by turning the power mode to OFF for 2 minutes. Then, restart the engine or turn the ignition to ON.

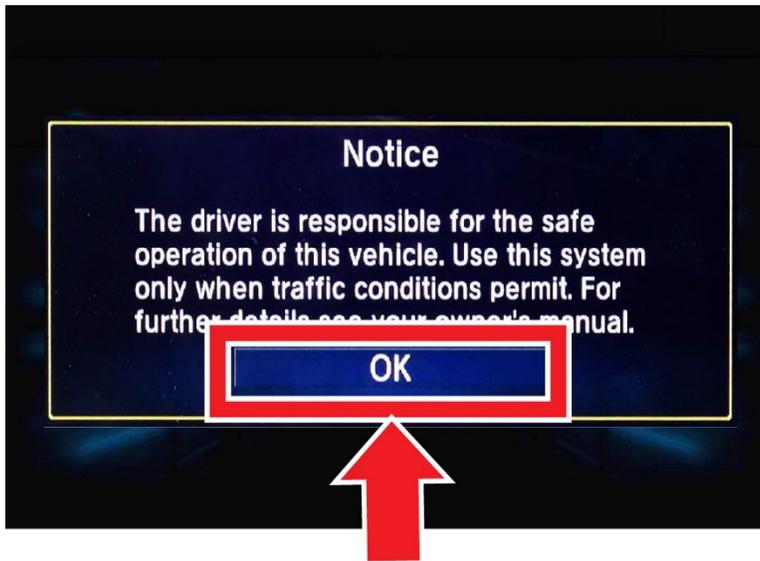
After the system reboots, click **OK** or wait for the safety notice to disappear.

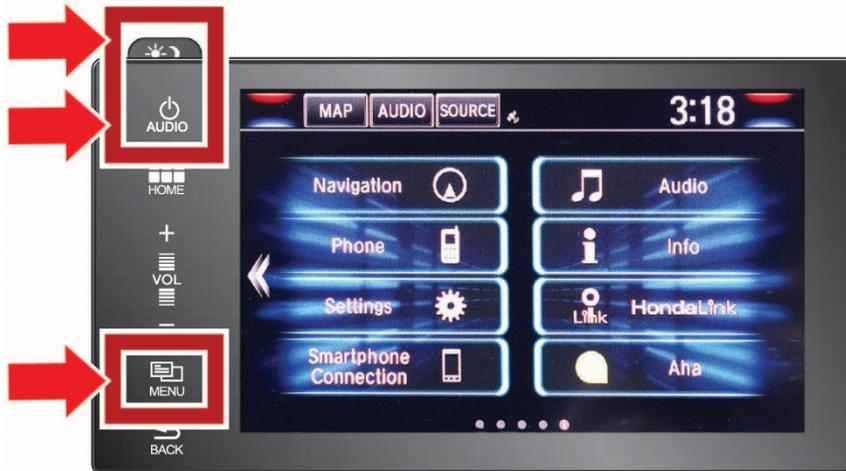
17. Press and hold the **Day/Night**, **Audio Power**, and **MENU** buttons at the same time.

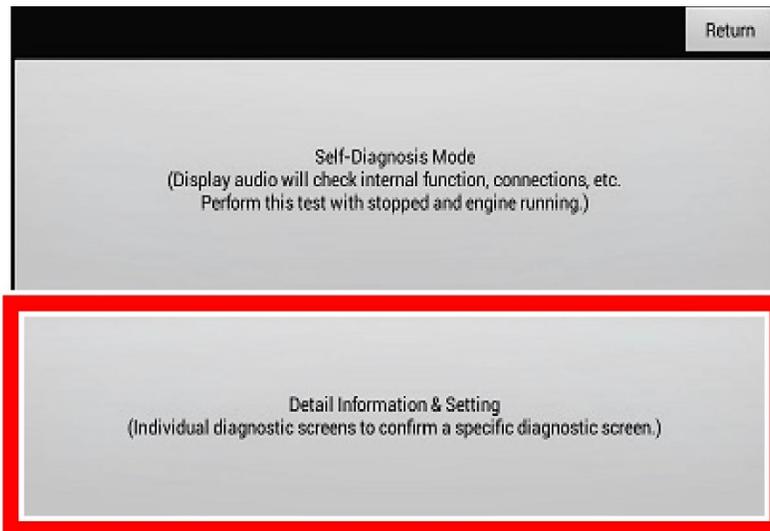
18. Select **Detail Information & Setting**.

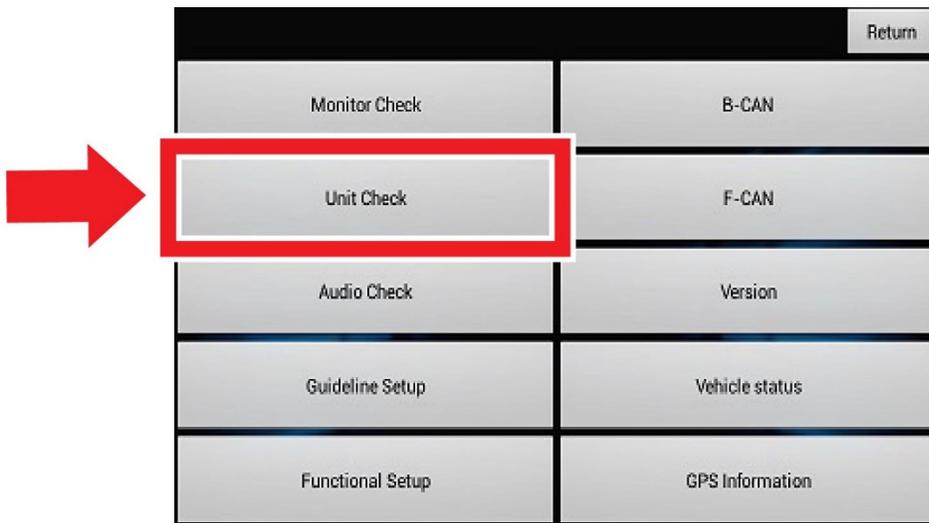
19. Select **Unit Check**.

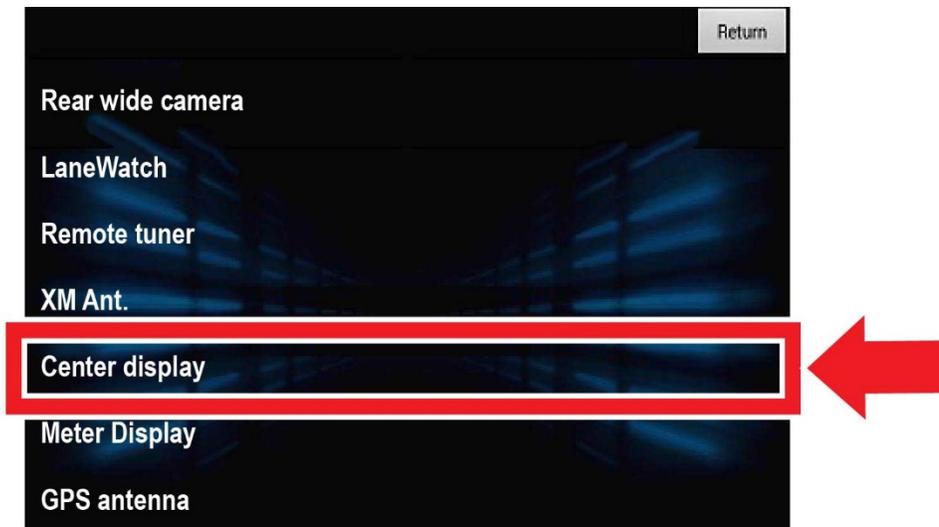
20. Scroll down and then select: **Center display**.

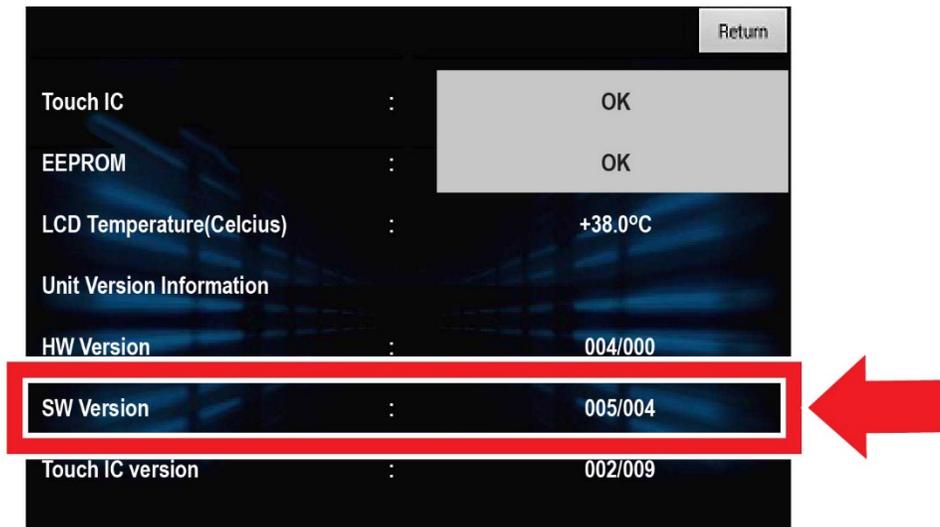
21. Scroll down to **SW Version**, and check that the new version **005/004** is indicated.

- If the new version is indicated, the process is complete.
- If the new software version is not indicated, you must reload the software again.
