Technical Service Bulletin

SUBJECT: POTENTIAL TRANSMISSION SHUDDER/SURGE WITH POSSIBLE DTC (CVT-8)			No: TSB-17-23-002
			DATE: April, 2017
			MODEL: See below
CIRCULATE TO:	<input type="checkbox"/> GENERAL MANAGER	<input checked="" type="checkbox"/> PARTS MANAGER	<input checked="" type="checkbox"/> TECHNICIAN
<input checked="" type="checkbox"/> SERVICE ADVISOR	<input checked="" type="checkbox"/> SERVICE MANAGER	<input checked="" type="checkbox"/> WARRANTY PROCESSOR	<input type="checkbox"/> SALES MANAGER

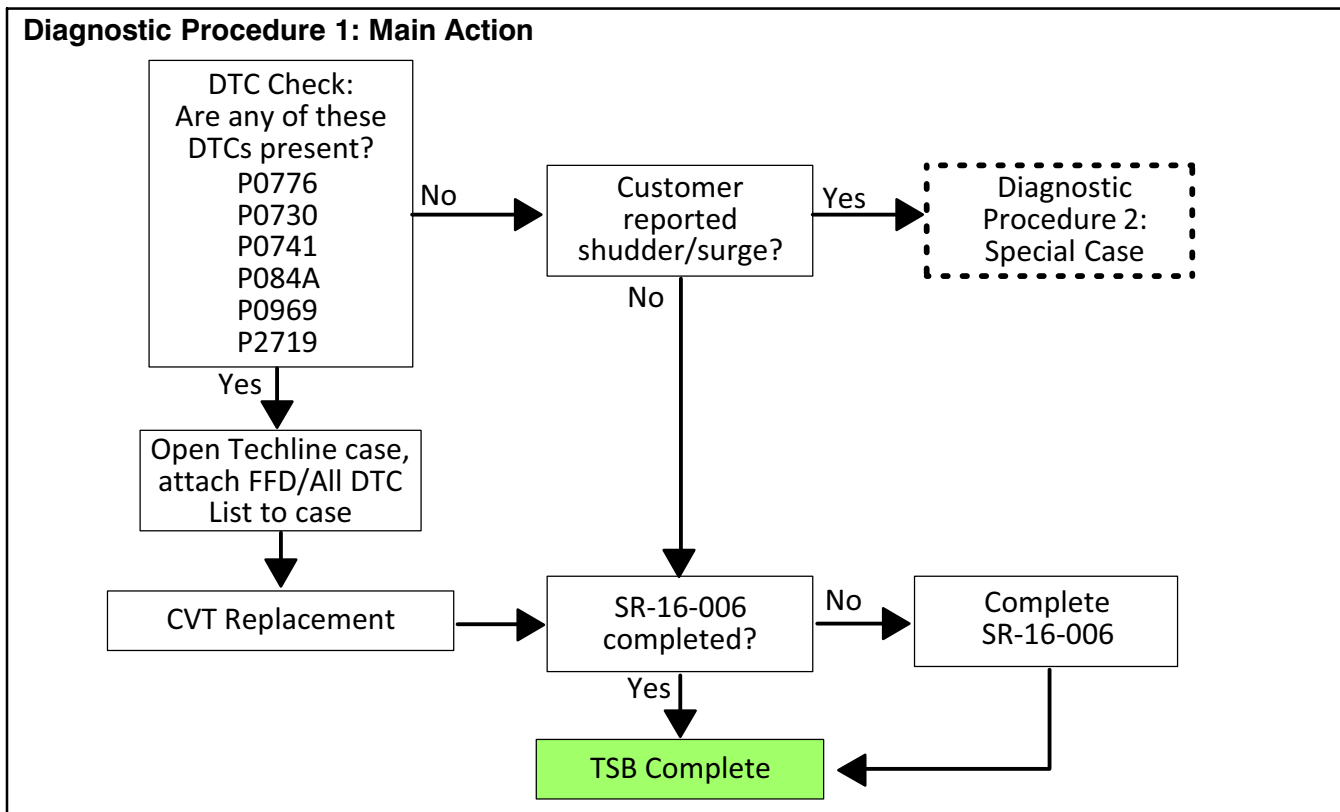
DIAGNOSTIC PROCEDURE 1: MAIN ACTION

1. Connect MUT-III to the vehicle and check for **any** of the following DTCs stored in the CVT ECU: P0776, P0730, P0741, P084A, P0969, P2719.

Are any of the DTCs listed above stored in the CVT ECU?

- **YES** – Go to step 3.
- **NO** – Go to step 2.

2. Did customer report that the vehicle exhibited (currently or previously) a shudder or surge condition? (This condition may also be described as engine flare, lack of acceleration, and/or car shake.)
 - **YES** – Go to “Diagnostic Procedure 2: Special Case” in this TSB.
 - **NO** – Go to step 4 to verify that SR-16-006 has been completed.

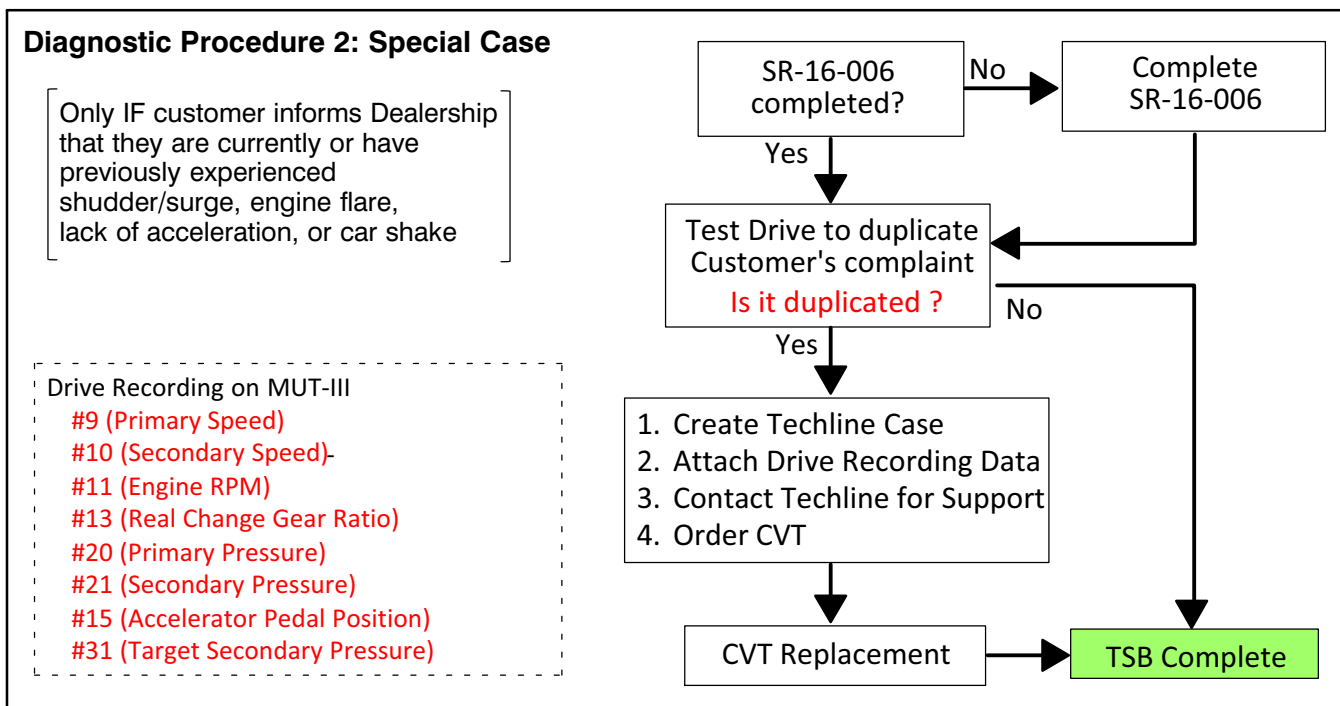
DIAGNOSTIC PROCEDURE 2: SPECIAL CASE

ONLY if customer reports a shudder/surge condition, follow this procedure **before** replacing the CVT-8 transmission.

1. Look up the vehicle’s VIN in the Warranty Superscreen and verify that SR-16-006 has been completed. If not completed, perform SR-16-006, then go to step 2.
2. Test drive the vehicle to see if the shudder/surge condition can be duplicated.
 - a. Refer to “Figure 1: Test Drive Procedure for Duplicating CVT-8 Belt Slip” on next page.
 - b. Setup MUT-III with the applicable Drive Recording parameters listed in the “Diagnostic Procedure 2: Special Case” diagram above.

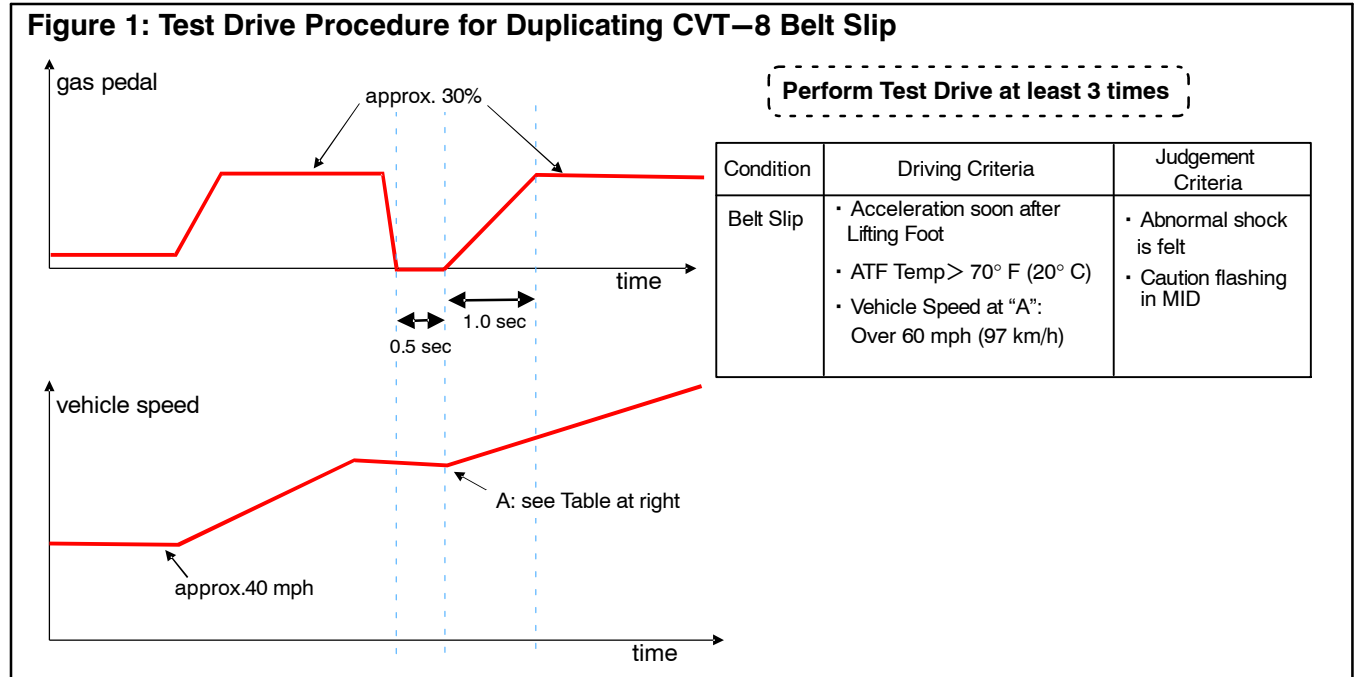
- c. Follow the Test Drive procedures to duplicate these conditions. Set the Manual Trigger when the shudder/surge condition is noticed.

3. Was the shudder/surge condition duplicated?
 - **YES** – Go to step 4.
 - **NO** – Repair is complete. Return vehicle to customer.
4. Create a Techline case.
5. Attach the following Drive Recording Data from MUT-III to the Techline case.

<u>No.</u>	<u>Description</u>	<u>No.</u>	<u>Description</u>
9	Primary Speed	20	Primary Pressure
10	Secondary Speed	21	Secondary Pressure
11	Engine RPM	15	Accelerator Pedal Position
13	Real Change Gear Ratio	31	Target Secondary Pressure
