Technical Service Bulletin

SUBJECT: SHIFT SHOCK WHEN COMING TO A STOP OR AFTER A COMPLETE STOP			No: TSB-17-23-003
			DATE: April, 2017
			MODEL: 2014-17 Mirage, 2017 Mirage G4
CIRCULATE TO:	<input type="checkbox"/> GENERAL MANAGER	<input checked="" type="checkbox"/> PARTS MANAGER	<input checked="" type="checkbox"/> TECHNICIAN
<input checked="" type="checkbox"/> SERVICE ADVISOR	<input checked="" type="checkbox"/> SERVICE MANAGER	<input checked="" type="checkbox"/> WARRANTY PROCESSOR	<input type="checkbox"/> SALES MANAGER

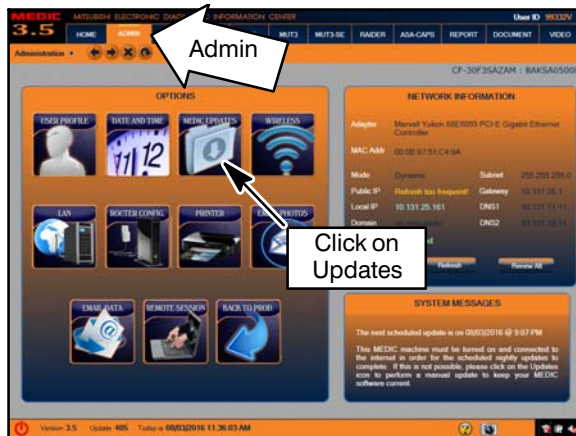
2. Select the MEDIC 3.5/4 Admin tab and click on “Updates.”

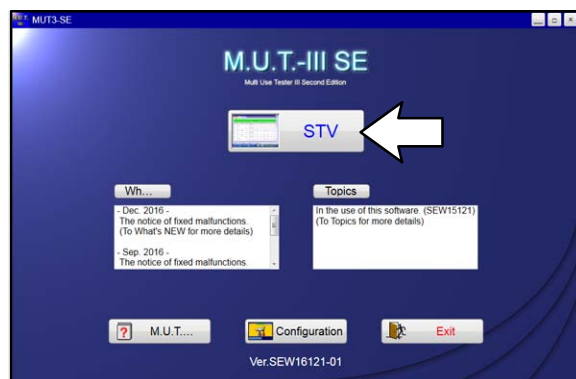
4. **STANDALONE MUT-III SCAN TOOL VIEWER (STV) ONLY: (MEDIC 3.5 USERS GO TO THE REPROGRAMMING PROCEDURE).** Verify that your MUT3-SE has the most current version of the reprogramming database:
From the MUT3-SE Main Page:
a. Click “STV.”

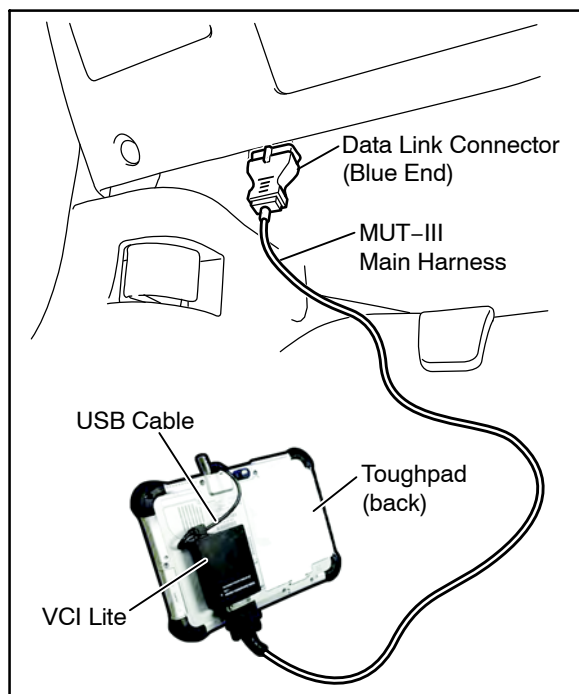
NOTE: VCI Lite and MEDIC 4.0 Toughpad shown for illustration purposes only.

- Turn the MEDIC PC/tablet on. If the battery indicator in the lower right hand corner of the screen does not show a full charge, it is recommended that either the battery be charged prior to beginning, or be used with the A/C power adaptor connected.
- Connect the USB cable to the VCI/VCI Lite.
- When the laptop/tablet displays the MUT-III main screen, connect the USB cable to the device.
- Connect the MUT-III main harness with the blue DLC connection to the VCI/VCI Lite.
- Connect the blue connection of the MUT-III main harness to the vehicle's data link connector.
- Turn the VCI power switch ON. Verify that the indicator lamp in the upper right corner of the screen is green.

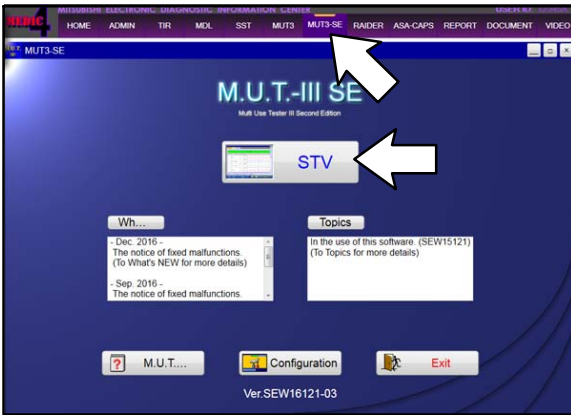
- Using MEDIC, from the main page, click the “MUT3–SE” icon at the top center of the screen to open MUT–III SE.

Click the STV button.

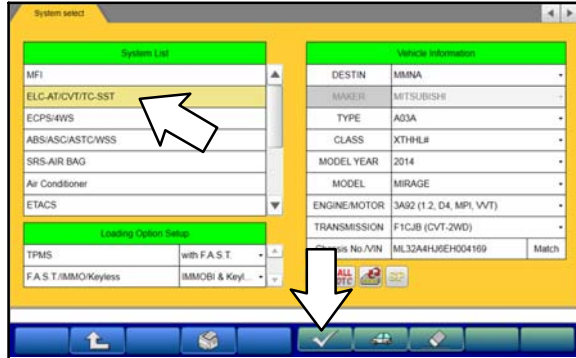
- a. Select “ELC–AT/CVT/TC–SST” from the System List, then click on the check mark at the bottom of the screen.

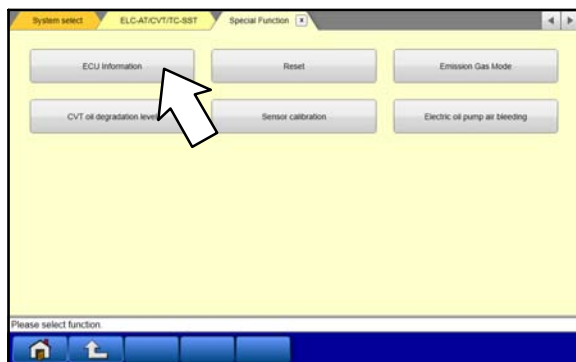
- c. Select “ECU Information.”

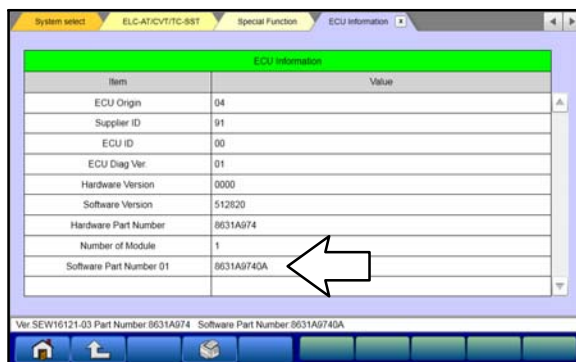
- d. If the Software Part Number listed is **not** at the latest level (shown in the CVT ECU Reprogramming table), proceed with the next step.

If the Software Part Number **is** at the latest level, then reprogramming is not necessary.

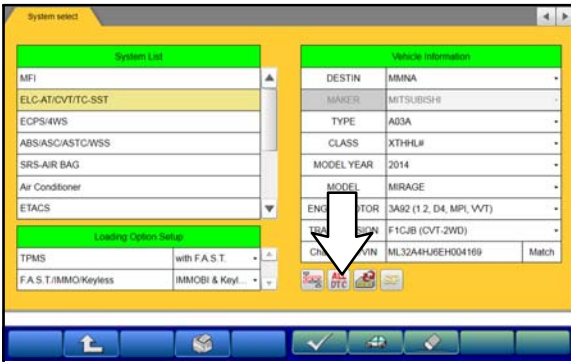
a. Click the home button to go back to the System Select screen.

Click the “ALL DTC” button.

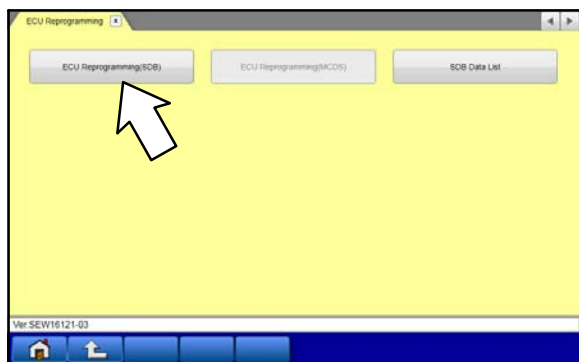
b. Select “ECU Reprogramming (SDB).”

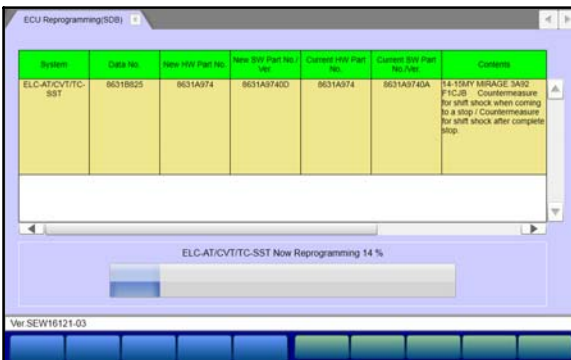
g. Once the reprogramming is initiated, the screen shown will indicate the reprogramming progress.
