INFINITI

CAMPAIGN BULLETIN

ECM Reprogram Retailer Inventory

Reference: P6335

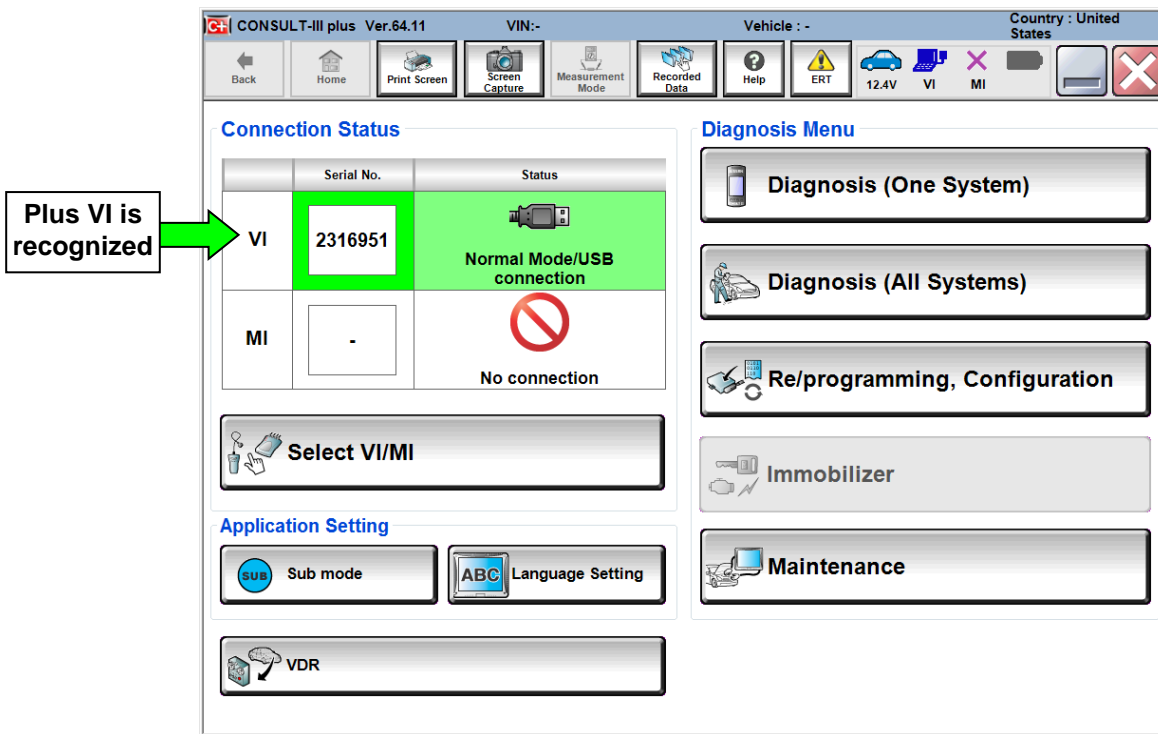
Figure 1

9. Wait for the plus VI to be recognized / connected.

- Serial number will display when the plus VI is recognized / connected.

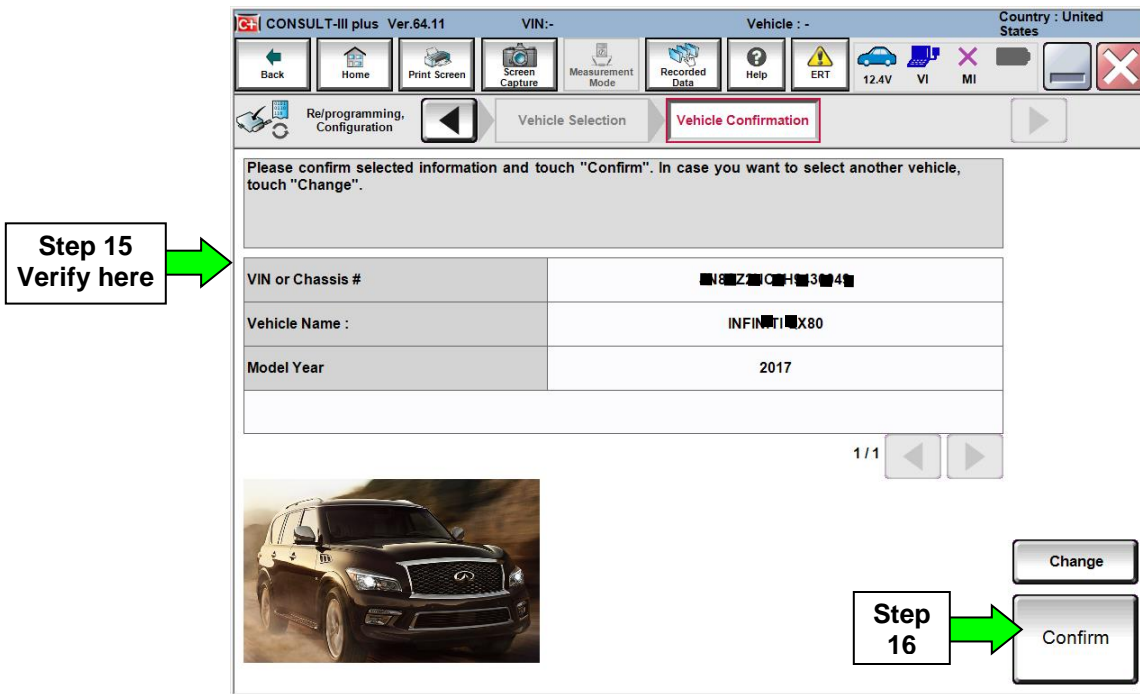
Figure 5

15. Make sure **VIN or Chassis #** matches the vehicle's VIN.

16. If the correct VIN is displayed, select **Confirm**.

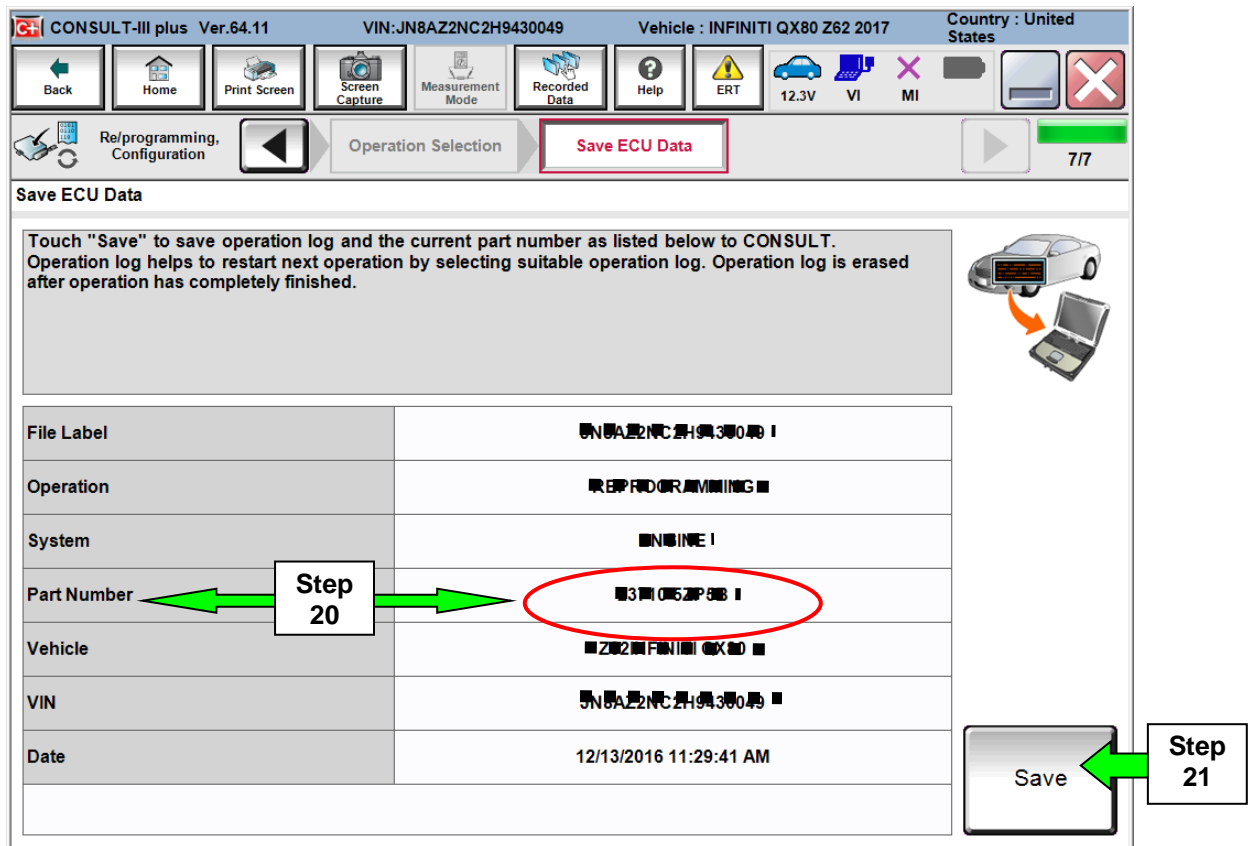
Figure 9

20. Find the ECM **Part Number** (see Figure 9) and write it on the repair order.

NOTE: This is the current Part Number (P/N).

B. Compare the P/N you wrote down to the numbers in the **Current ECM Part Number** column in **Table A** below.

Model	Current <u>ECM</u> Part Number: 23710 -
2017 QX80	5ZP2B, 5ZP2C, 5ZP3B, 5ZP3C, 5ZP4B, 5ZP4C, 5ZP5B, 5ZP5C

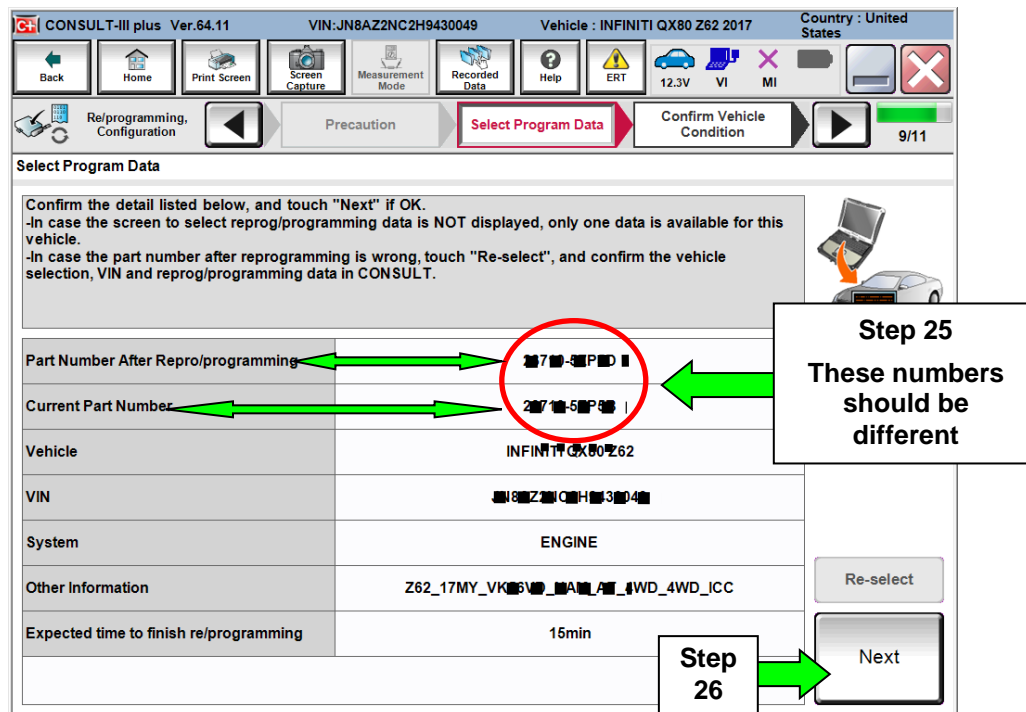
Figure 11

25. Read the **Current Part Number** and **Part Number After Reprogramming**. They should be different.

26. Select **Next**.

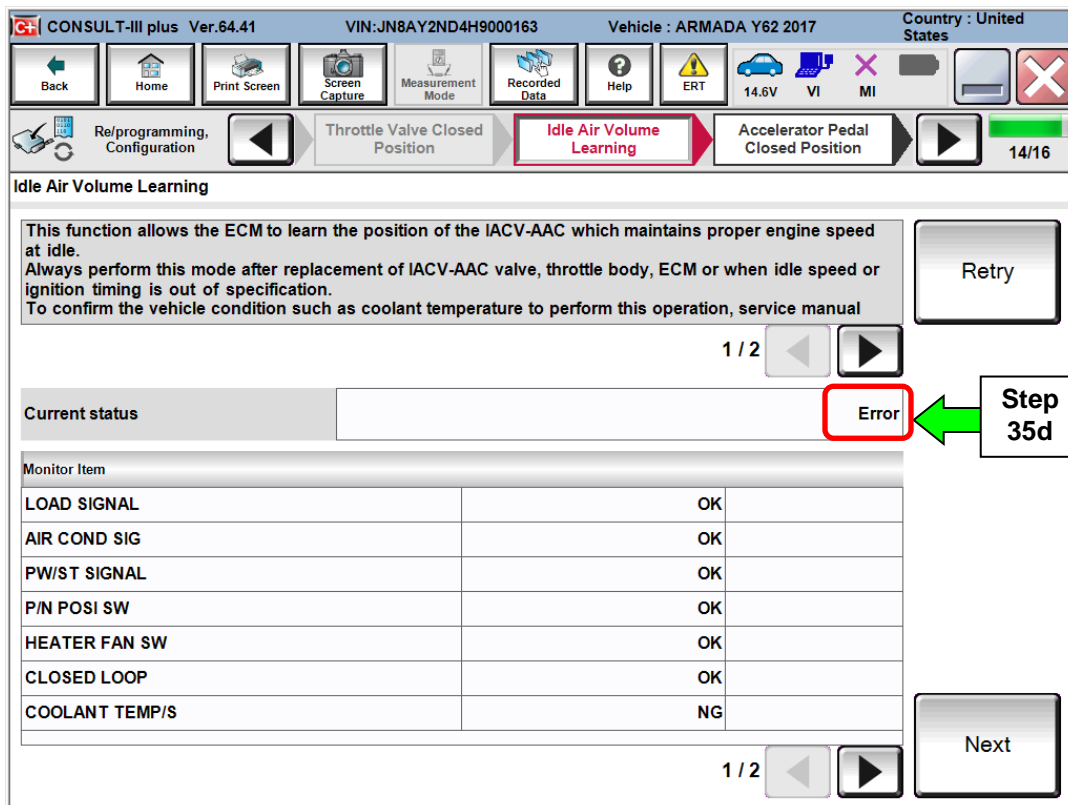
Figure 23

d. Wait for Current Status to change to **Error**.

IMPORTANT: The next step is to perform **Idle Air Volume Learn (IAVL)**. However, at this time it will **NOT** complete correctly and **will error**. IAVL will be completed later after DTC clear at Step 48.
