EC17-006

MIL ON WITH DTC P0101, P010B, AND/OR P0106

APPLIED VEHICLES: 2016-2017 Q50 (V37)
2017 Q60 (V37)

APPLIED ENGINE: VR30DDTT (V6 twin turbo engine)

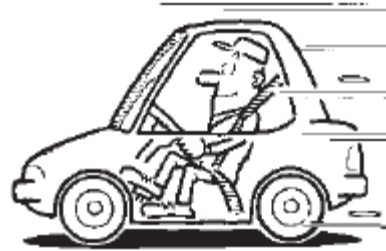
Figure A

- Most instructions for reprogramming with CONSULT-III plus (C-III plus) are displayed on the CONSULT PC screen.
- If you are not familiar with the reprogramming procedure, *click here*. This will link you to the "CONSULT- III plus (C-III plus) Reprogramming" general procedure.
- Take the vehicle for a 10 minute drive in order to meet the following Idle Air Volume Learn (IAVL) conditions:
 - Engine coolant temperature: 70 - 105°C (158 - 221°F)
 - Battery voltage: More than 12.9V (at idle)
 - Transmission: Warmed up

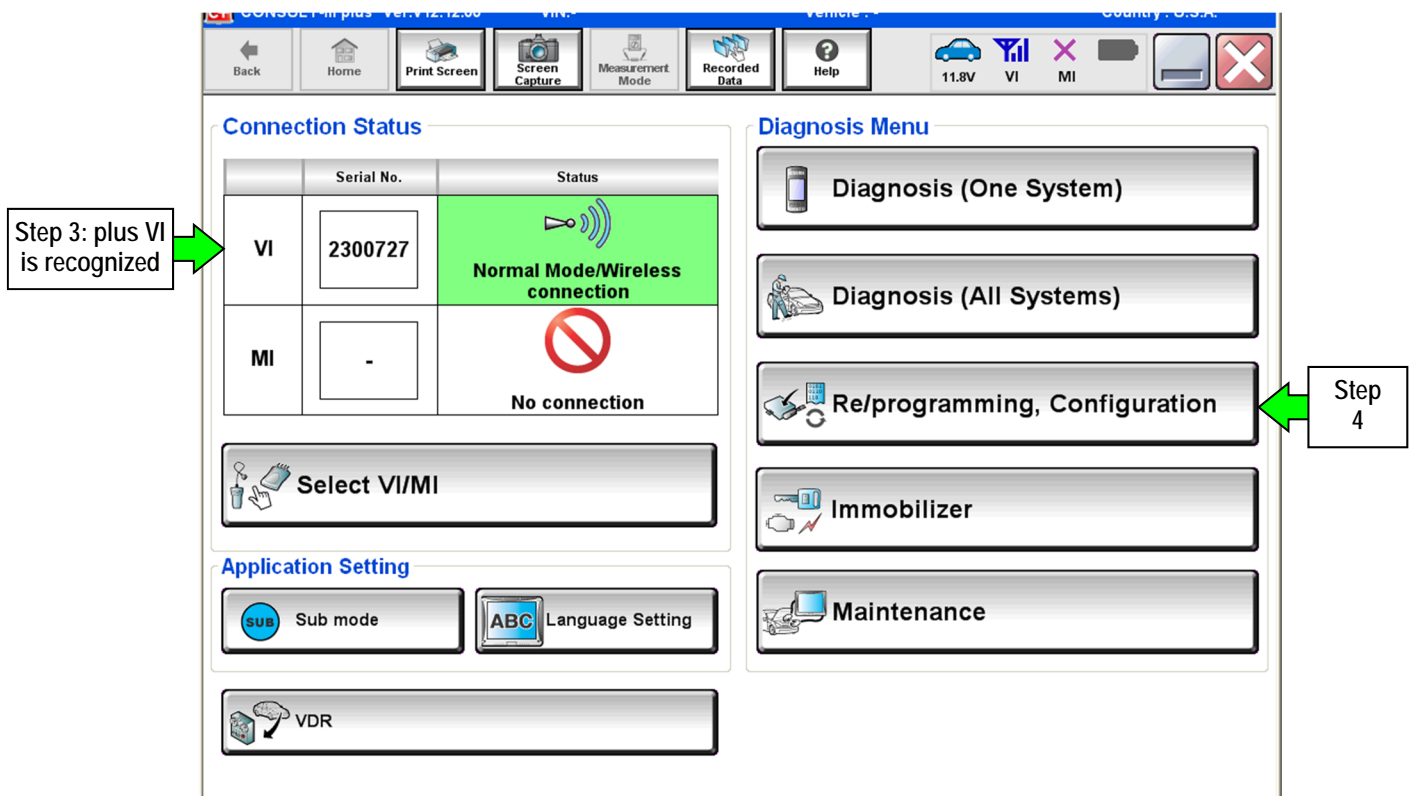
Figure 1

1. Connect the CONSULT PC to the vehicle to begin the reprogramming procedure.
2. Open / start C-III plus.
3. Wait for the plus VI to be recognized.
 - The Serial No. will display when the plus VI is recognized.
4. Select Re/programming, Configuration.

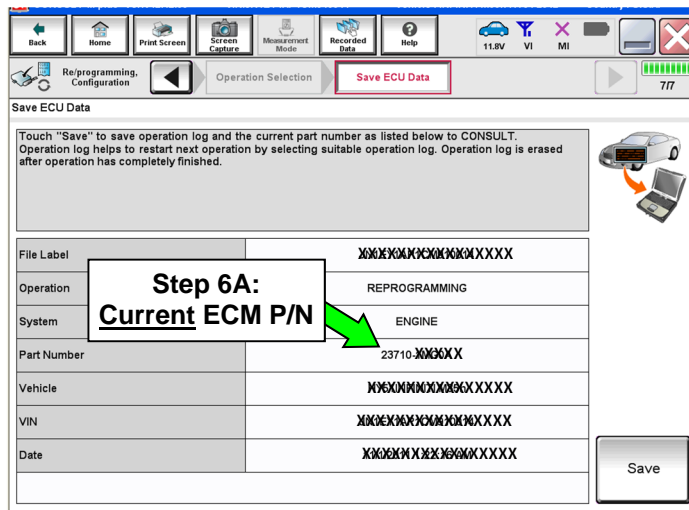
6. When you get to the screen shown in Figure 2, confirm this bulletin applies as follows.

A. Find the ECM **Part Number** and write it on the repair order.

NOTE: This is the current ECM Part Number (P/N).

5. Follow the on-screen instructions and navigate the C-III plus to the screen shown in Figure 2 on the next page.

B. Compare the P/N you wrote down to the numbers in the **Current ECM Part Number** column in **Table A** below.

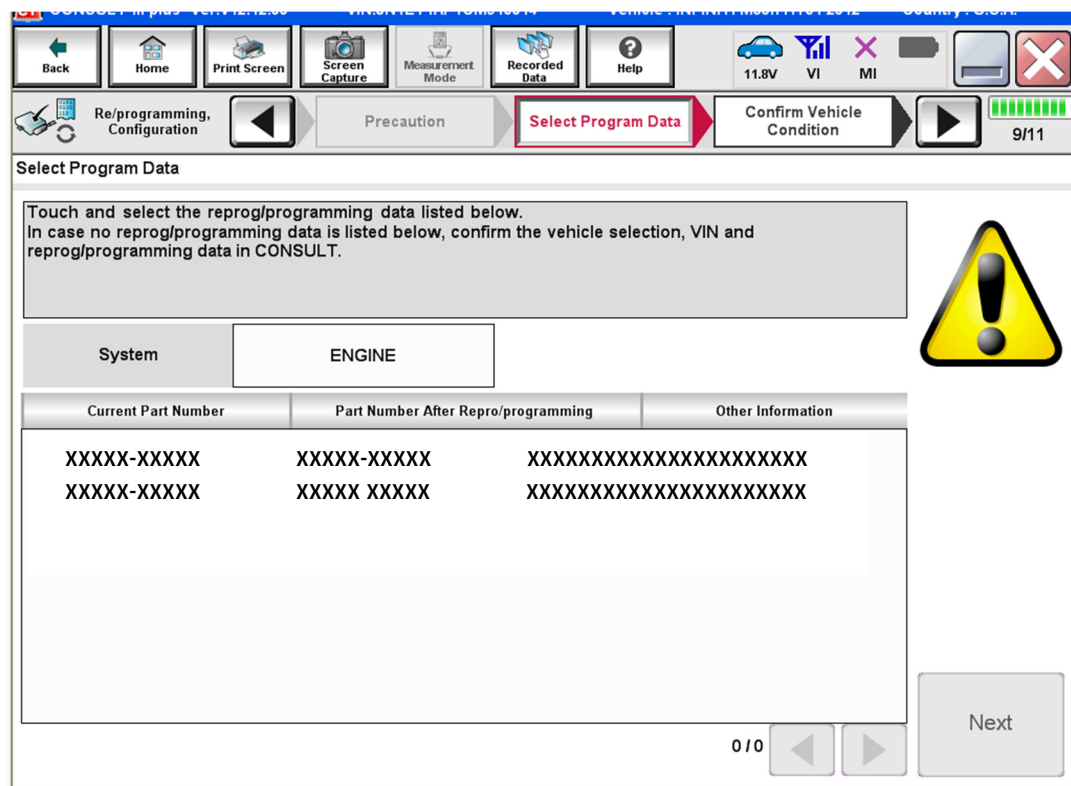
- In some cases, more than one new P/N for reprogramming is available.
 - If more than one new P/N is available, the screen in Figure 3 displays.
 - Select and use the reprogramming option that **does not** have the message “Caution! Use ONLY with ITBXX-XXX”.
- If you get this screen and it is blank (no reprogramming listed), it means there is no reprogramming available for this vehicle. Close C-III plus and refer back to ASIST for further diagnosis.

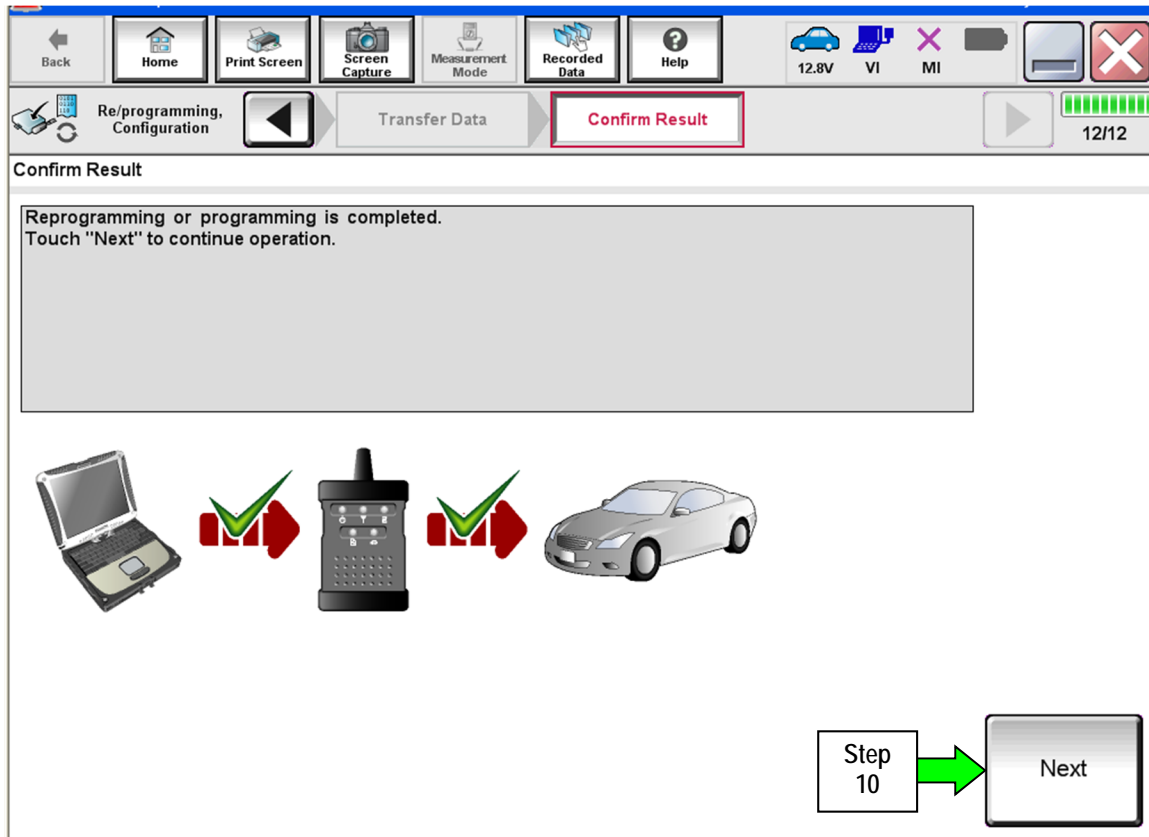
8. When the screen in Figure 4 displays, reprogramming is complete.

NOTE: If the screen in Figure 4 does not display (reprogramming does not complete), refer to ECM recovery on the next page.

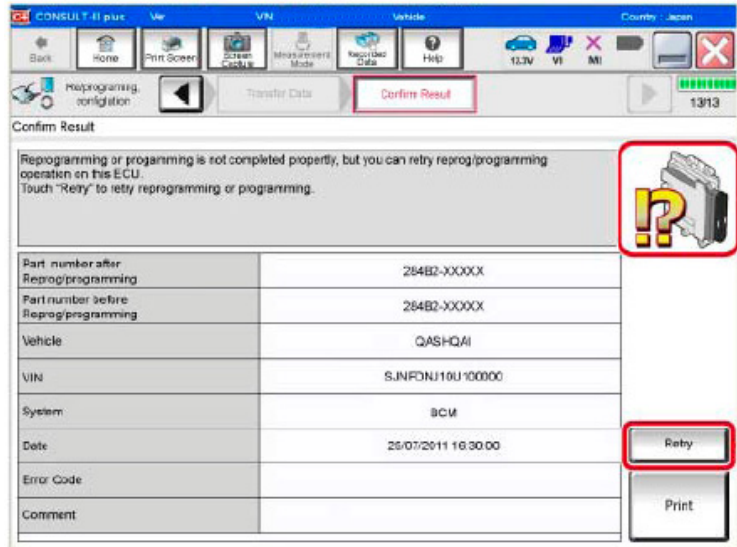
Figure 5

If reprogramming does not complete and the “!?” icon displays as shown in Figure 5:

- Check battery voltage (12.0 - 15.5 V).
- Ignition is ON, engine OFF.
- External Bluetooth® devices are OFF.
- All electrical loads are OFF.
- **Select retry and follow the on screen instructions.**
- “Retry” may not go through on first attempt and can be selected more than once.

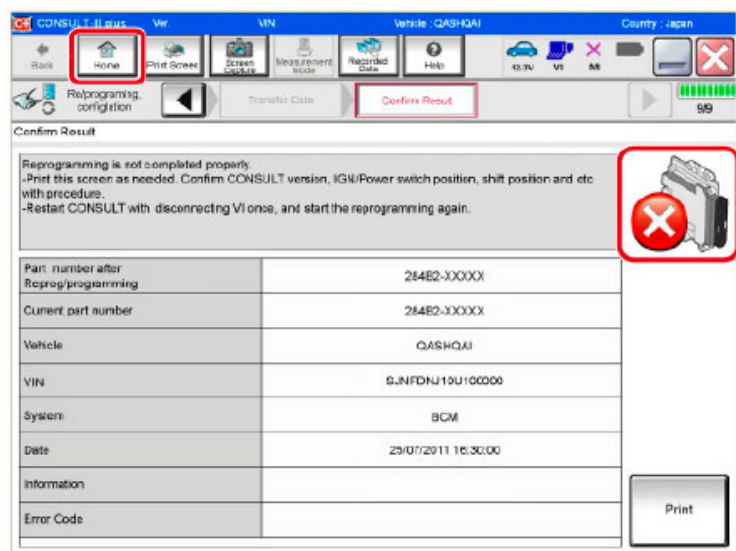
Figure 6

If reprogramming does not complete and the “X” icon displays as shown in Figure 6:

- Check battery voltage (12.0 - 15.5 V).
- CONSULT A/C adapter is plugged in.
- Ignition is ON, engine OFF.
- Transmission is in Park.
- All C-III plus / VI cables are securely connected.
- All C-III plus updates are installed.
- **Select Home, and restart the reprogram procedure from the beginning.**

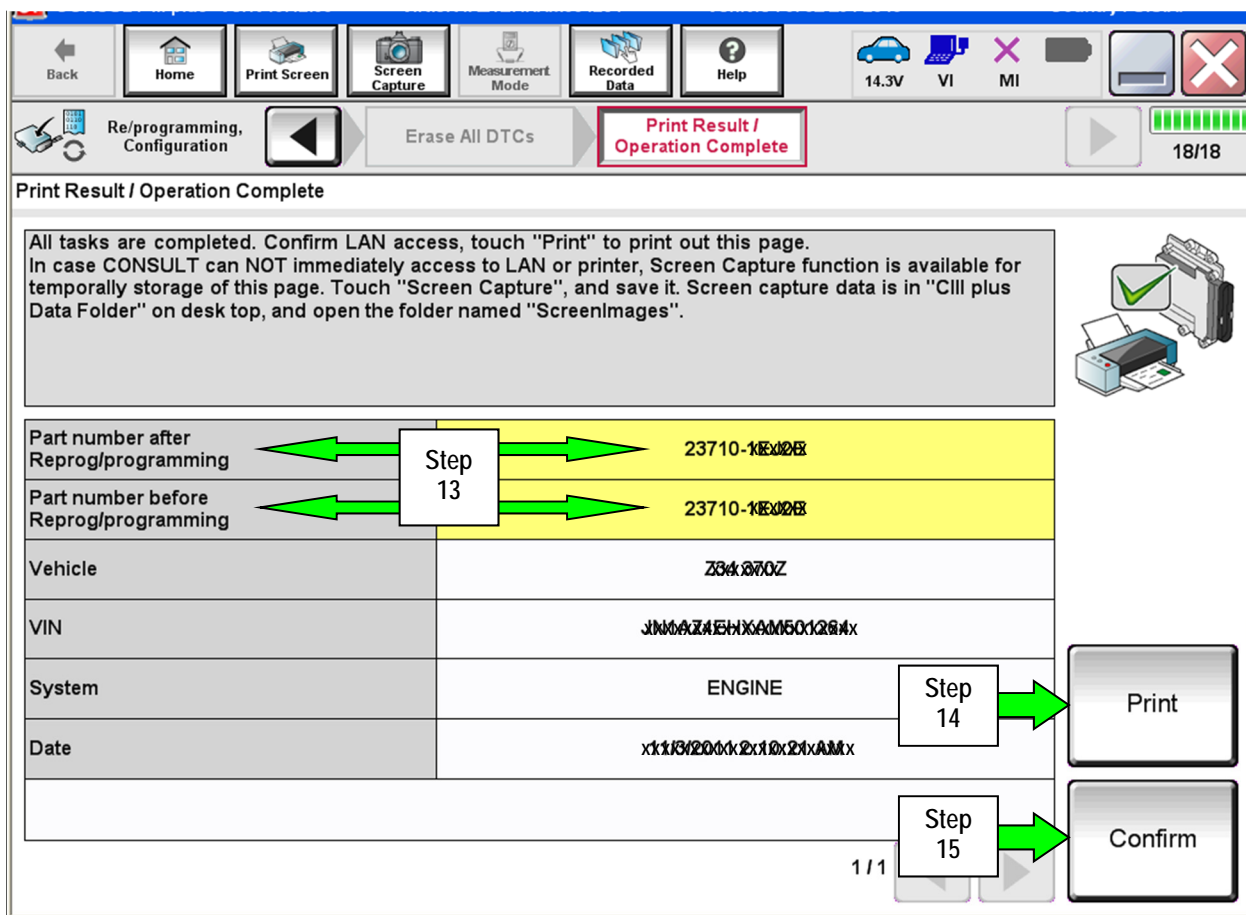
12. When the entire reprogramming process is complete, the screen in Figure 7 will display.
13. Verify the before and after part numbers are different.
14. Print a copy of this screen (Figure 7) and attach it to the repair order for warranty documentation.
15. Select **Confirm**.
