AT17-002a

2017 QX80 SHIFT SHOCK, LACK OF POWER, AND/OR RPM FLUCTUATES

APPLIED VEHICLES: 2017 QX80 (Z62)

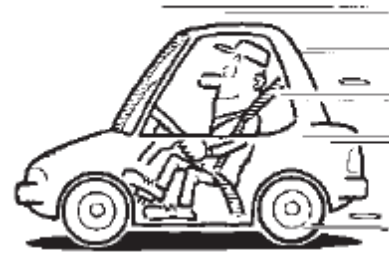
Figure A

- Take the vehicle for a 10 minute drive in order to meet the following Idle Air Volume Learn (IAVL) conditions:
 - Engine coolant temperature: 70 -100°C (158 - 212°F)
 - Battery voltage: More than 12.9V (At idle)
 - Transmission: Warmed up

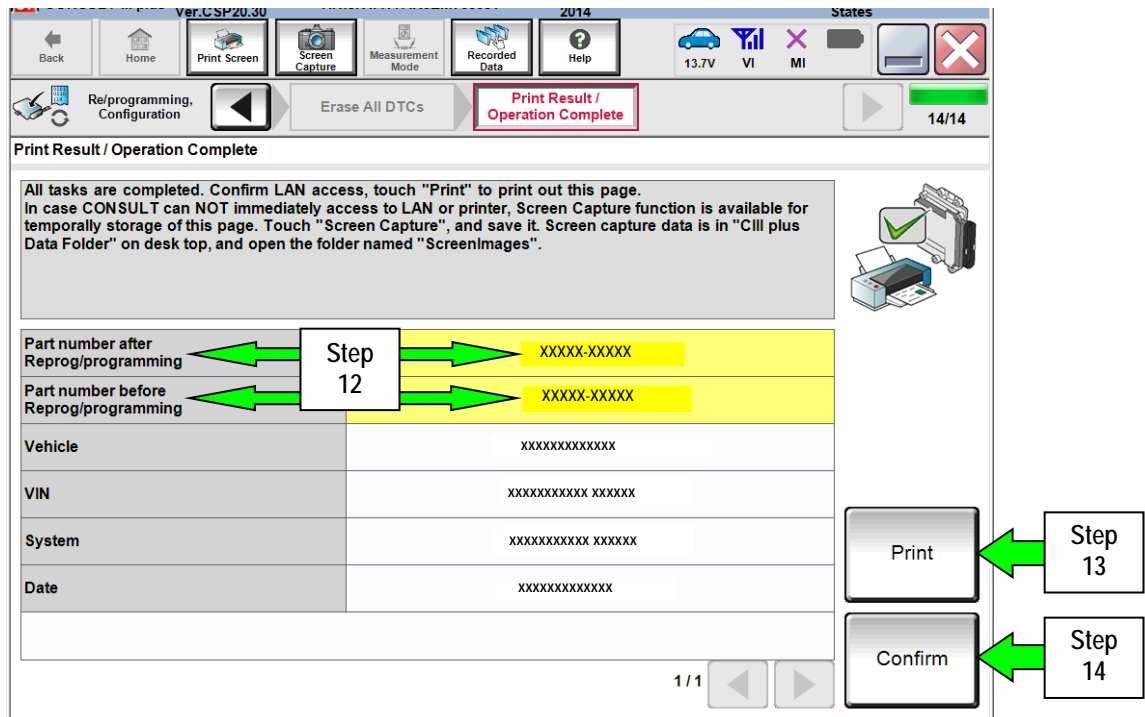
11. When the entire reprogramming process is complete, the screen in Figure 7 will display.
12. Verify the before and after part numbers are different.
13. Print a copy of this screen (Figure 7) and attach it to the repair order for warranty documentation.
14. Select **Confirm**.

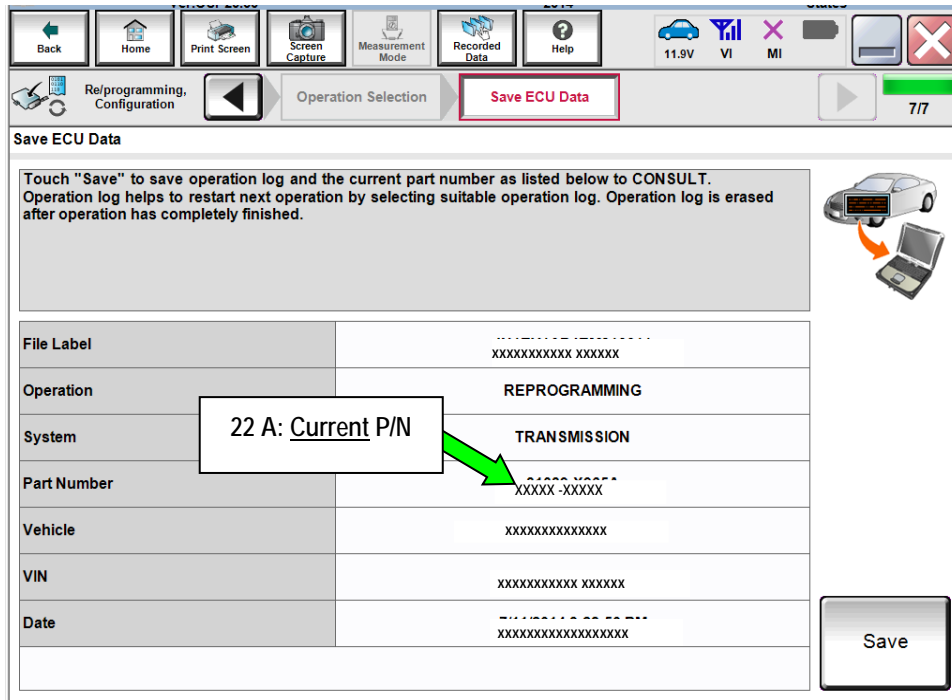
22. When you get to the screen shown in Figure 9, confirm TCM reprogram applies as follows.

A. Find the TCM **Part Number** and write it on the repair order.

NOTE: This is the current TCM Part Number (P/N).

21. Follow the on-screen instructions and navigate C-III plus to the screen shown in Figure 9 below.

B. Compare the P/N you wrote down to the numbers in the **Current TCM Part Number** column in **Table B** below.
