SERVICE BULLETIN

Classification: EL17-009	Reference: NTB17-024	Date: April 10, 2017
-----------------------------	-------------------------	-------------------------

NAVIGATION SYSTEM REBOOTS WHEN SXM TRAFFIC IS ENABLED

APPLIED VEHICLES:	2010-2017 370Z (Z34) 2013 Altima Coupe (L32) 2010-2011 Altima Hybrid (L32) 2010-2012 Altima Sedan (L32) 2013-2015 Armada (TA60) 2017 Armada (Y62) 2010-2016 GT-R (R35) 2010-2014 Maxima (A35) 2011-2014 Murano (Z51) 2011-2014 Murano CrossCabriolet (Z51) 2013-2016 Pathfinder (R52) 2014 Pathfinder Hybrid (R52) 2011-2016 Quest (E52)

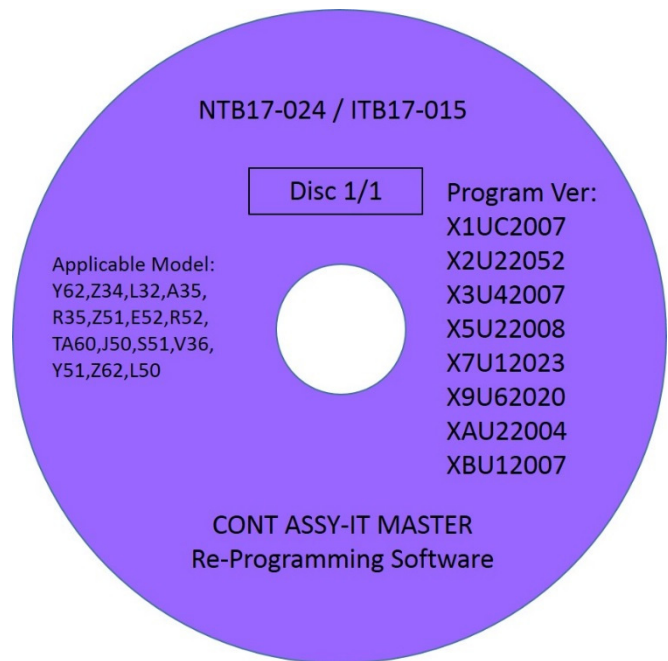
Figure A

Re-programming software DVD required for this procedure:

- Each dealer has been mailed one NTB17-024/ITB17-015 Re-programming Software DVD, free of charge, from Clarion.
- Should you require an additional NTB17-024/ITB17-015 Re-programming Software DVD due to loss or damage, it can be ordered free of charge by contacting Clarion toll free at 1-800-347-8933.

Update the Navigation system software using the DVD shown on page 2.

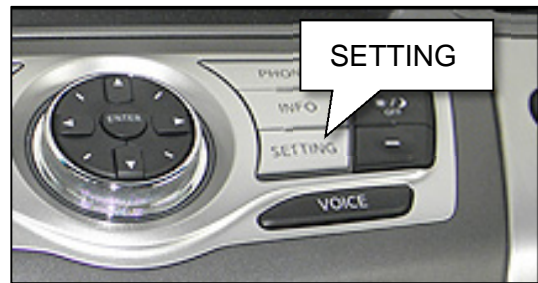
Figure 1

a. Press the **SETTING** button.

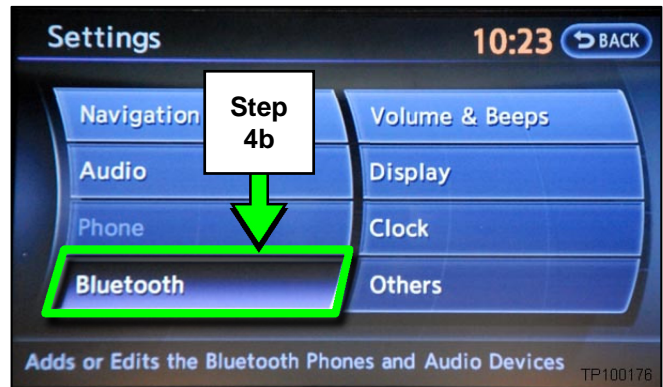
Figure 2

b. Select **Bluetooth**.

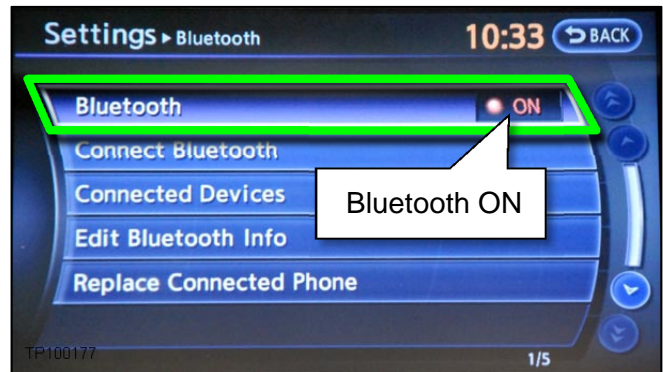
Figure 3

c. Take note of the current setting (ON or OFF) for Bluetooth. See Figures 3 and 4.

- This preference will need to be reset in a later step.
- Bluetooth is ON when the ON indicator displays in orange.
- Bluetooth is OFF when the ON indicator is "grayed" out.

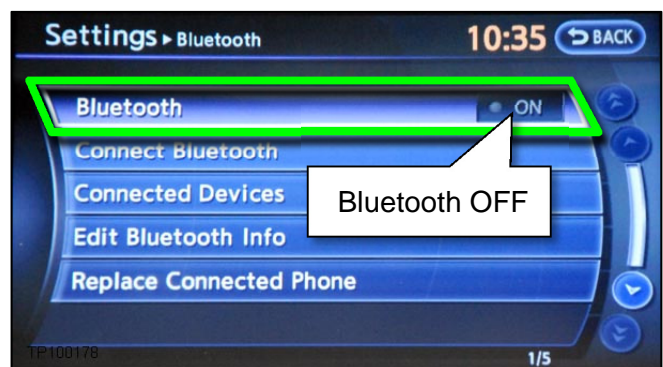
Figure 4

d. Make sure Bluetooth is OFF.

- Selecting **Bluetooth** will change the setting from ON to OFF or OFF to ON.

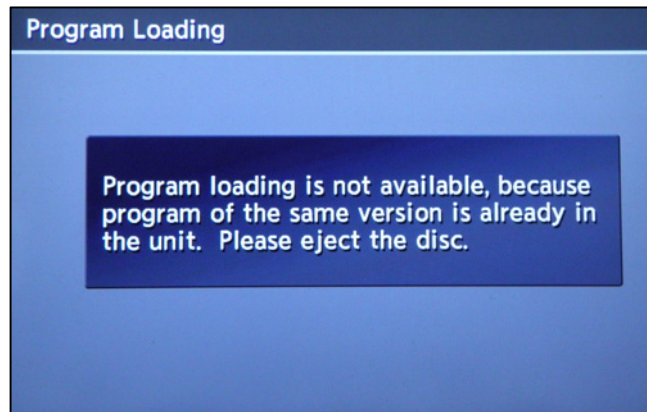
- If the screen in Figure 5 is displayed:
 - Remove the DVD from the CD slot.
 - Proceed to step 15 on page 7.

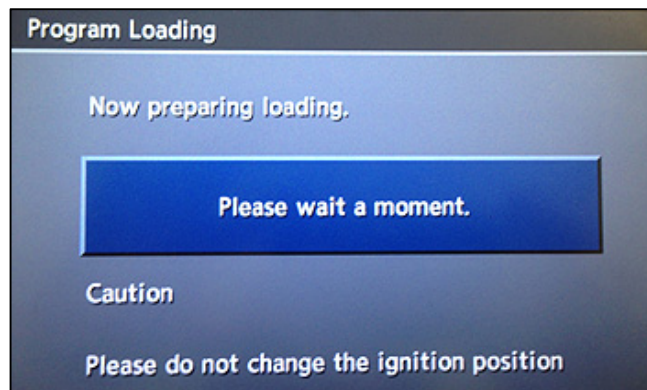
- If “Now preparing loading” shown in Figure 6 is displayed, follow the on screen Caution while the Navigation is updated.

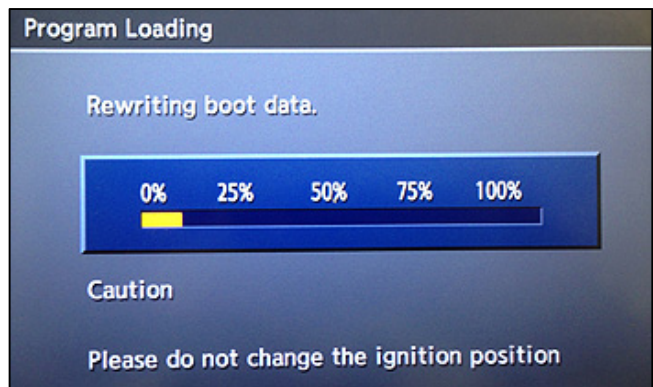
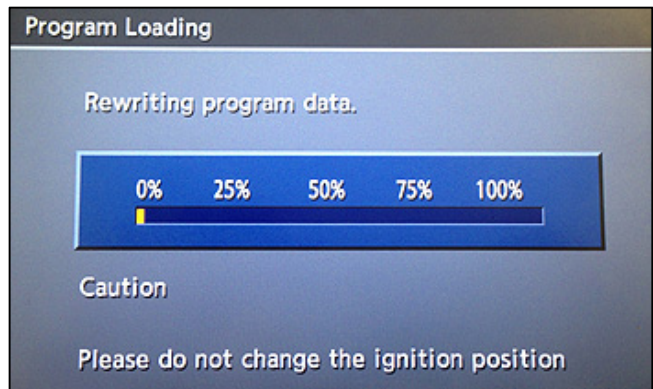
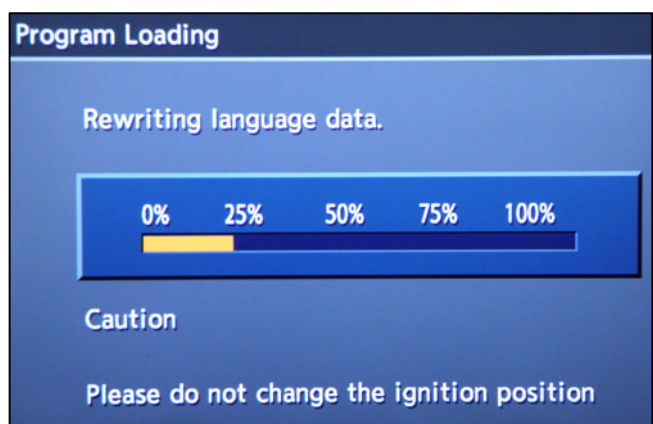
7. During the first part of the update process, 3 more screens will be displayed along with a percentage of completion (progress) bars:

- Rewriting boot data (Figure 7)
- Rewriting program data (Figure 8)
- Rewriting language data (Figure 9)

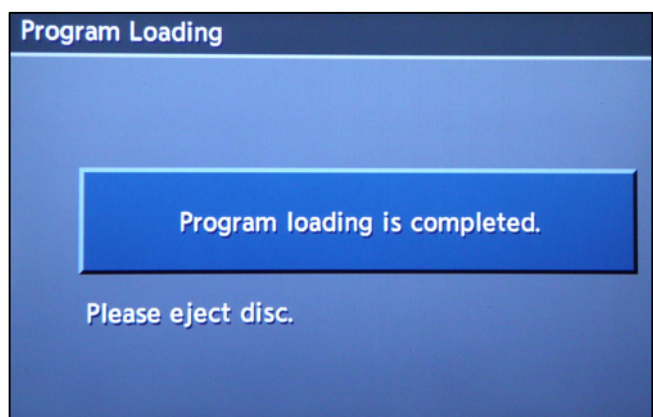
Figure 10

- “Program loading is completed” will be displayed (Figure 10).
- The Re-programming Software DVD will automatically eject.

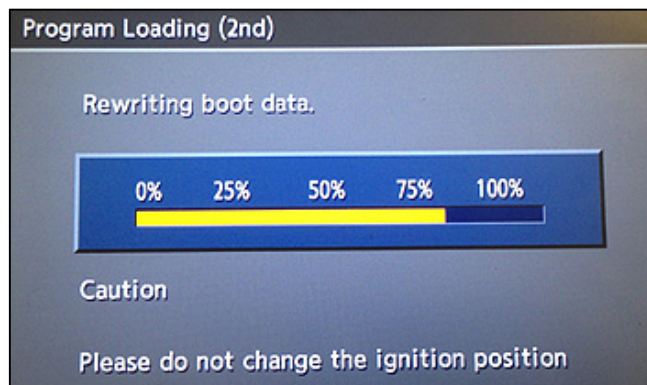
10. After the DVD is removed, the Navigation system will restart and a screen may display a message to “Please insert disc”.

- If “Please insert disc” is displayed:
 - Re-insert the same Re-programming Software DVD for a second time.
- If “Please insert disc” is not displayed:
 - Re-programming is complete. Proceed to step 13.

11. “Rewriting boot data” and “Rewriting program data” will be displayed once the DVD is reinstalled.

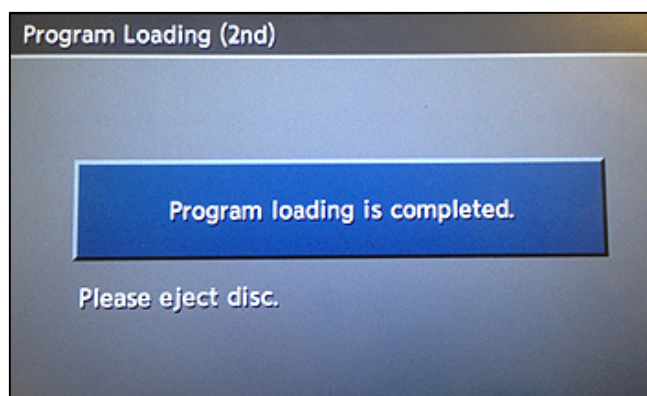
Figure 14

- “Program loading is completed” will be displayed (Figure 14).
- The Re-programming Software DVD will automatically eject.
- The Navigation system will restart.

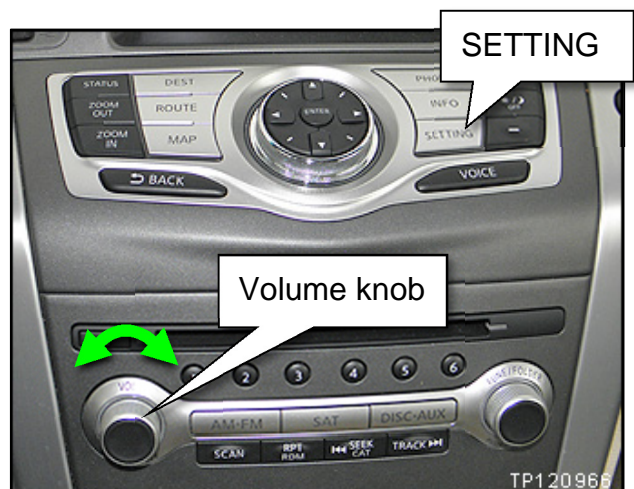
Figure 17

16. Put the AV system into System Diagnostic Mode as follows:

- a. Press and hold the **SETTING** button.
 - b. While holding the **SETTING** button, turn the volume control knob right and left several times.
- When the system goes into the System Diagnostic Menu, the screen in Figure 18 on the next page will display.

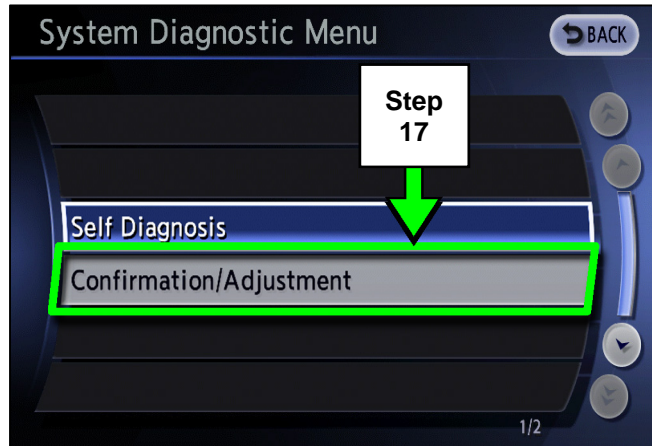
Figure 18

17. Select **Confirmation/Adjustment**.

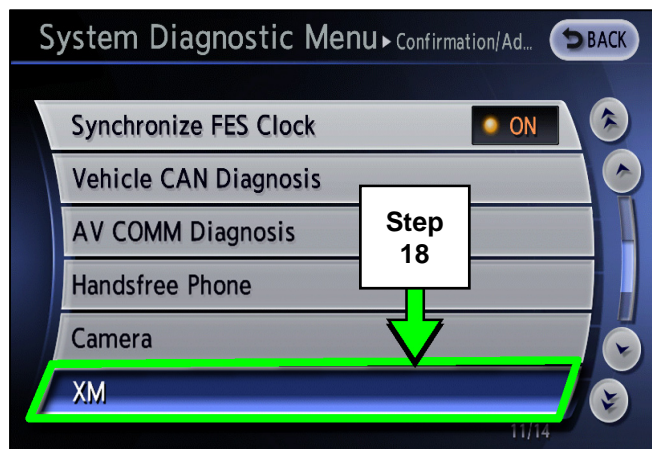
Figure 19

18. Select **XM**.

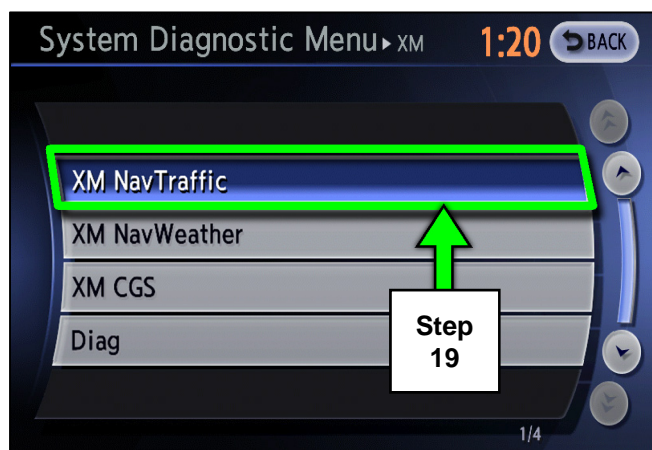
Figure 20

19. Select **XM NavTraffic**.

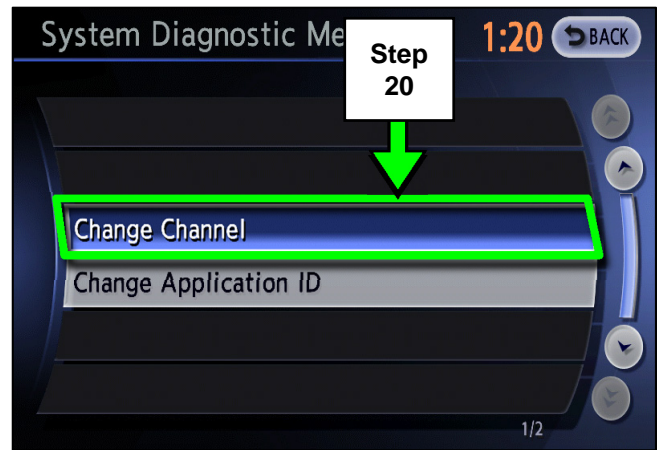
Figure 21

20. Select **Change Channel**.

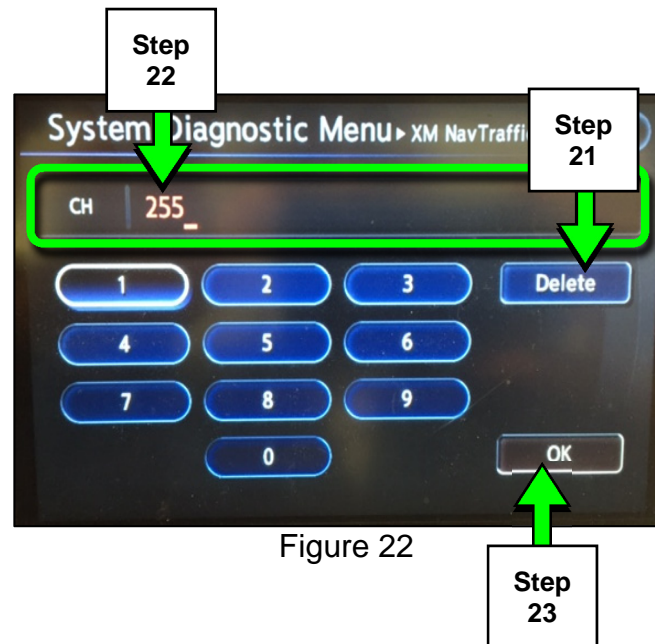
Figure 22

21. Press **Delete** until all numbers entered in the "CH" field are erased.

22. Enter "255".

23. Select **OK**.

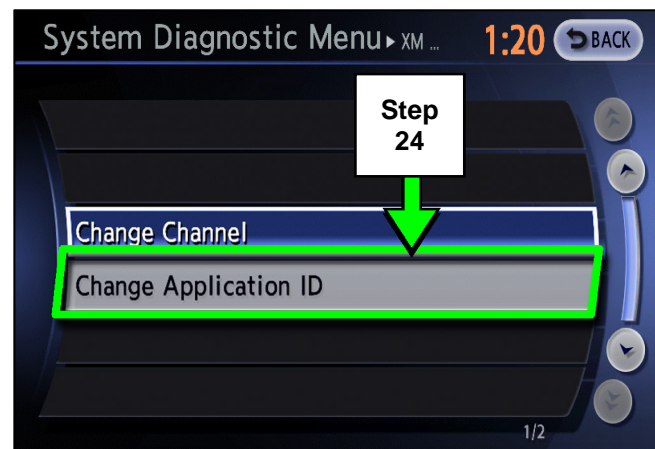
Figure 23

24. Select **Change Application ID**.

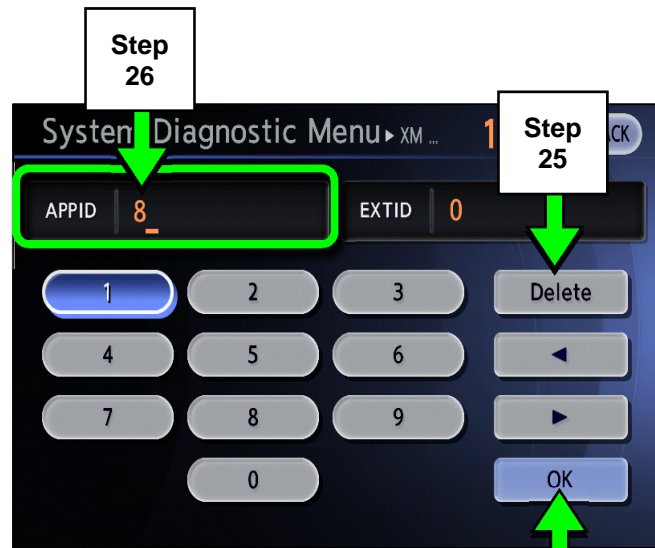
Figure 24

25. Press **Delete** until all numbers entered in the “APPID” field are erased.

26. Enter “8” into the APPID field.

27. Select **OK**.

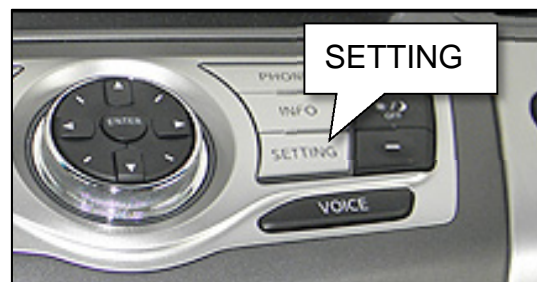
Figure 25

- a. Press the **SETTING** button.

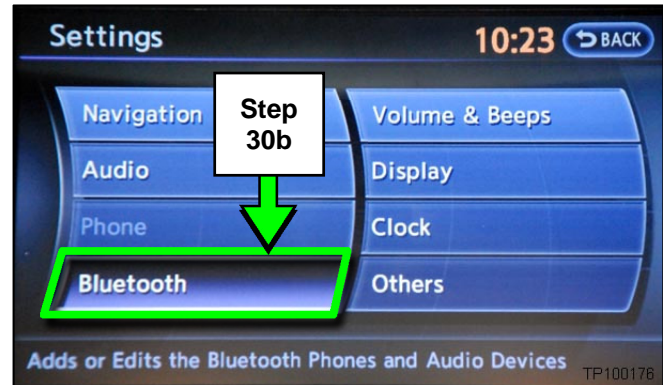
Figure 26

b. Select **Bluetooth**.

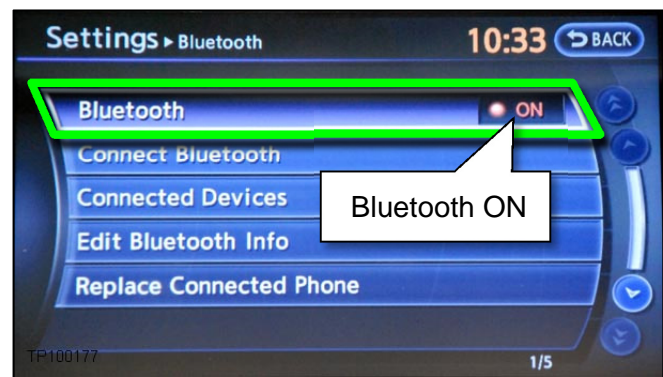
Figure 27

c. Select **Bluetooth** to change the setting to ON.

- Bluetooth is ON when the ON indicator displays in orange.
