SERVICE BULLETIN

Classification: AT17-001b	Reference: NTB17-016b	Date: April 18, 2017
------------------------------	--------------------------	-------------------------

2017 ARMADA, TITAN AND TITAN XD SHIFT SHOCK, LACK OF POWER, AND/OR RPM FLUCTUATES

- APPLIED VEHICLES:** 2017 Armada (Y62)
2017 Titan (A61)
2017 Titan XD (A61)
- APPLIED ENGINE:** VK56VD (Gasoline V8)
- APPLIED TRANSMISSION:** 7AT - RE7R01B

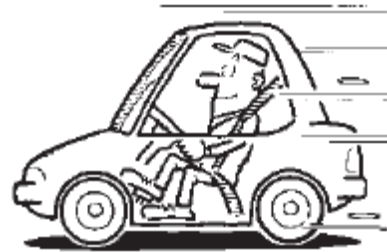
Figure A

- Take the vehicle for a 10 minute drive in order to meet the following Idle Air Volume Learn (IAVL) conditions:
 - Engine coolant temperature: 70 -100°C (158 -212°F)
 - Battery voltage: More than 12.9V (At idle)
 - Transmission: Warmed up
