GROUP ELE	MODEL 2015MY Various Models
NUMBER 128 (Rev 1, 03/24/2017)	DATE March 2017

TECHNICAL SERVICE BULLETIN

SUBJECT: SERVICE ACTION: AUDIO SOFTWARE
UPGRADE (SA276)

This bulletin provides the procedure to upgrade the audio software on some 2015MY Soul (PS), Sportage (SL), Optima (TF, QF), Forte (YD), and Sorento (XMa) vehicles to incorporate Bluetooth and Voice Recognition improvements. Follow the procedure outlined in this bulletin to perform an audio logic improvement. Before conducting the procedure, verify that the vehicle is included in the list of affected VINs.

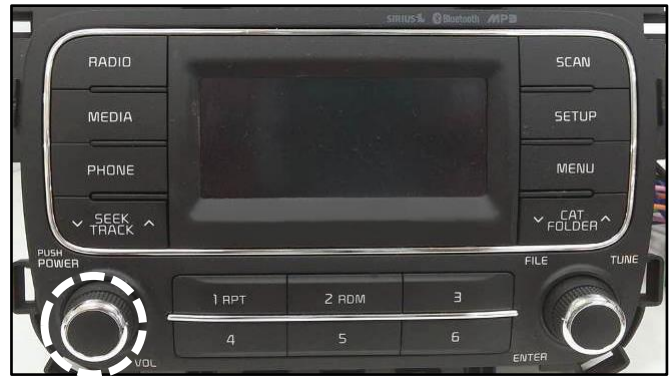
1. Start the vehicle or connect the Midtronics GR8-1299 charger.
2. Record the customer’s radio presets before performing the upgrade.
3. Turn the head unit OFF.

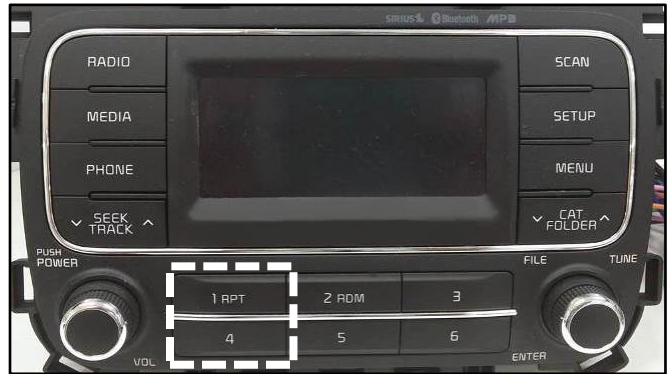
4. Press and hold preset button “1” and then preset button “4” and continue to hold both for five (5) seconds.

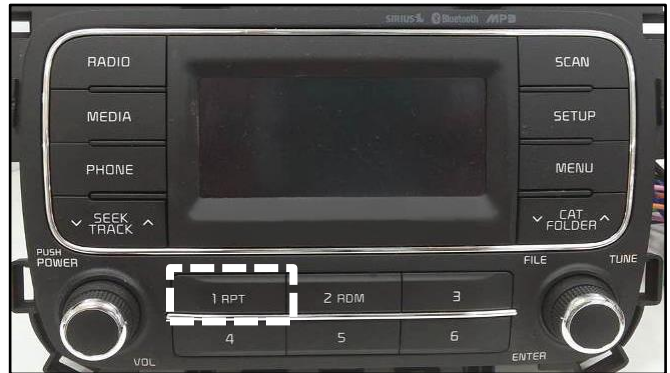
5. Immediately after releasing preset buttons “1” and “4”, press preset button “1” four (4) times in a row quickly within half a second each.

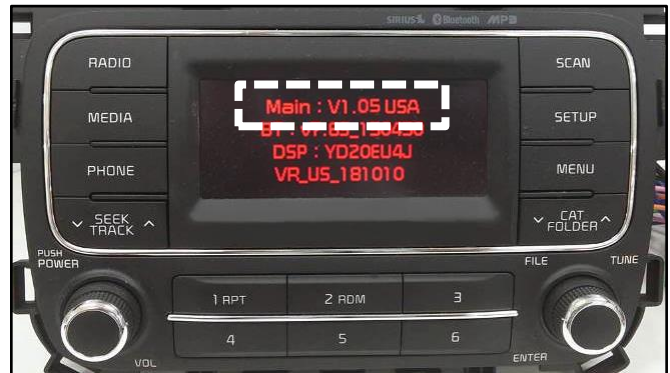
6. Check the software version and verify that it matches the versions below:

Model	Current Version
Soul (PS)	V1.02, V1.03
Sportage (SL)	V1.03, V1.04
Optima (TF, QF)	V1.03, V1.04
Forte (YD)	V1.05, V1.06
Sorento (XMa)	V1.04, V1.05

- Verify that the software upgrade is successful by checking the software version by following software inspection procedure steps 3 to 6 on page 2 of this bulletin. If update is not successful, restart the procedure from step 3.

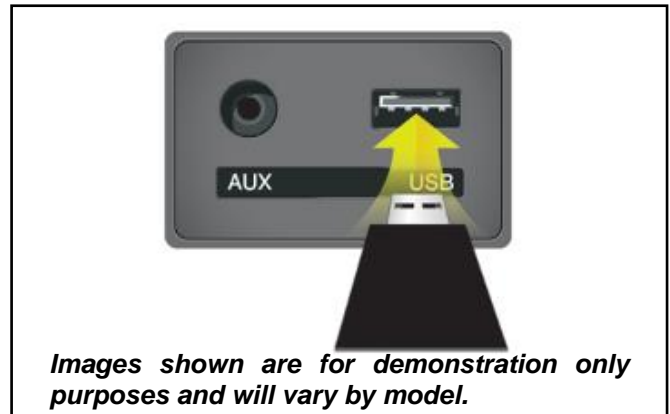
8. With the S/W version screen displayed, obtain the USB stick labeled **15MY SA (AUDIO/UVO)** (white) from your Service Manager and insert it in the vehicle's USB port.

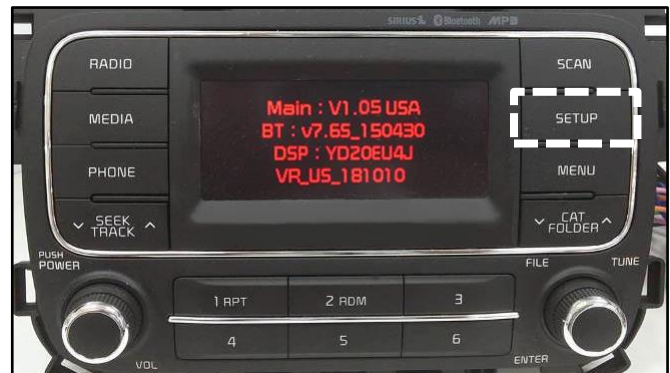
9. Press the **SETUP** button.

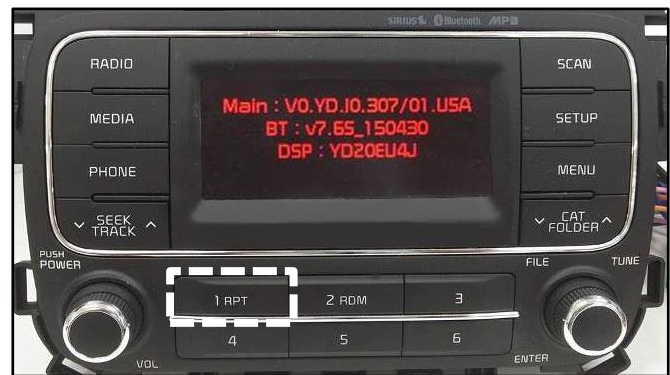
10. Press preset button "1" to display the firmware upgrade menu.

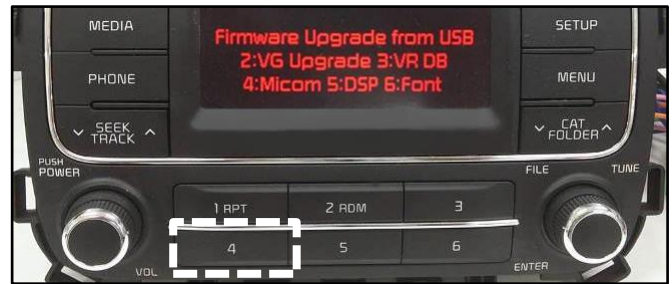
11. Once the Firmware upgrade menu is displayed, press preset button “4” to update **MICOM**.

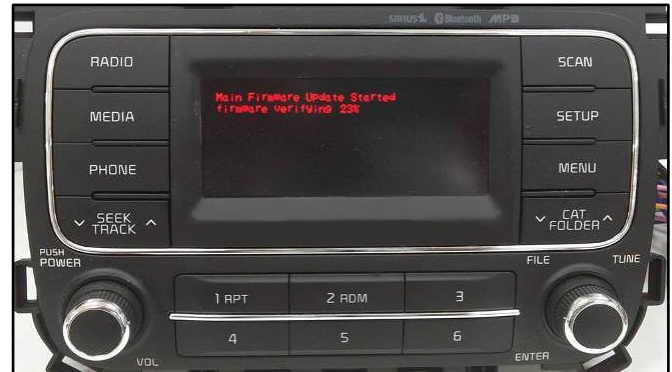
12. In some cases, the firmware upgrade (1/2) will begin and system will display the progress on the screen. Once the upgrade is complete, the head unit will automatically reset and then turn off. Monitor this part of the upgrade to ensure the second upgrade begins (see step 13 below).

The firmware update will take approximately three (3) minutes to complete. Do NOT remove the USB or turn the radio or vehicle OFF while the update is in progress.

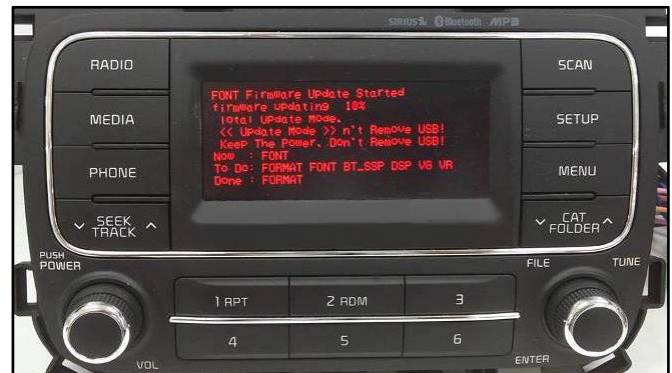
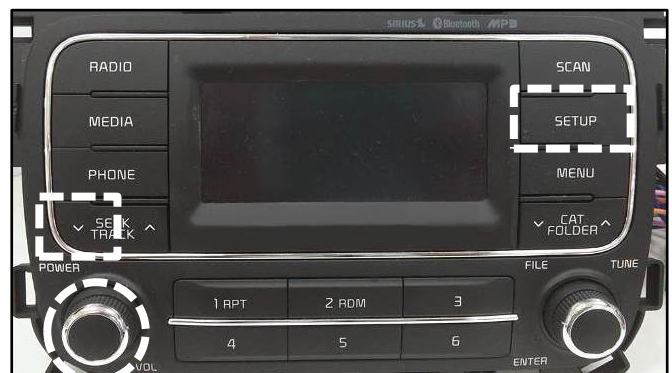
13. In some cases, the upgrade (2/2) will automatically begin and system will display the progress on the screen. Once the upgrade is complete, the head unit will automatically reset and then turn off.

On other vehicles, the upgrade (2/2) will not automatically begin. Turn off the head unit, press and hold **SEEK DOWN V** and then press **SETUP** and continue to hold both for two (2) seconds or more and then release.

The upgrade will proceed to “Format → Font → BT → DSP → VG → VR”.

The update will take approximately twenty (20) minutes to complete. Other services can be performed while the system upgrade is in progress. Do NOT remove the USB or turn the radio or vehicle OFF while the update is in progress.

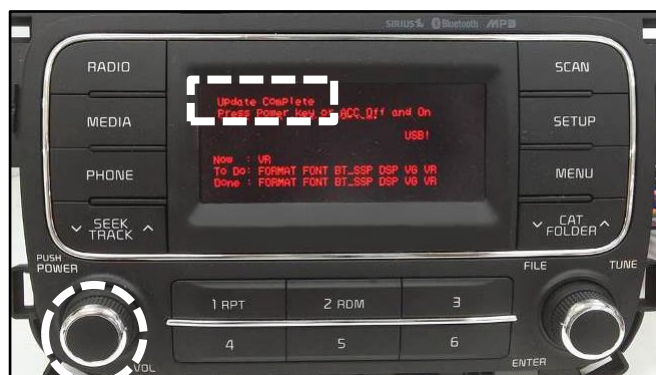
- Once the update is complete, the screen as shown will be displayed (Update Complete). Press the power button to restart the unit.

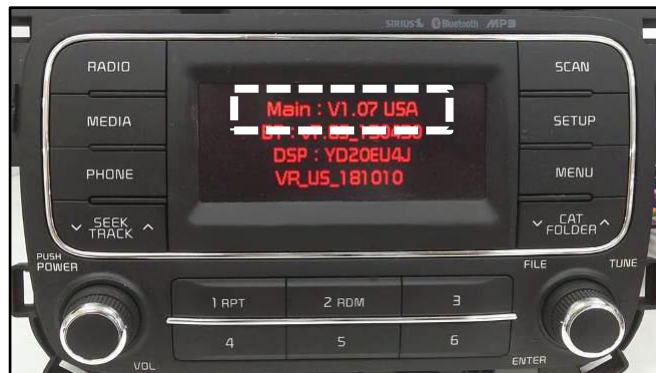
Model	New Version
Soul (PS)	V1.05
Sportage (SL)	V1.08
Optima (TF, QF)	V1.07
Forte (YD)	V1.09
Sorento (XMa)	V1.07
