MODEL
2014-2016MY Soul (PS)
2014-2016MY Sorento (XMa)/(UMa)
2014-2016MY Optima (TF HEV)
2014-2015MY Optima (QF/TF)
2014-2016MY Forte (YD)
2014-2016MY Sportage (SL)
2015-2016MY Sedona (YP)

NUMBER
100 (Rev 4,
04/17/2017)

TECHNICAL SERVICE BULLETIN

UVO SYSTEM UPGRADE

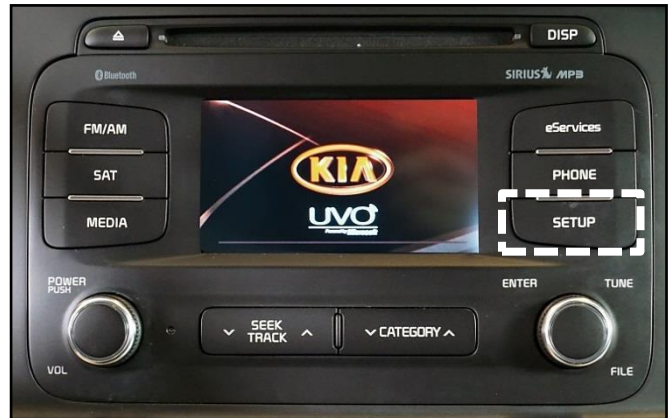
1. Start the vehicle or connect the Midtronics GR8-1299 charger.
2. Record the customer’s radio presets before performing the upgrade.
3. With the head unit ON, press **SETUP**.

*** NOTICE**
 Button layouts may differ by model.

15. Verify that the software upgrade is successful by checking the software version by following software inspection procedure steps 3 to 6 on page 2 of this bulletin. If update is not successful, restart the procedure from step 3.
16. Reprogram the customer's radio presets if necessary.
17. Pair a phone and make a call confirming Bluetooth is operational. Delete phone from system after testing.
18. Use voice recognition to pull up a radio station and confirm voice recognition is operational.
19. Assist or advise customer that they should delete phone pairings and re-pair all phones.

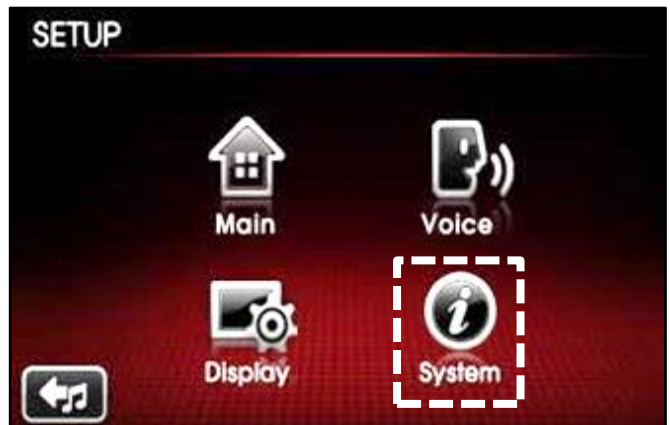
4. Touch “System”.

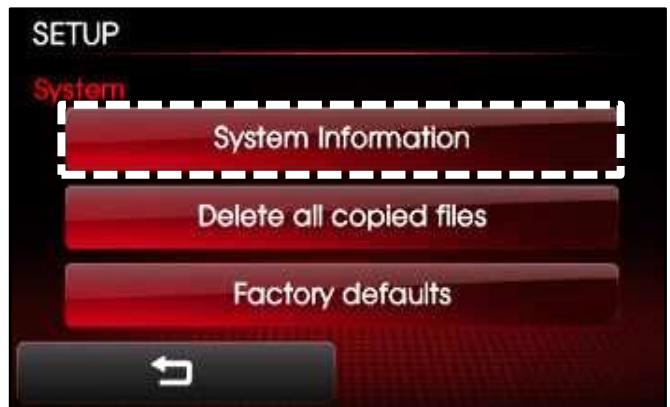
5. Touch “System Information”.

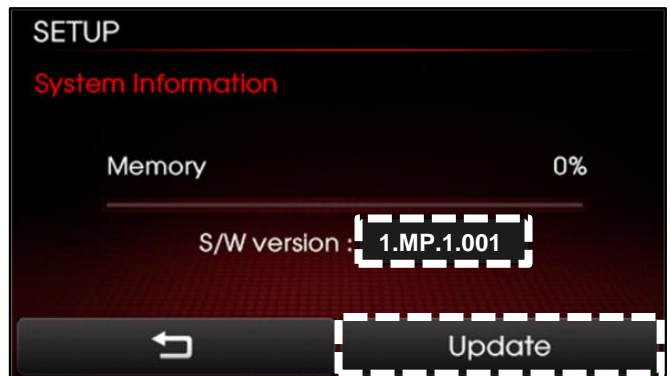
6. Check the software version and verify that it matches the versions below:

Current Version
1.MP.1.001 to 1.MP.1.017

If it matches, continue to the next step.
 If it does not match, contact Techline.

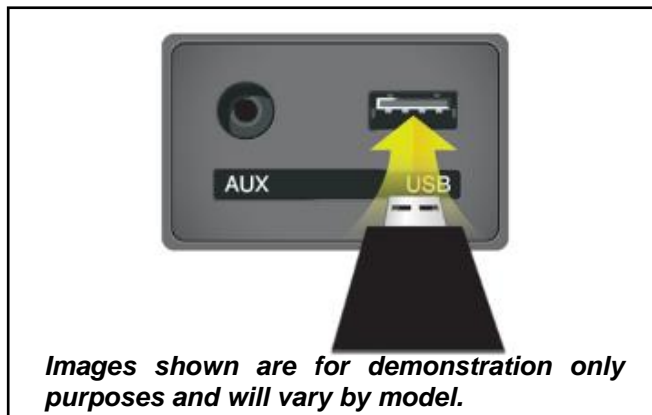
- If performing the upgrade using a USB stick, with the S/W version screen displayed, obtain the USB stick labeled **14MY VDS AUD/UVO (8V)** (green) from your Service Manager and insert it in the vehicle's USB port.

Allow the music files to play and then press the **POWER** button to turn the head unit off.

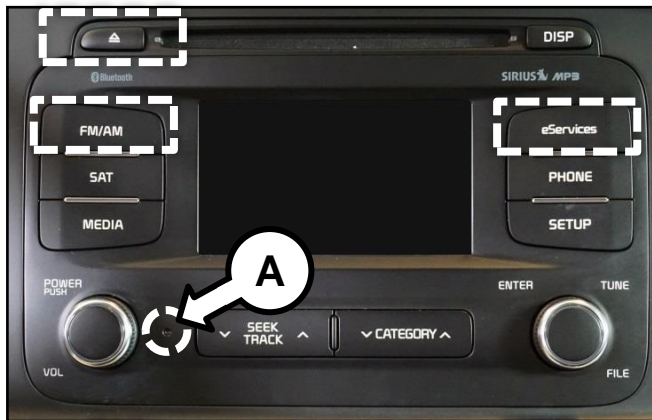
- Once the AUM initialization process is complete or having inserted the USB upgrade stick, for Sportage (SL), Optima (TF, QF, TFH), Forte (YD), and Sorento (XMa) vehicles, press and hold the **CD EJECT** button, **FM/AM** button, and **eServices** button. While holding the three (3) buttons, use a ballpoint pen or a similar tool and press the **RESET** button (A).

For Soul (PS) vehicles, press and hold the **FM/AM** button and **eServices** button. While holding the two (2) buttons, use a ballpoint pen or a similar tool and press the **RESET** button (A).

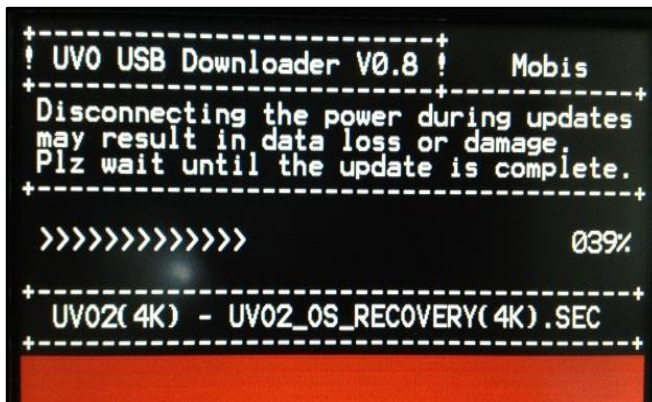
- The head unit will automatically reset and begin the program download.

The download will take approximately 3-5 minutes to complete and should be monitored to confirm completion. Do NOT remove the USB or the turn the radio or vehicle OFF while the download is in progress.

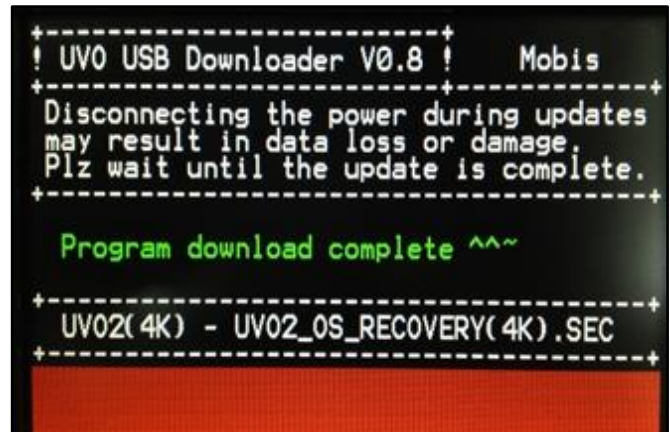
11. Once the download is complete, the screen as shown to the right should be displayed.

If the screen displays “Program download failed!!”, restart the procedure from step 3.

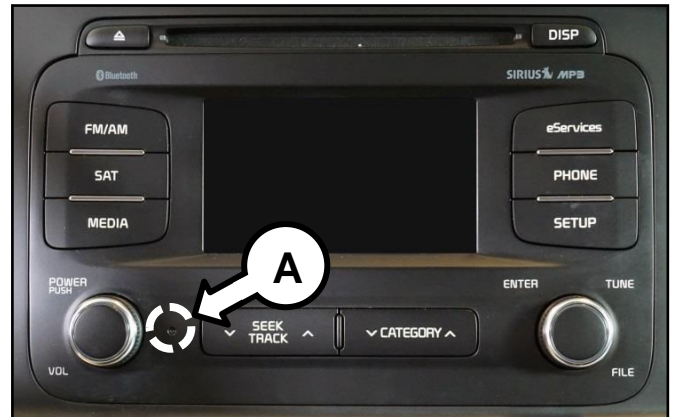
12. Press the **RESET** button (A) using a ballpoint pen or a similar tool.

Do **NOT** remove the **USB** or turn the **radio** or **vehicle OFF** while the update is in progress.

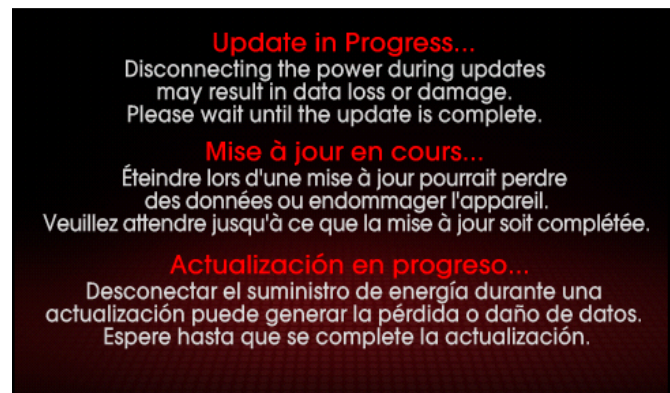
13. The software upgrade should begin and the screen as shown to the right should be displayed.

The head unit may restart several times. The update will take approximately 10-15 minutes to complete. Other services can be performed while the system upgrade is in progress. Do **NOT** remove the **USB** or turn the **radio** or **vehicle OFF** while the update is in progress.

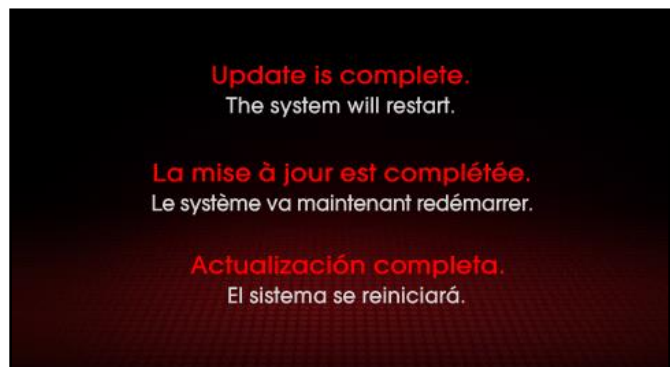
14. The head unit will automatically restart once the upgrade is complete.
