GROUP ENG	MODEL 2017MY Forte (YDm) 2.0L MPI
	NUMBER 165	DATE April 2017
TECHNICAL SERVICE BULLETIN		
SUBJECT: SERVICE ACTION: ECU LOGIC IMPROVEMENT FOR DTC P030X (SA285)

This bulletin provides the procedure to improve the logic of the Electronic Control Unit (ECU) on some 2017MY Forte (YDm) vehicles equipped with 2.0L MPI engine, produced from May 30, 2016 to February 22, 2017, which may experience a malfunction indicator lamp illumination with **DTC P0300, P0301, P0302, P0303, or P0304**. To correct this concern, apply the improved logic to the ECU using the KDS download as described in this bulletin. For confirmation that the latest reflash has been applied to a vehicle you are working on, verify the ROM ID using the table on page 2 of this bulletin. Before conducting the procedure, verify that the vehicle is included in the list of affected VINs.

ECU Upgrade Procedure:

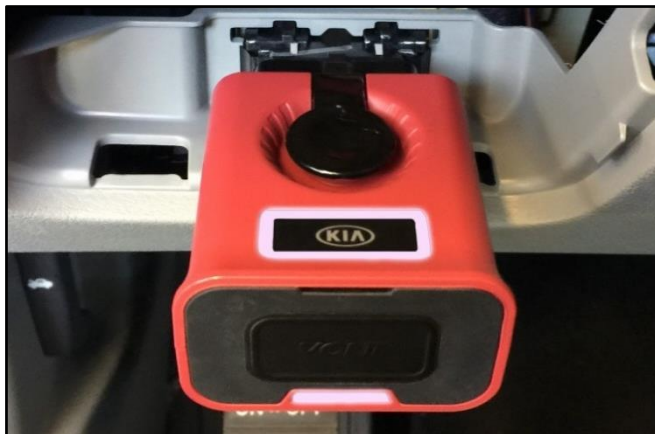
1. Connect the VCI-II to the OBD-II connector, located under the driver's side of the instrument panel.

The ECU upgrade function on KDS is operating wirelessly. It is not necessary to perform the upgrade via USB cable.

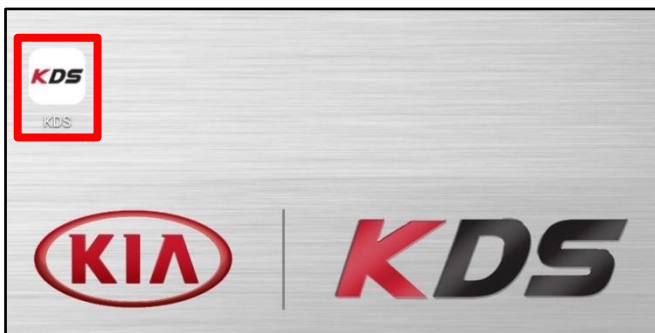
2. With the ignition ON, turn ON the KDS tablet. Select **KDS** from the home screen.
