| GROUP ENG | MODEL 2016MY Optima (JFa) 2.4L |

TECHNICAL SERVICE BULLETIN

SUBJECT: COMBINATION TSB / SERVICE ACTION: IDLE STABILITY & SHIFT QUALITY IMPROVEMENT (SA294)

This bulletin provides the procedure to improve the logic of the Electronic Control Unit (ECU) and the Transmission Control Unit (TCU) on some 2016MY Optima (JFa) vehicles, produced from September 3, 2015 through November 22, 2016, which may experience a vibration and/or hesitation when releasing the brake pedal after coming to stop, and/or a shift quality concern, such as a harsh downshift, upshift, and/or shift delay. To correct this concern, apply the improved logic to the ECU and TCU using KDS download as described in this bulletin. For confirmation that the latest reflash has been applied to a vehicle you are working on, verify the ROM ID using the table on pages 2-3 of this bulletin. Before conducting the procedure, verify that the vehicle is included in the list of affected VINs.

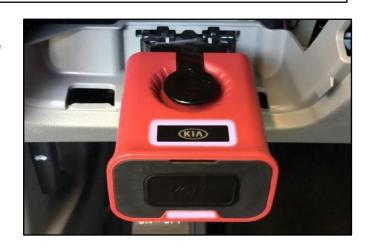
The ECU upgrade function on KDS is operating wirelessly. It is not necessary to perform the upgrade via USB cable.

2. With the ignition ON, turn ON the KDS tablet. Select **KDS** from the home screen.
