GROUP <b>ENG</b>	MODEL <b>2016MY Sorento (UMa) 2.4L</b>
	NUMBER <b>169</b>	DATE <b>May 2017</b>
<b>TECHNICAL SERVICE BULLETIN</b>		
<b>SUBJECT:</b> COMBINATION TSB / SERVICE ACTION: SHIFT QUALITY IMPROVEMENT (SA295)

This bulletin provides the procedure to improve the logic of the Electronic Control Unit (ECU) and the Transmission Control Unit (TCU) on some 2016MY Sorento (UMa) 2.4L vehicles, produced from October 29, 2014 through December 15, 2016, which may experience a shift quality concern, such as a harsh downshift, upshift, and/or shift delay. To correct this concern, apply the improved logic to the ECU and TCU using KDS download as described in this bulletin. For confirmation that the latest reflash has been applied to a vehicle you are working on, verify the ROM ID using the table on pages 2-3 of this bulletin. Before conducting the procedure, verify that the vehicle is included in the list of affected VINs.

## SHIFT QUALITY IMPROVEMENT (SA295)

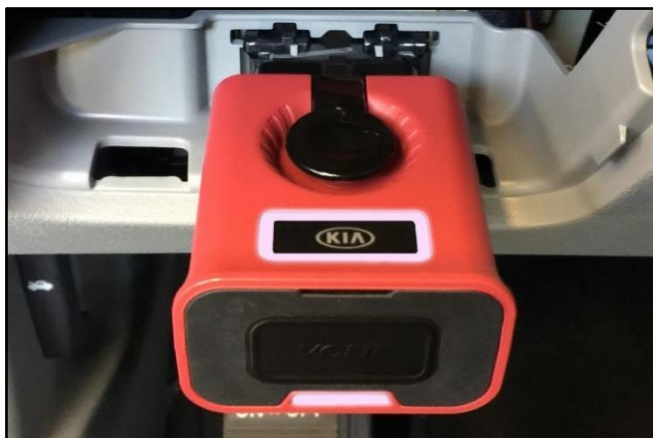
1. Connect the VCI-II to the OBD-II connector, located under the driver's side of the instrument panel.

The ECU upgrade function on KDS is operating wirelessly. It is not necessary to perform the upgrade via USB cable.

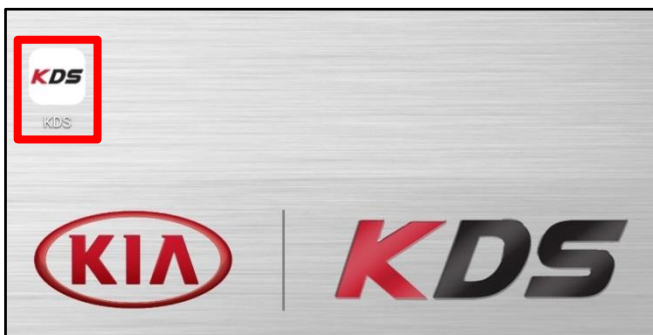
2. With the ignition ON, turn ON the KDS tablet. Select **KDS** from the home screen.

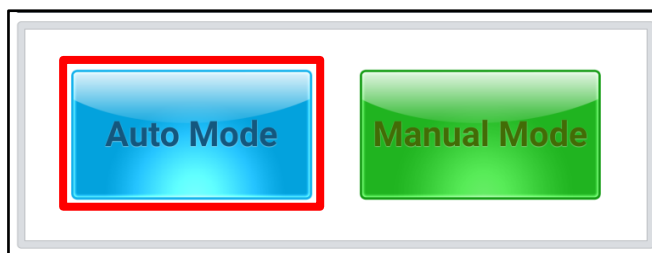
6. Select **Auto Mode**.

Do NOT attempt to perform a Manual Mode upgrade UNLESS Auto Mode fails. Always follow the instructions given on the KDS in either Auto or Manual mode.

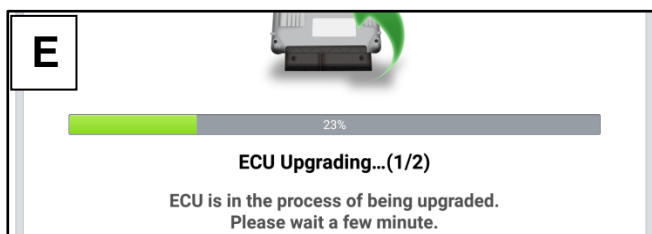
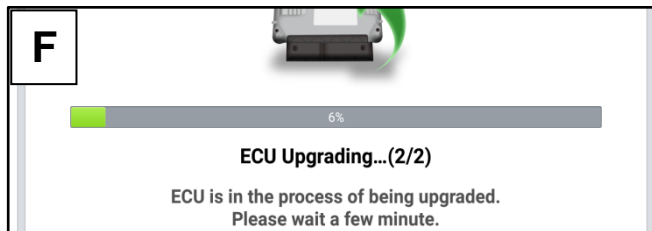
8. The ECU upgrade will begin and the progress of the upgrade will appear on the bar graph. Upgrade part (1/2) (E) will download the upgrade event to the VCI-II. Upgrade part (2/2) (F) will upgrade the ECU.

9. If a "Communication Fail" screen appears, verify that the VCI-II and KDS are communicating properly. Touch **OK** and restart the procedure from step 4.

10. When instructed on the KDS, turn the ignition **OFF** for ten (10) seconds then back on. Touch **OK** to continue.

11. Once the upgrade is complete, touch **OK** to finalize the procedure.

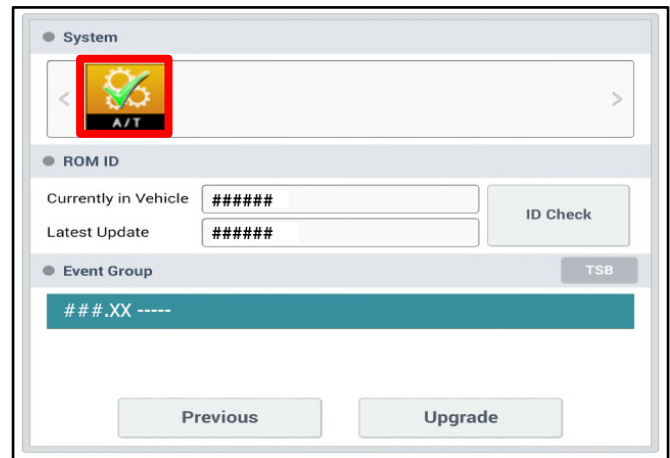
13. Repeat steps 4-11 and perform **Upgrade Event (330)** with the **A/T** system selected under the System selection menu.

When prompted, select **YES** to check for Diagnostic Trouble Codes (DTC) and erase any DTCs stored such as EPS, ESC, and TPMS that may have been set during the upgrade.
