GROUP TRA	MODEL 2016MY Optima (JFa) 2.0T Sorento (UMa) 2.0T, 3.3L
	NUMBER 069	DATE May 2017
<b>TECHNICAL SERVICE BULLETIN</b>		
SUBJECT: COMBINATION TSB / SERVICE ACTION: SHIFT QUALITY IMPROVEMENT (SA292)

This bulletin provides the procedure to improve the logic of the Transmission Control Unit (TCU) on some 2016MY Optima (JFa) 2.0T, produced from August 28, 2015 through October 7, 2016, Sorento (UMa) 2.0T, produced from October 29, 2014 through December 9, 2016, and Sorento (UMa) 3.3L vehicles, produced from October 27, 2014 through December 22, 2016, which may experience a shift quality concern, such as a harsh downshift, upshift, and/or shift delay. To correct this concern, apply the improved logic to the TCU using the KDS download as described in this bulletin. For confirmation that the latest reflash has been applied to a vehicle you are working on, verify the ROM ID using the table on pages 2-3 of this bulletin. Before conducting the procedure, verify that the vehicle is included in the list of affected VINs.

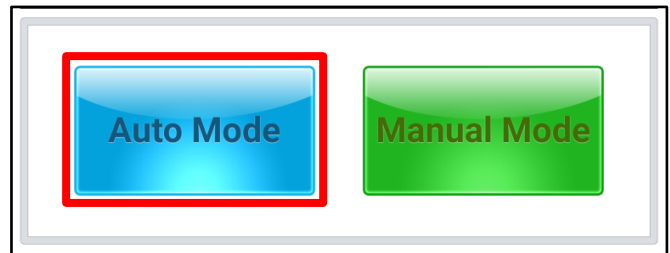
7. Select **A/T** system under the System selection menu.

Touch **ID Check** (D) and confirm that the latest update is available

Select **Upgrade Event (326, 329, or 333)** and select **Upgrade** to continue.

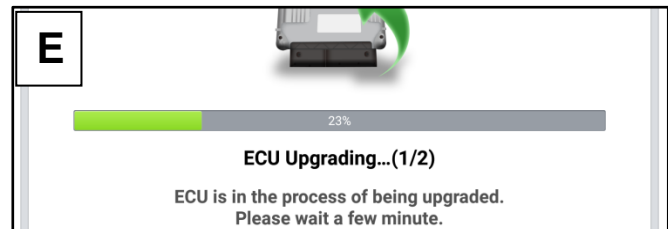
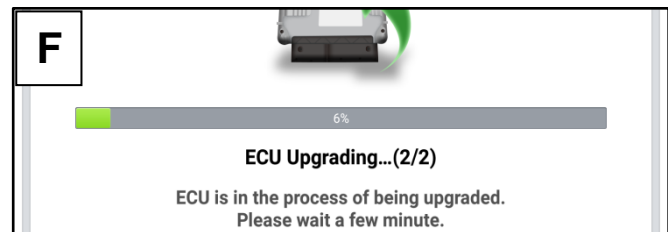
9. If a "Communication Fail" screen appears, verify that the VCI-II and KDS are communicating properly. Touch **OK** and restart the procedure from step 4.
