# In-Shop Campaign, ISX15 CM2350 VGT Actuator Calibration

This In-Shop Campaign is being issued to recalibrate the Variable Geometry Turbocharger (VGT) actuator of certain ISX15 CM2350 engines. It provides authorization for certified repair locations to recalibrate the VGT actuator anytime the unit is in for maintenance or repairs, with certain restrictions on reimbursement.

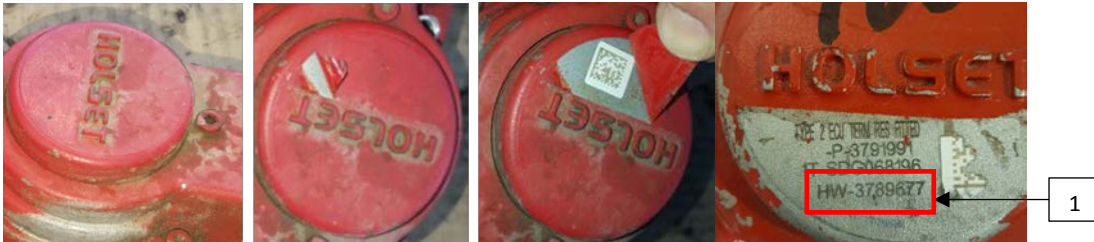
Figure 0. Turbo Actuator Pictures

1. Using a paint scrapper remove paint covering part name as seen below in Figure 0
2. Record the Hardware Part Number [1] Figure 0

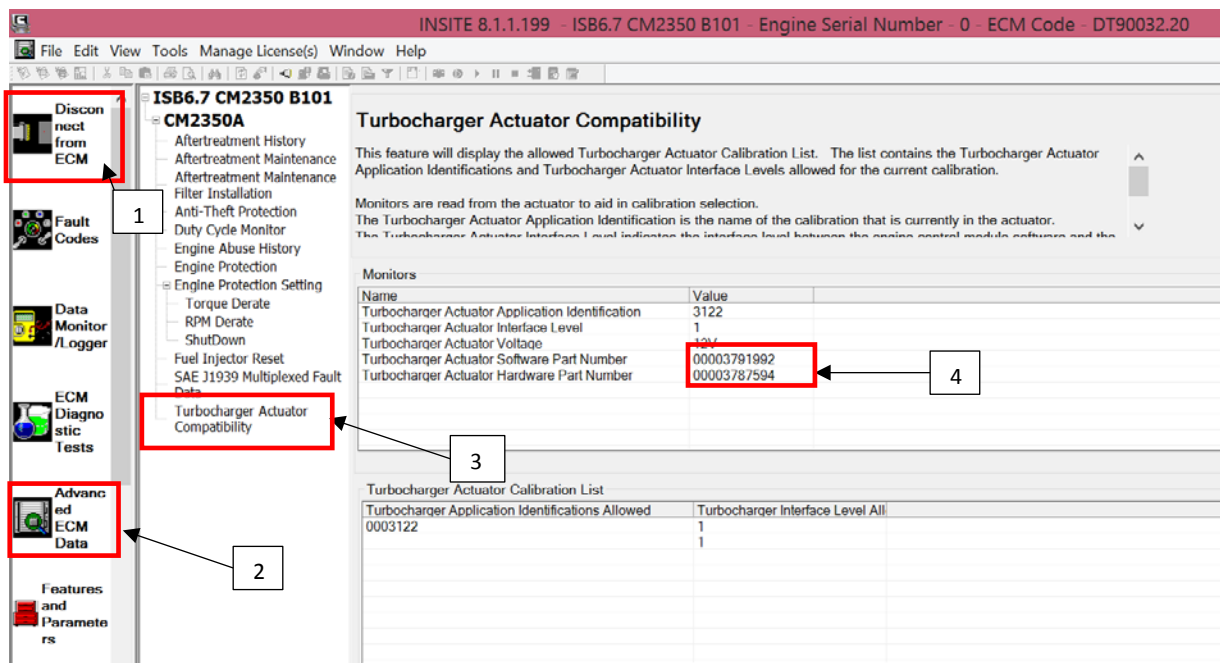
Figure 1. Turbocharger Actuator Hardware Part Number Screen

1. Connect to ECM [1]. Figure 1.
2. Select Advanced ECM Data Button [2]. Figure 1.
3. Click “Turbocharger Actuator Compatibility” [3]. Figure 1.
4. Document both the 7 digits of Turbocharge Actuator Hardware and Software Part Number [4]. Figure 1. This hardware number is needed later in the procedure.

5. Compare Hardware Part Number on Data Plate to Hardware Part Number Recorded in Step 4
6. If part numbers do not match DO NOT PROCEED, THE ACTUATOR HAS THE MOST CURRENT ALLOWABLE SOFTWARE; updating beyond this software revision may cause damage to the actuator. No further repairs are necessary. Close the campaign as an inspection only.
7. Disconnect From ECM [1]. Figure 1.
8. Open Insite- Calibration Selection [6]. Figure 2.
9. Click on **ECM/PDD Code Search** [7]. Figure 2.

1. Connect to ECM [1]. Figure 1.
2. Open Insite- Calibration Selection [6]. Figure 2.
3. Select ECM/PDD button [8]. Figure 2.

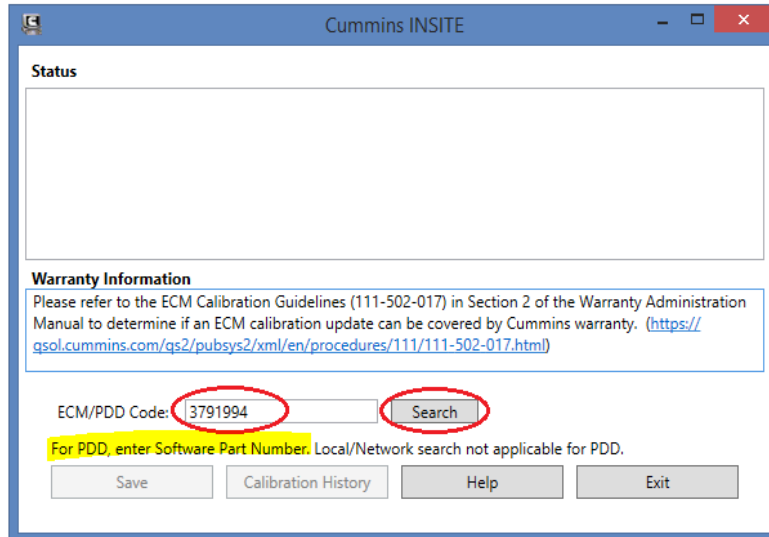
*Figure 3. Calibration Selection*

10. Enter the **Software Part Number** of the Turbo Actuator Controller Figure [3]
11. Click the **Search** button
  - o Note – PDD codes only search the web. It will not search the local or network drives.
12. Click **Save**.
  - o If the Save button is grayed out this indicates the latest calibration has previously been saved to your Calibration Workspace. Proceed to next steps.
  - o Note – The PDD code will save to the Calibration Workspace on the user's hard drive
  - o Click **"Exit"**

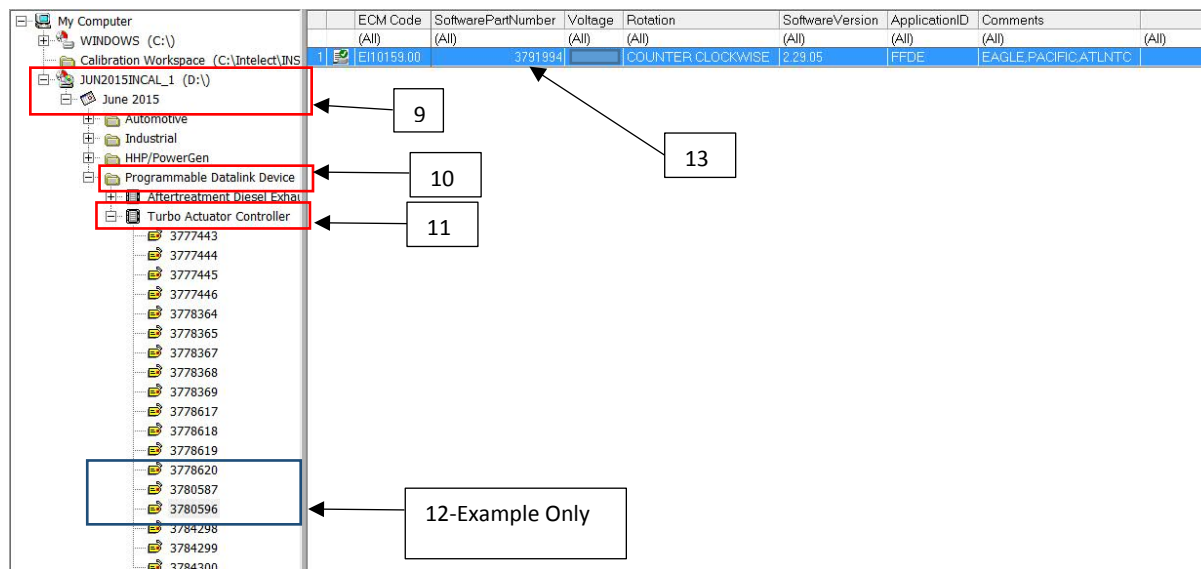
Figure 4. Actuator Hardware Number and Software Selection Screen

4. Expand the drive and month of the INCAL™(Calibration Workspace) [9]. Figure 4.
5. Select Programmable Datalink Device [10]. Figure 4.
6. Expand Turbo Actuator Controller [11]. Figure 4.
7. Select the Turbo Actuator Controller (Actuator Hardware Part Number) [12] that matches the number documented in step 3. Figure 4.
8. Left click on the Software Part number [13], and then right click to select “transfer to device”.
