02210 Version 2

HVAC Display Flashes or Flickers

AFFECTED VEHICLES

Year	Model	Trim	VIN Range
2014–15	MDX	ALL with navigation	ALL

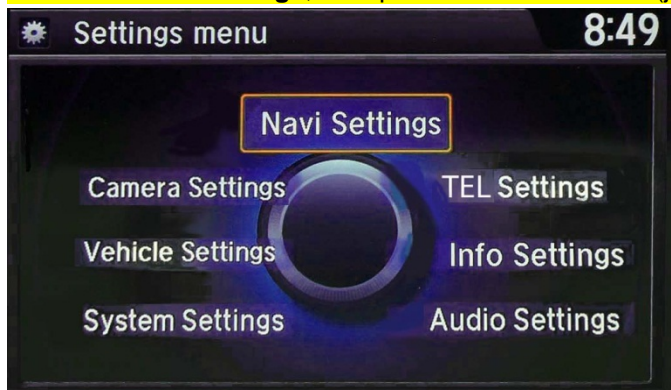
- Press the Settings button.
 - Select **Navi Settings**, then press the interface dial (jog knob).

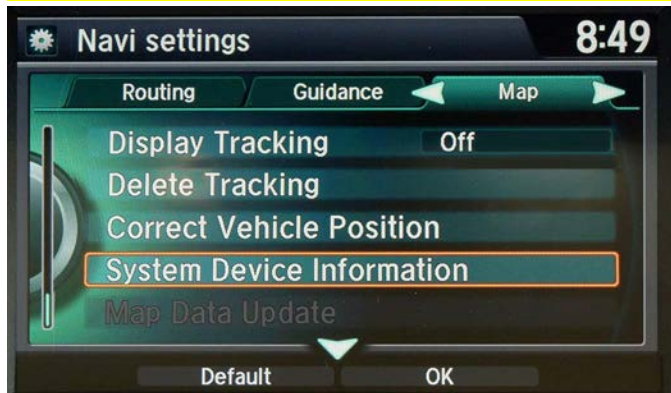
- Scroll down and select **System Device Information**.

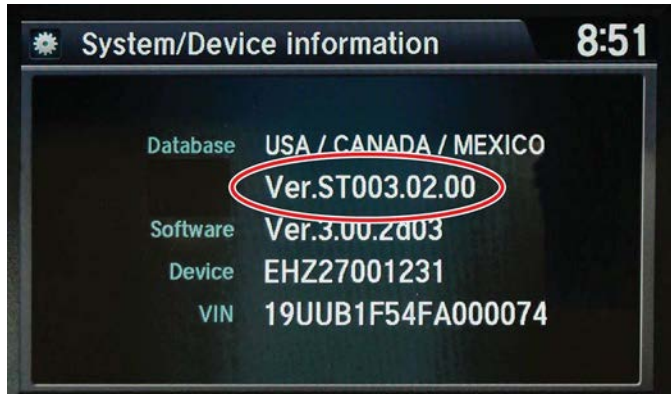
- Check the Database version is VER.ST003.02.00.
 - If the version matches, continue to step 4.
 - **If the version is different, go to S/B 14-037 and do the map database update. The map database must be completely installed, including the background update, before continuing with this bulletin. If you try to update the ODMD without doing 14-037, the ODMD will not work properly.**

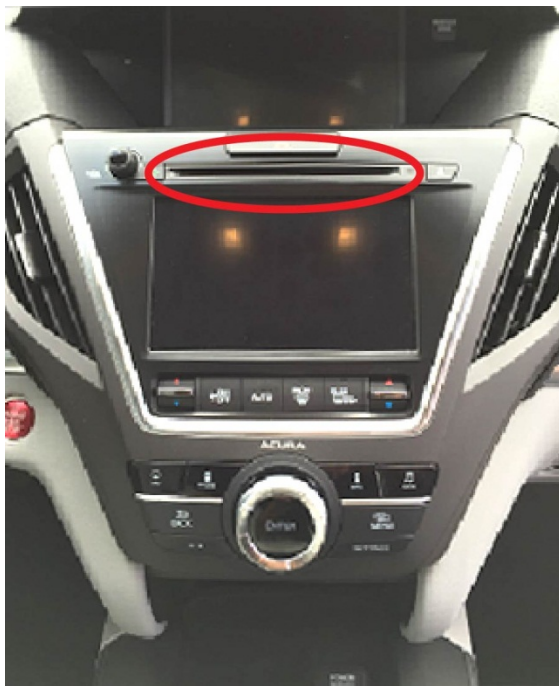
4. Set the power mode to OFF, then to ON and wait for the navigation system to boot up. **Insert the RED DVD** into the CD slot as shown. See TOOL INFORMATION.

NOTE: The power mode must remain ON during the entire update procedure. If the power mode is set to OFF, the engine is started, or the DVD is removed at any time during the update process, the audio-navigation unit will be locked up and you will need to use the RECOVERY PROCEDURE.

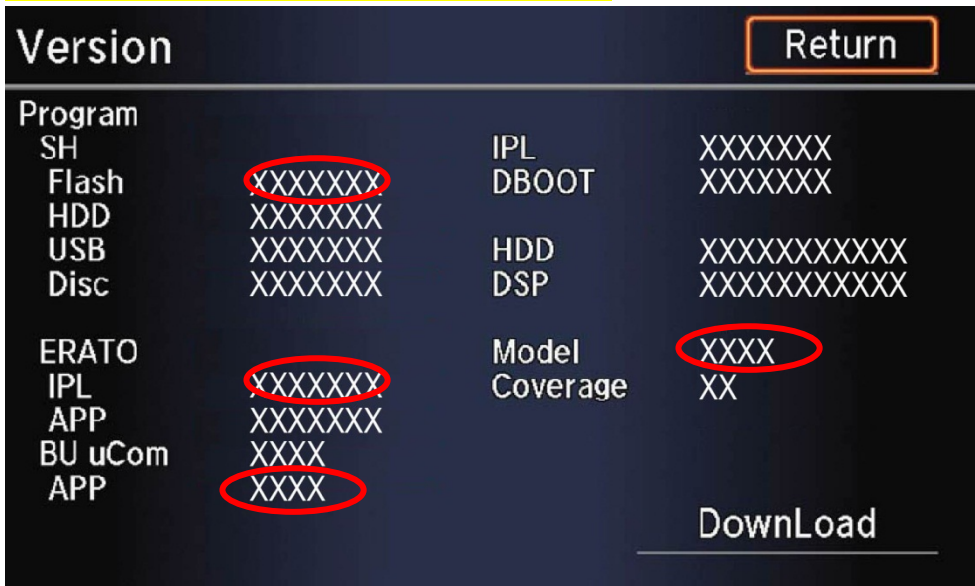
12. Verify that the software versions were updated to the new version as shown:

Software	2015 MDX with RES	2015 MDX without RES
SH Flash	4.00.2309	4.00.2309
ERATO IPL	4.00.5004	4.00.5004
BU uCom APP	4.003.604	4.003.804
Model	TZ5A	TZ5A

NOTE: If the Version information does not match the table above after doing the update, or the update won't auto start, select **Download** and press the interface dial.

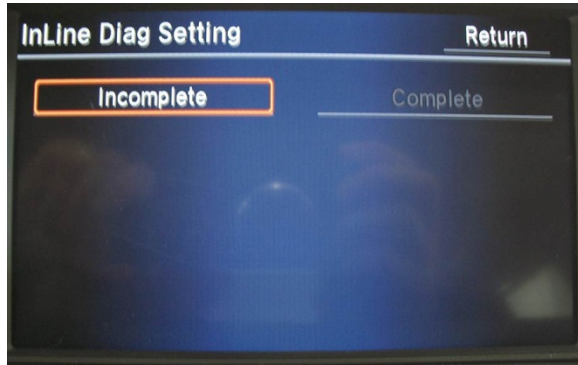
- Move the vehicle to an open area. Start the engine if not already done.
- Press and hold the NAVI, BACK, and MENU buttons until the **Select Diagnosis Items** screen appears.
- Press and hold the NAVI button.
- Select **Incomplete**. The system restarts.

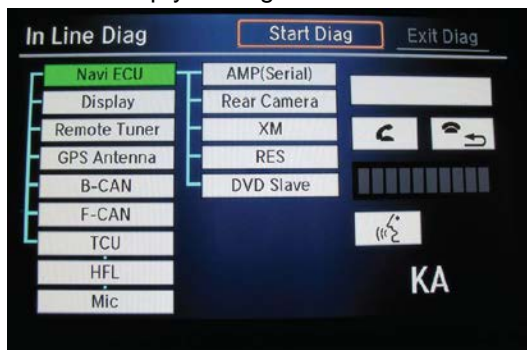
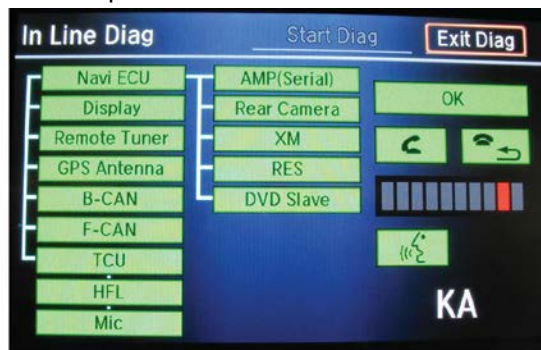
- When the **In-Line Diag** screen appears, select **Start Diag**.
- Make sure all the icons turn green.

NOTE: To get all the icons to turn green, make sure that you do the following:

- Press the Pick-up button.
- Press the Hang-up button.
- Press the Talk button.
- Snap your fingers in front of the microphone to complete the test.

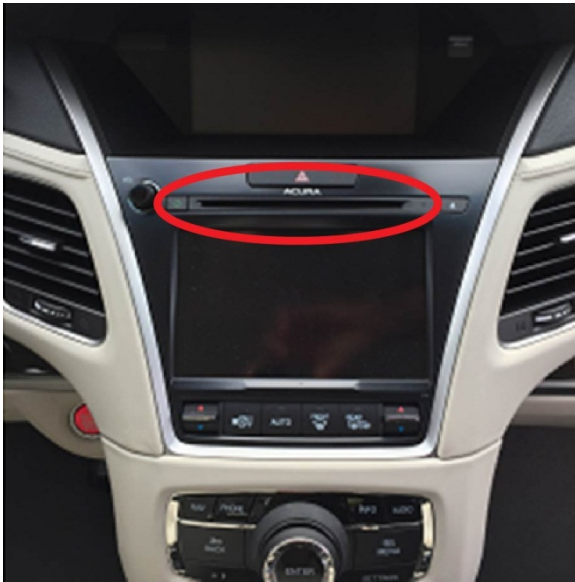
- **If the vehicle does not have navigation, do not use this software update.** If you do, you may permanently damage the audio unit.
 - Apply this software update only to the vehicles listed under AFFECTED VEHICLES; otherwise this software update can permanently damage the unit.
 - If you accidentally update the wrong vehicle, contact Tech Line; if the unit must be replaced, your dealership may be debited for the replacement cost.
1. Connect a battery charger or a fully charged jumper battery to the vehicle and leave it connected during the entire update procedure to maintain a steady voltage.
 2. Set the power mode to ON.
 3. Wait for the navigation system to boot up. **Insert the BLUE DVD** into the CD slot as shown. See TOOL INFORMATION.

NOTE: The power mode must remain ON during the entire update procedure. If the power mode is set to OFF, the engine is started, or the DVD is removed at any time during the update process, the audio-navigation unit will be locked up and you will need to use the RECOVERY PROCEDURE.

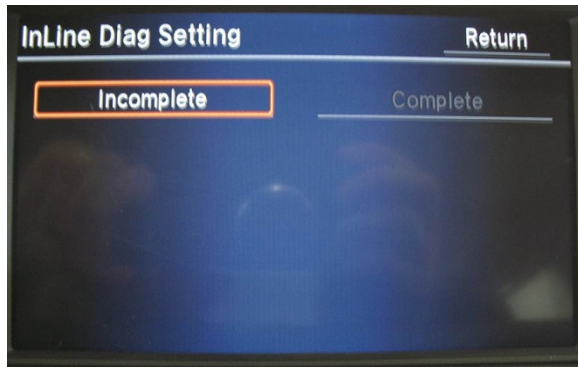
- Move the vehicle to an open area. Start the engine if not already done.
- Press and hold the NAVI, BACK, and MENU buttons until the **Select Diagnosis Items** screen appears.
- Press and hold the NAVI button.
- Select **Incomplete**. The system restarts.

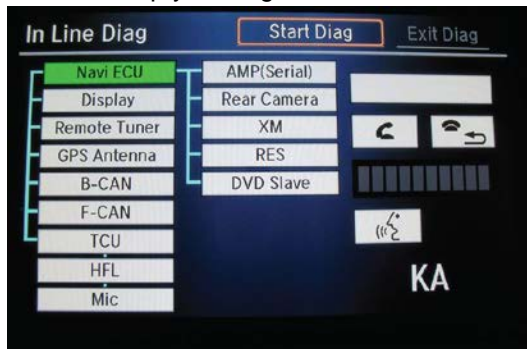
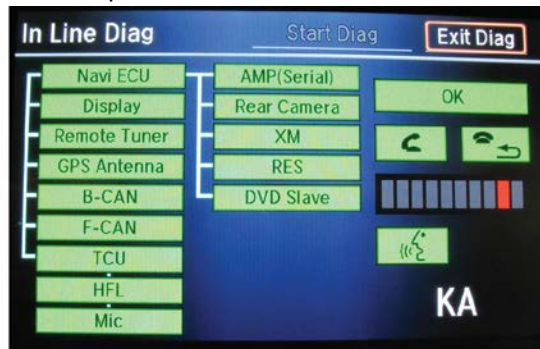
- When the **In-Line Diag** screen appears, select **Start Diag**.
- Make sure all the icons turn green.

NOTE: To get all the icons to turn green, make sure that you do the following:

- Press the Pick-up button.
- Press the Hang-up button.
- Press the Talk button.
- Snap your fingers in front of the microphone to complete the test.
