July 26, 2017

07115 Version 4

Audio Unit Display Beeps or Changes Screens by Itself

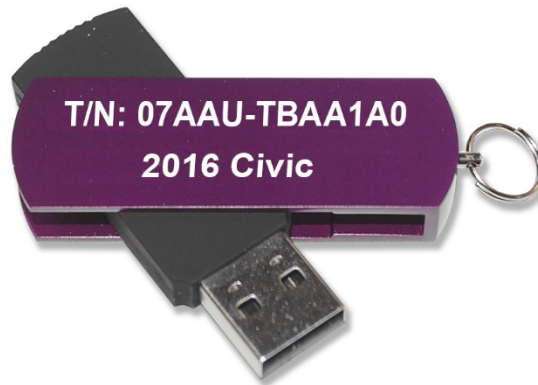
Tool Name	Part Number
Audio-Navigation System Update Device (purple USB update tool)	07AAU-TBAA1A0

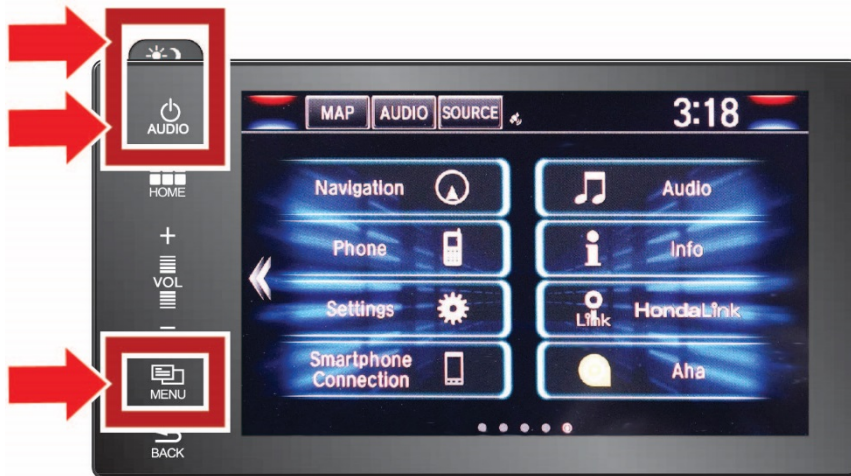
1. Prepare the vehicle for the update.
 - If the engine will be running, park the vehicle outside in a well ventilated area or attach an appropriate exhaust vent. Go to step 2.
 - If the engine will not be running, connect an active charger to the battery. Go to step 3.
2. Start the engine and leave it running throughout the entire software update process. Go to step 4.
3. Push the Engine Start button twice to turn the power mode to ON (not Accessory mode).
4. Press and hold the **Day/Night**, **Audio Power**, and **MENU** buttons at the same time.

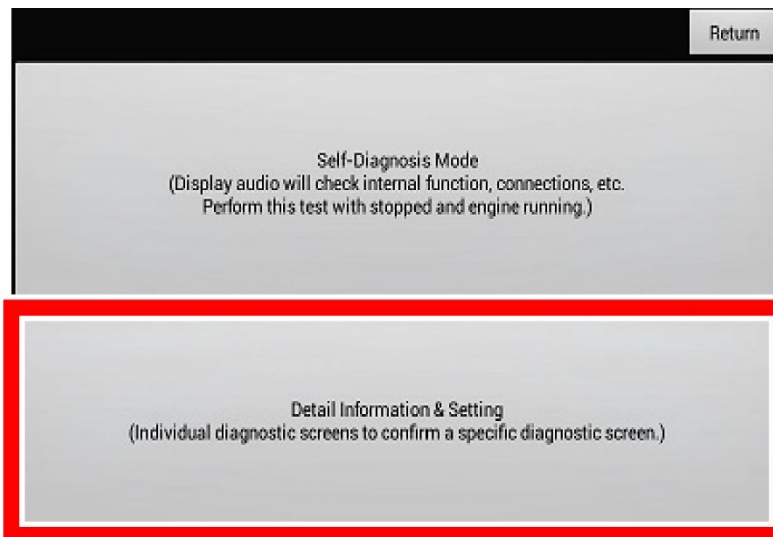
5. Select **Detail Information & Setting**.

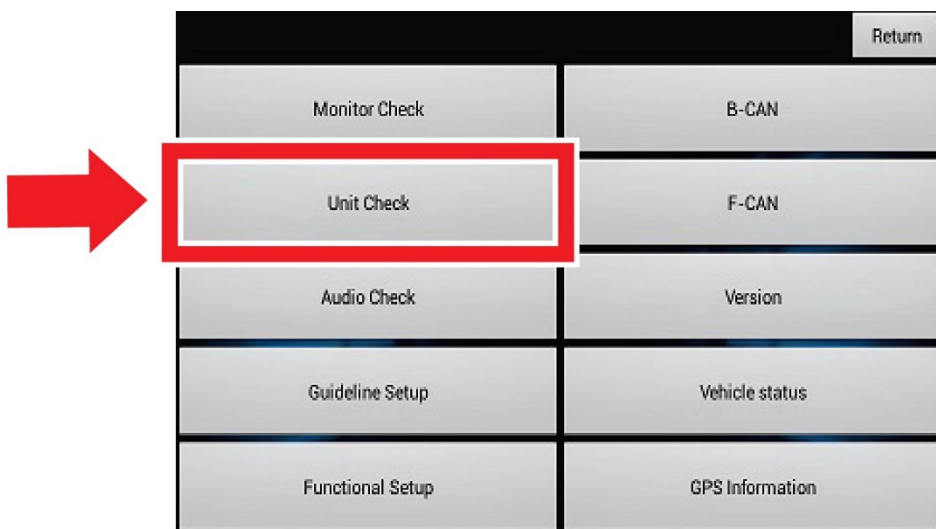
Select **Unit Check**.

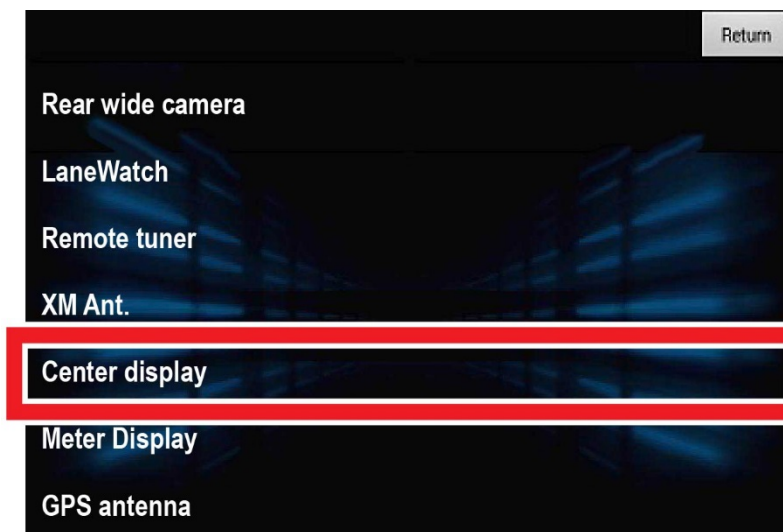
6. Scroll down and then select: **Center display**.

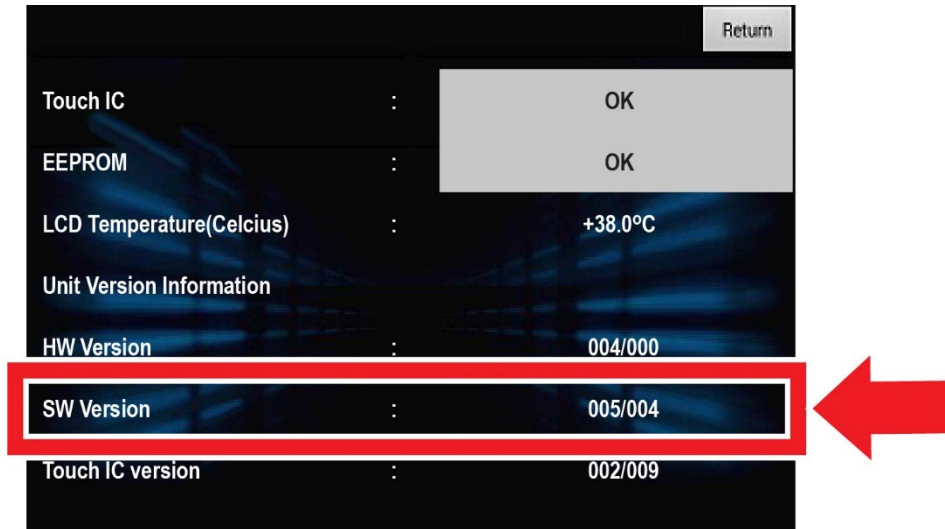
7. Scroll down to **SW Version**, and check what software version is indicated.

- If **005/004** is indicated, the software is already the latest version. This bulletin does not apply. Continue with normal troubleshooting.
- If the software version indicated is not **005/004**, continue with the update. Go to step 10.

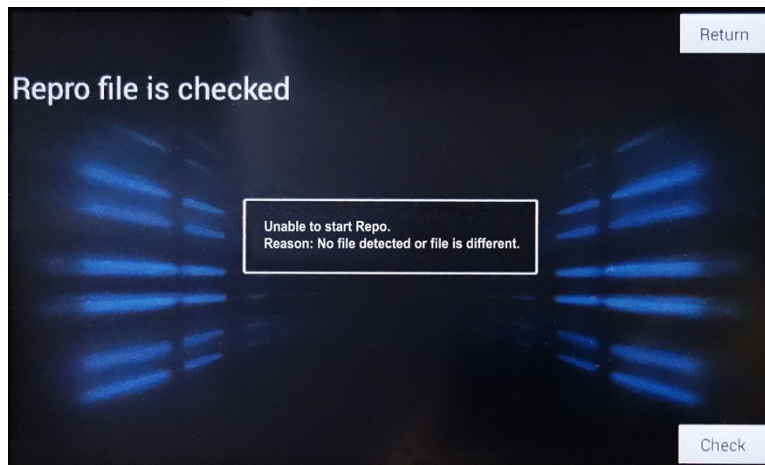
NOTE: If the “**Unable to start Repo. Reason: No files detected or file is different**” message appears, the display is already updated to the latest software version. This bulletin does not apply.

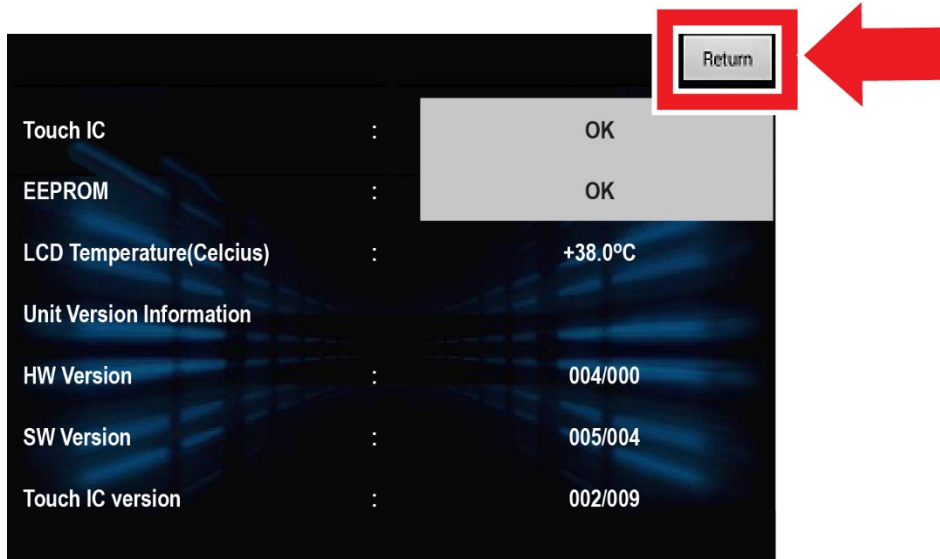
8. Select **Return** to return to the **Unit Check** menu screen.

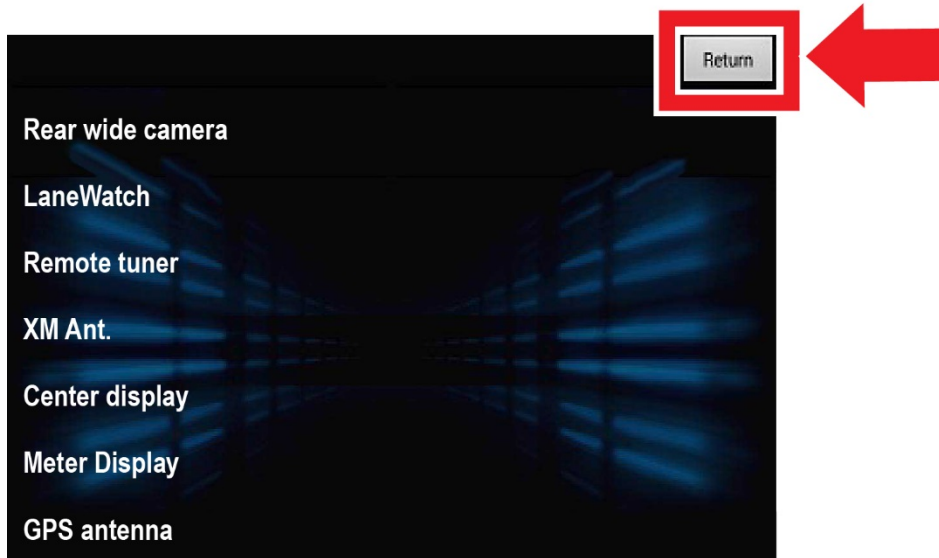
9. Select **Return** to return to the **Detail & Information Setting** menu screen.

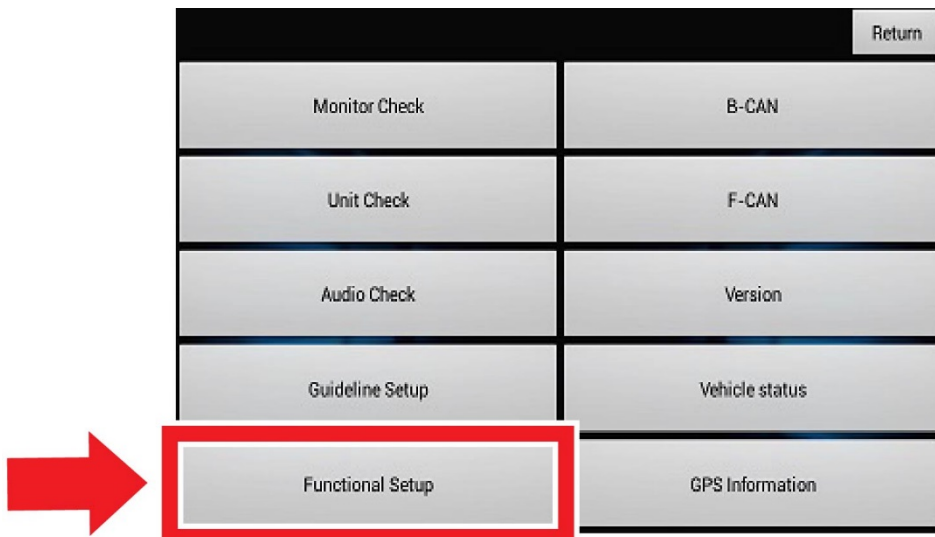
10. Select **Functional Setup**.

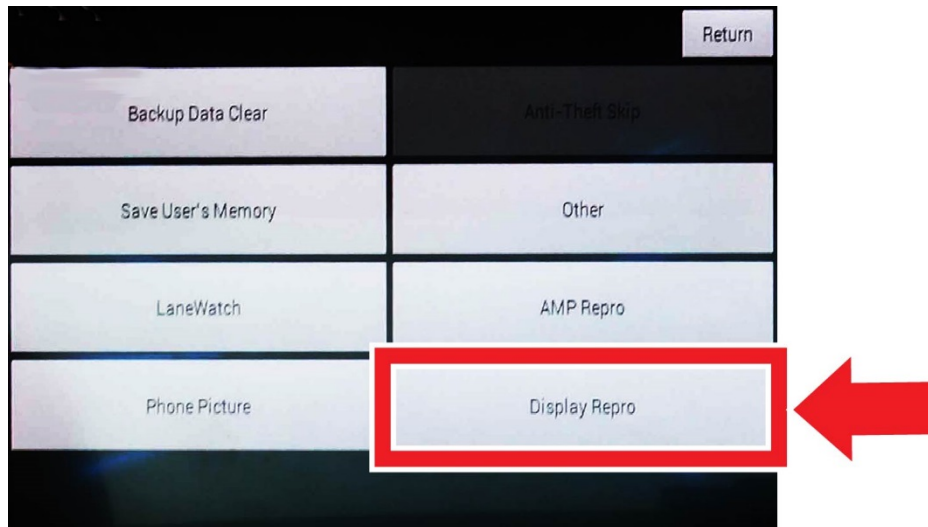
11. Select **Display Repro**.

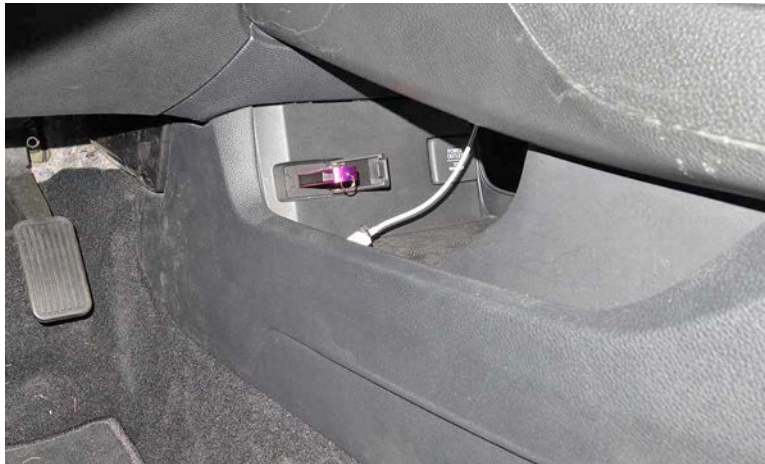
12. Plug the purple USB update device into the USB port below and behind the audio unit near the driver's knee area.

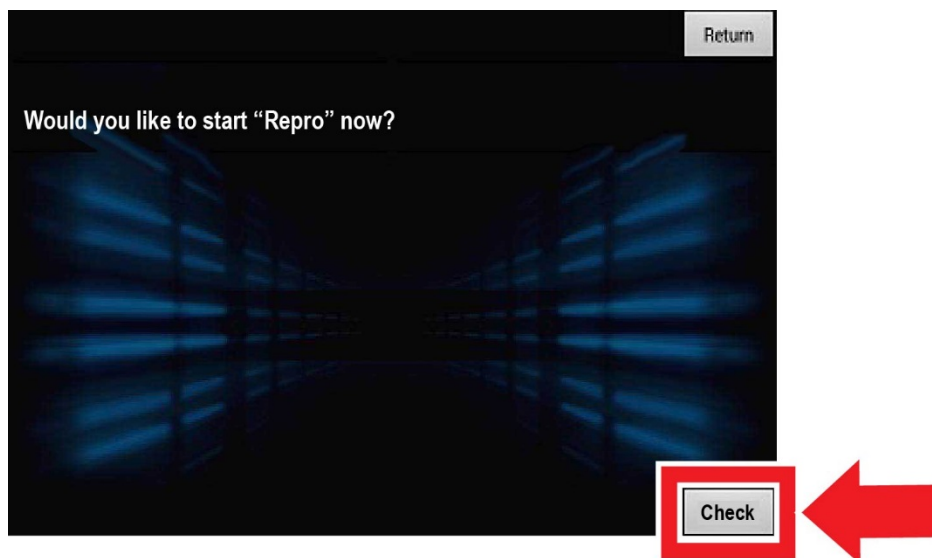
13. When the “Would you like to start “Repro” now?” message appears, select **Check**.

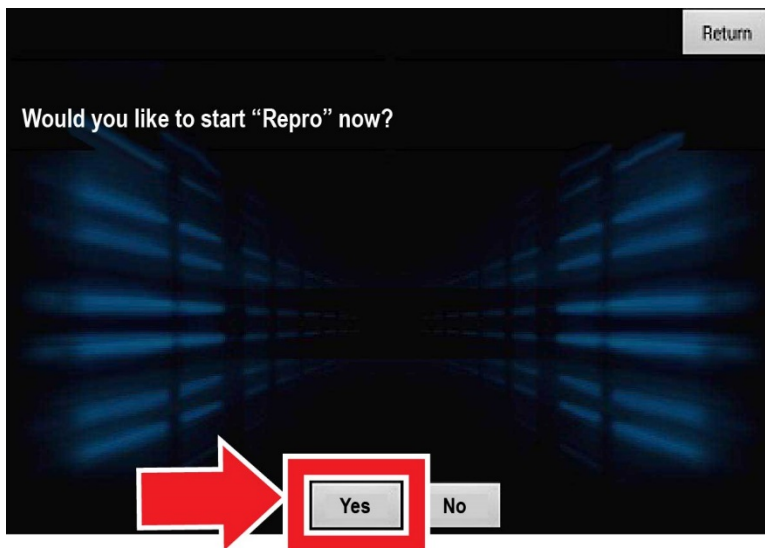
14. After checking the “Would you like to start “Repro” now?” message, select **Yes**.

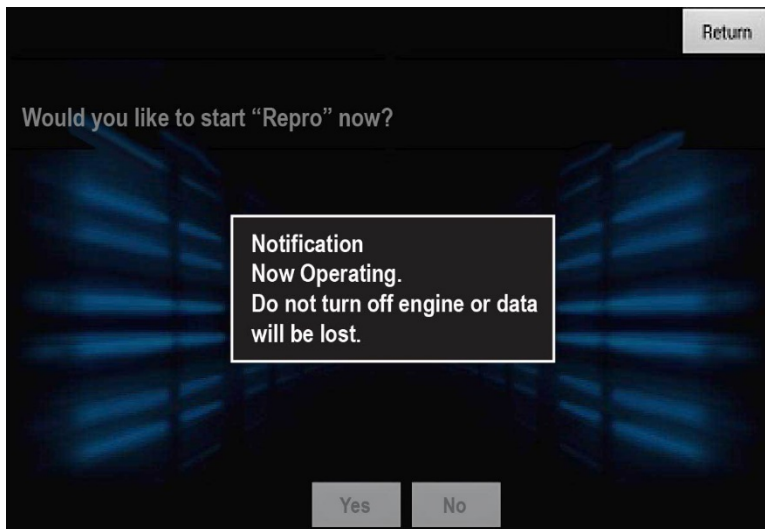
The software update should start. It takes up to 3 minutes to complete the update. Once you start the update, you do not have to stay with the vehicle.

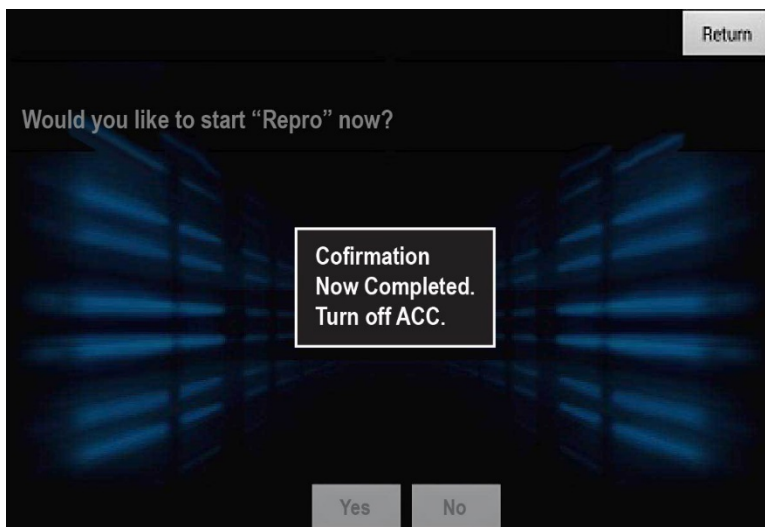
15. If the update operation completes normally, it will automatically reboot the display. If the “**Confirmation Now completed. Turn off ACC**” message appears, reboot the head unit by turning the power mode to OFF for 2 minutes. Then, restart the engine or turn the ignition to ON.

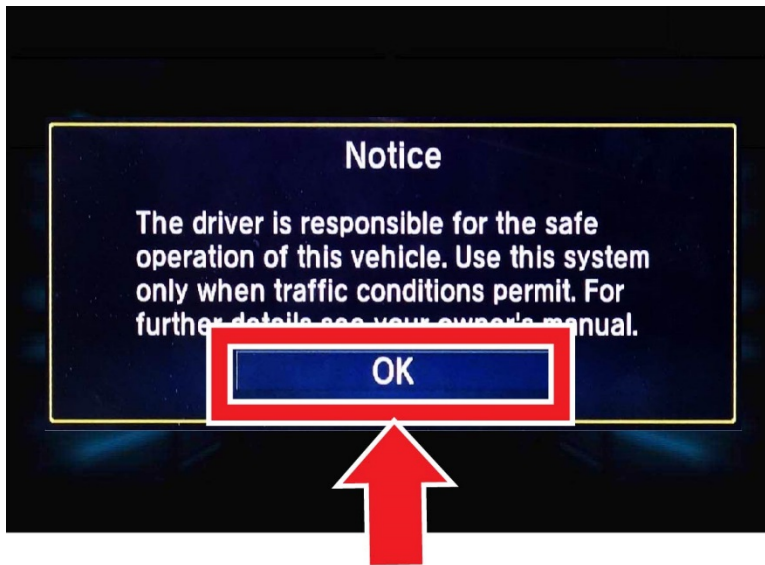
After the system reboots, click **OK** or wait for the safety notice to disappear.

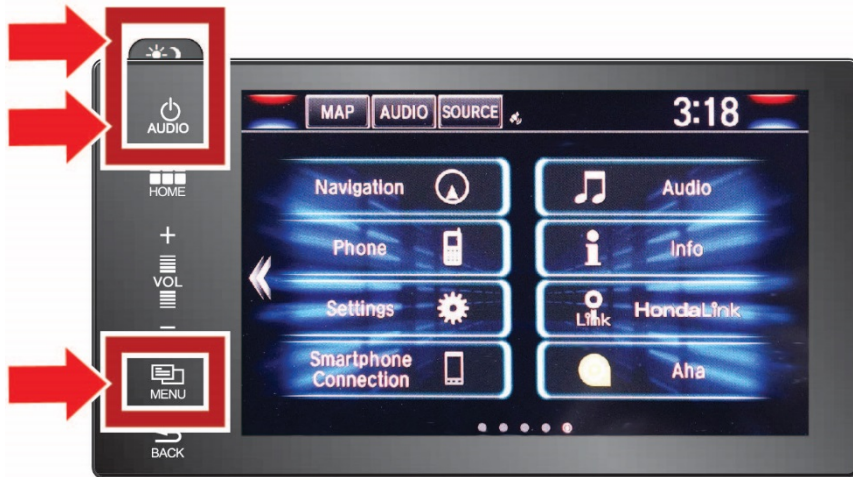
17. Press and hold the **Day/Night**, **Audio Power**, and **MENU** buttons at the same time.

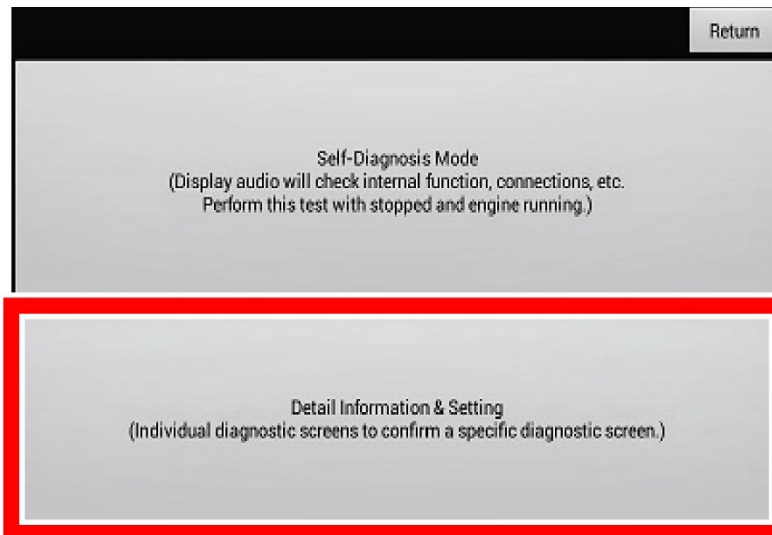
18. Select **Detail Information & Setting**.

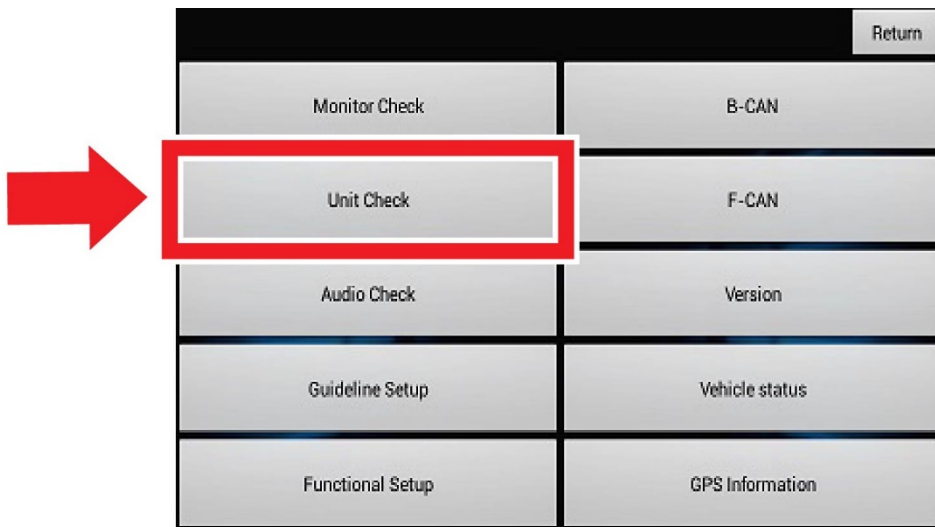
19. Select **Unit Check**.

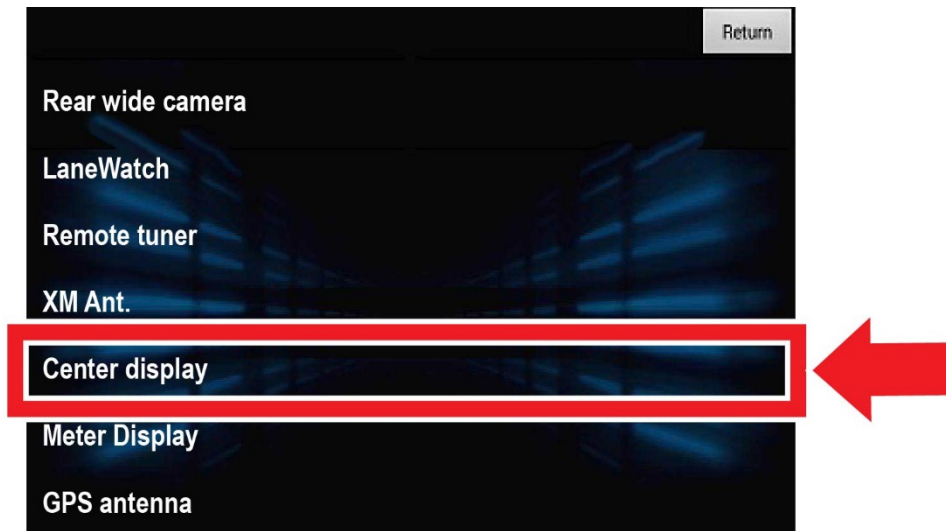
20. Scroll down and then select: **Center display**.

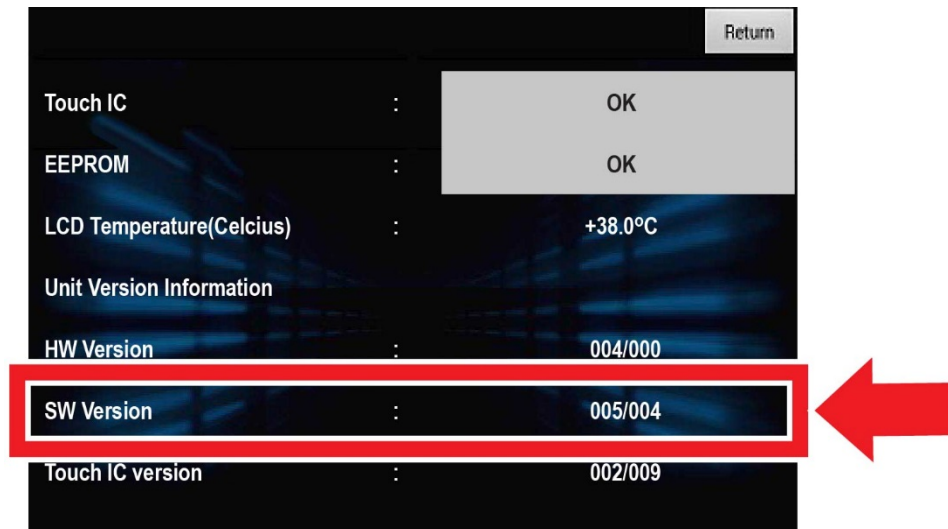
21. Scroll down to **SW Version**, and check that the new version **005/004** is indicated.

- If the new version is indicated, the process is complete.
- If the new software version is not indicated, you must reload the software again.
