# Entune Audio Head Unit Software Update (Fujitsu Ten)

YEAR(S)	MODEL(S)	ADDITIONAL INFORMATION
2016 - 2017	Camry, Camry HV, Corolla, Prius C, RAV4, RAV4 HV

Some 2016 – 2017 model year vehicles equipped with Entune™ Audio (version UU.10.48), Entune™ Audio Plus (version EU.10.68 or EU.20.25 or EU.20.28) or Entune™ Premium Audio (CU.10.71 or CU.10.72 or CU.20.05 or CU.20.08) may exhibit 1 or more of the following conditions:

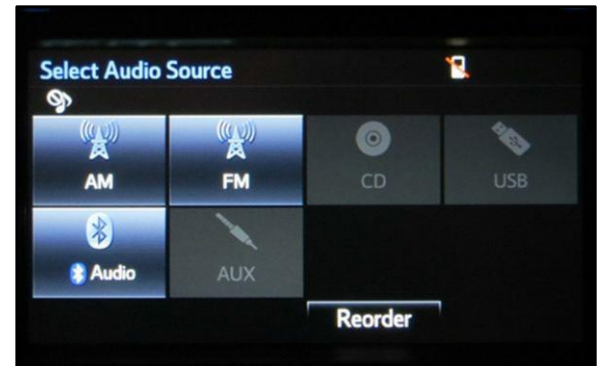
Figure 2.

2. Perform steps 7 – 11 and verify the latest software needs to be applied.  
Is the software up to date?
  - **YES** — This bulletin does NOT apply. Continue diagnosis using the applicable Repair Manual.
  - **NO** — Continue to step 3.
3. Insert the USB drive into the vehicle USB port.
4. Start the engine.
5. Wait for the screen to display.

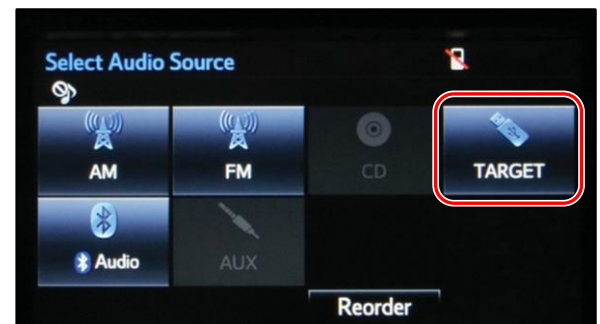
Figure 3.

6. Wait until the USB source icon highlights and displays the USB name with the icon.

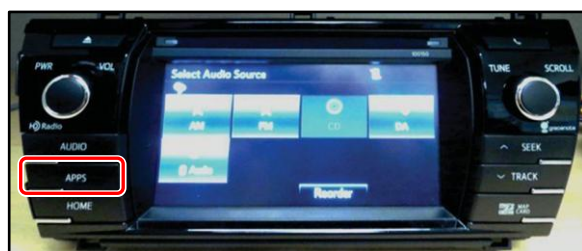
**Figure 5. Camry, Corolla, RAV4**

- B. For Entune™ Audio Plus/Entune™ Premium Audio:
  - (1) Press the *APPS* button on the left or right of the panel.

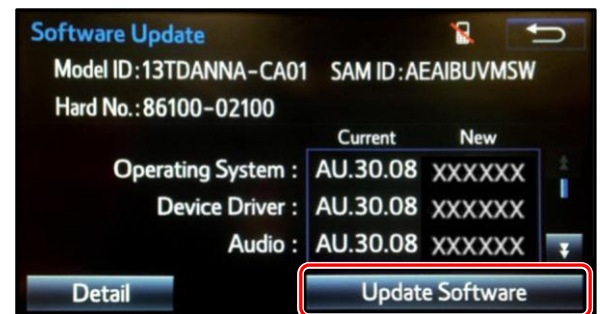
Figure 14.

- Select *Update Software* on the "Software Update" screen.

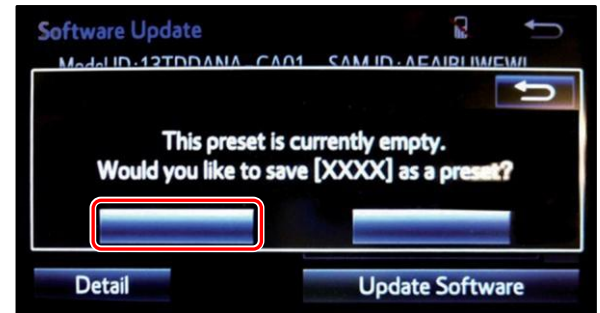
Figure 16.

Entune™ Audio Plus ONLY: Select the left box on the "This preset is currently empty. Would you like to save [XXXX] as a preset?" pop-up.

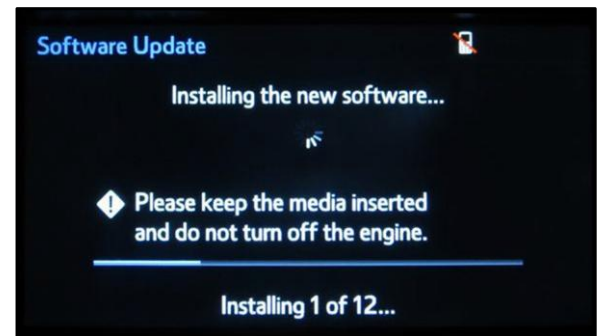
Figure 17.

14. This unit will begin installation.

Do NOT turn off ACC before the software is ready for updating.

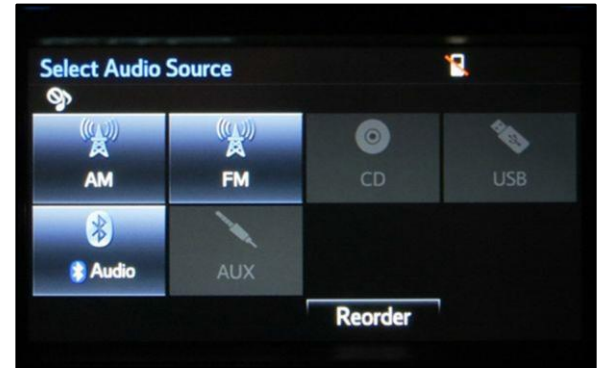
Figure 21.

19. Wait for the “Select Audio Source” screen to display.
