August 3, 2017

05309 Version 1

## AcuraLink® Sending Excessive Notifications for Low Power

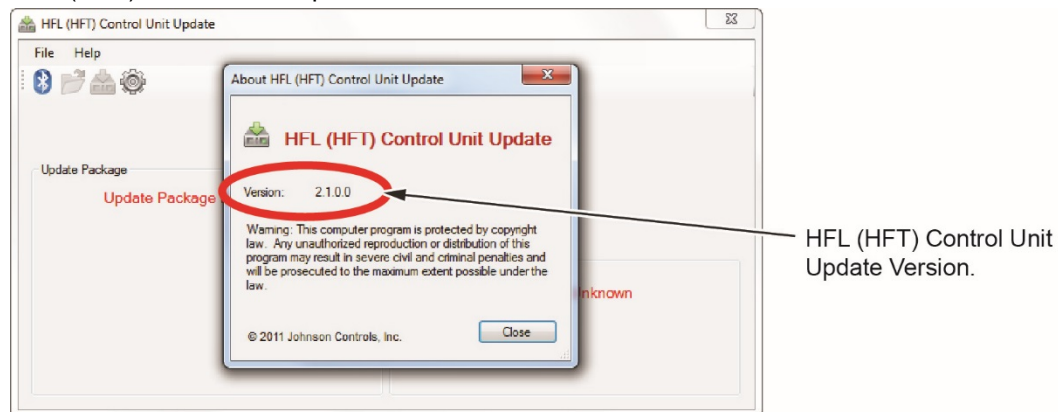
i-HDS Software Version: **3.102.029 or later**

HFL (HFT) Control Unit Update Version: **2.1.0.0 or later**

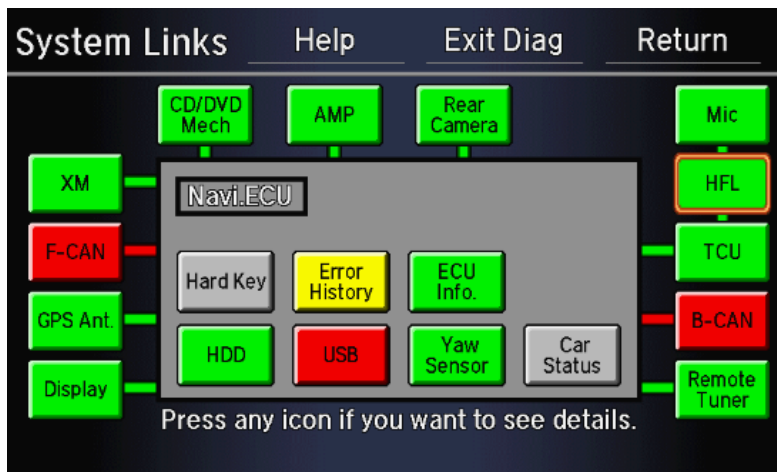
7. The **System Links** screen will appear, and an automatic diagnostic check will start. After the process completes, and the **Press any icon if you want to see details** message appears, select **HFL**.

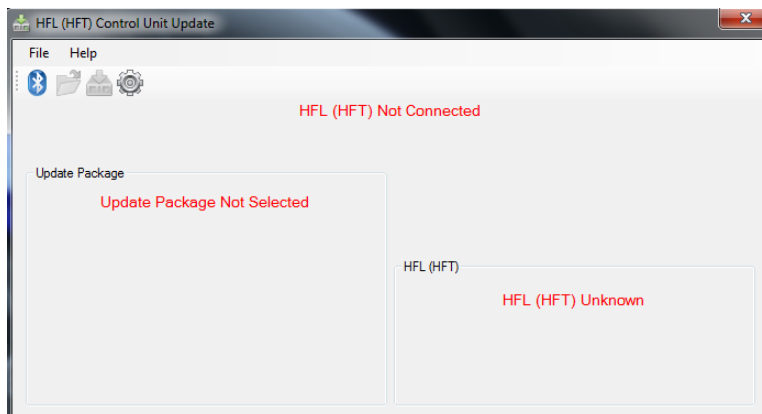
8. On the i-HDS laptop, double-click the HFL control unit update icon to launch the Honda HFL (HFT) Control Unit Update Tool (HFL update tool).

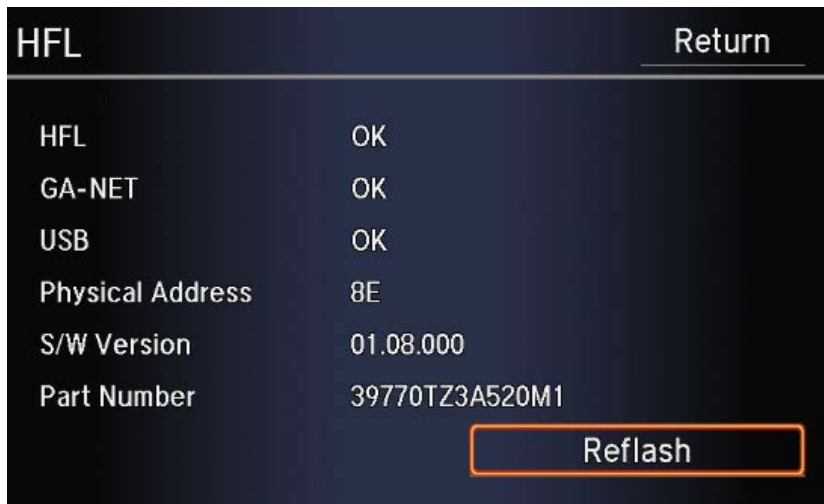
9. On the **HFL** screen, select **Refresh**. The HFL system enters its refresh readiness mode.

NOTE: If the HFL is "NG", the **Refresh** button will be grayed out and you will not be able to complete the HFL control unit update procedure. Troubleshoot for and repair any audio DTCs before continuing.

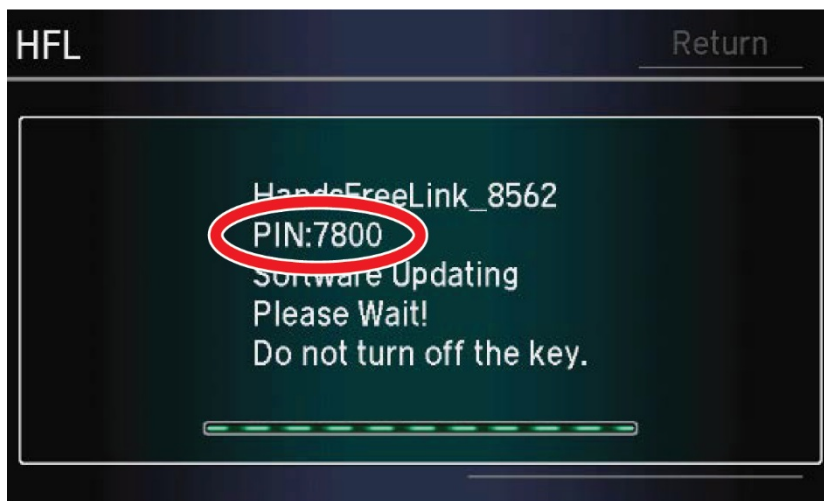
10. The **HFL** screen then displays a 4-digit PIN code. Write this PIN down, you need it to complete the HFL update.

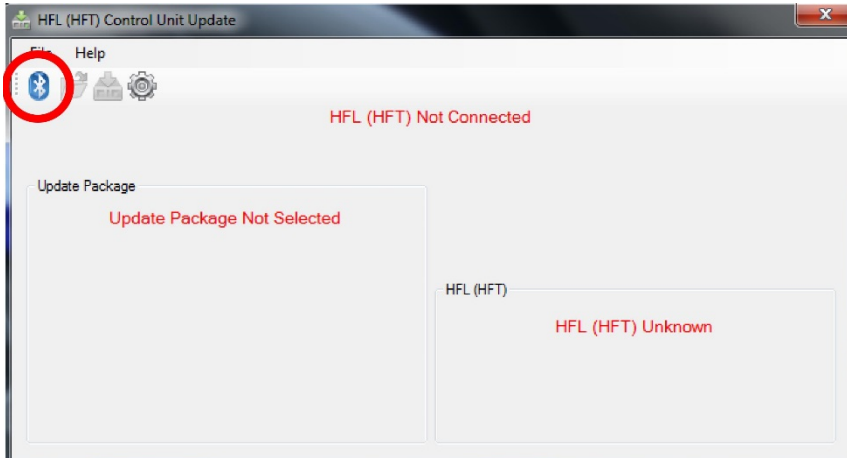
11. In the HFL update tool, click on the *Bluetooth* icon in the upper left corner of the screen to pair with the vehicle's HFL.

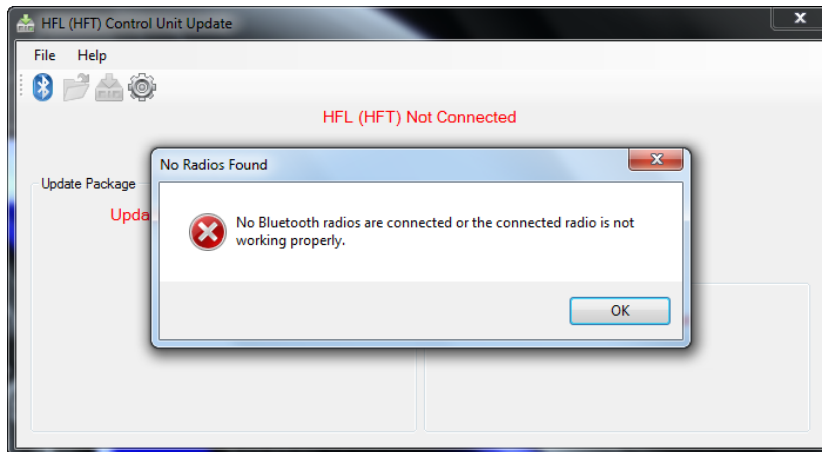
NOTE: If an active *Bluetooth* adapter is not found on the i-HDS laptop, this error message will appear. Review the REQUIRED TOOLS and EQUIPMENT section of this service bulletin for a recognized *Bluetooth* device. Contact your IT support for additional help.

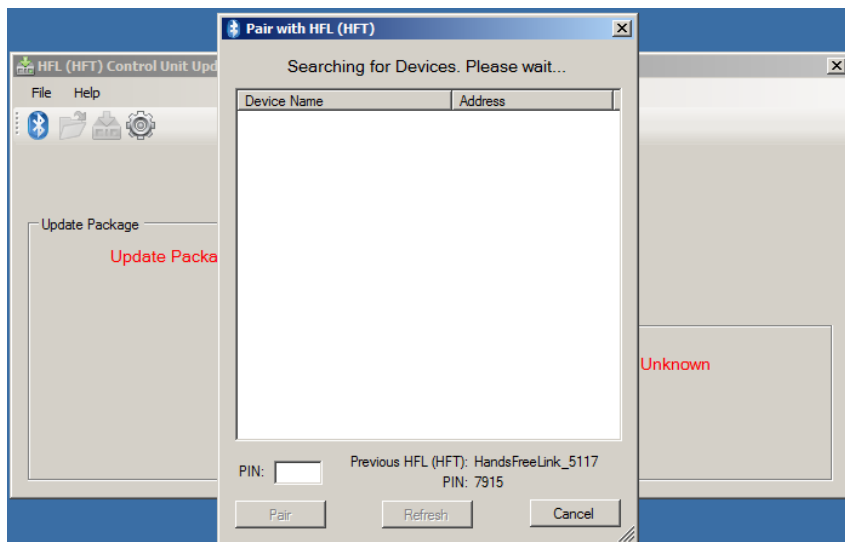
12. In the HFL update tool, the **Pair with HFL (HFT)** window pops up. Wait a few seconds for the display to show **All Detected Bluetooth Devices**. If no devices are found after about 30 seconds, click **Refresh**.

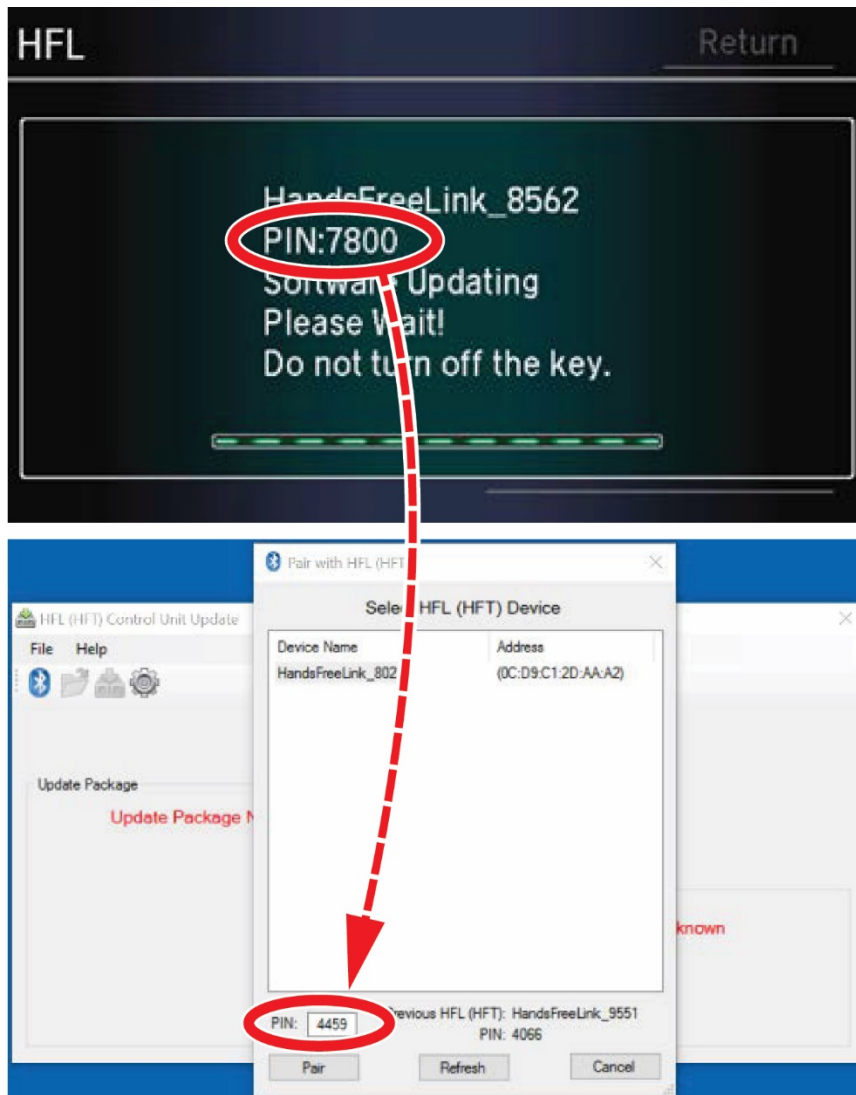
13. In the HFL update tool, once the *Bluetooth* device has been detected, enter the four-digit PIN code from the vehicle's display screen into the lower left hand corner of the pop-up window. Click **Pair** to begin the pairing process.

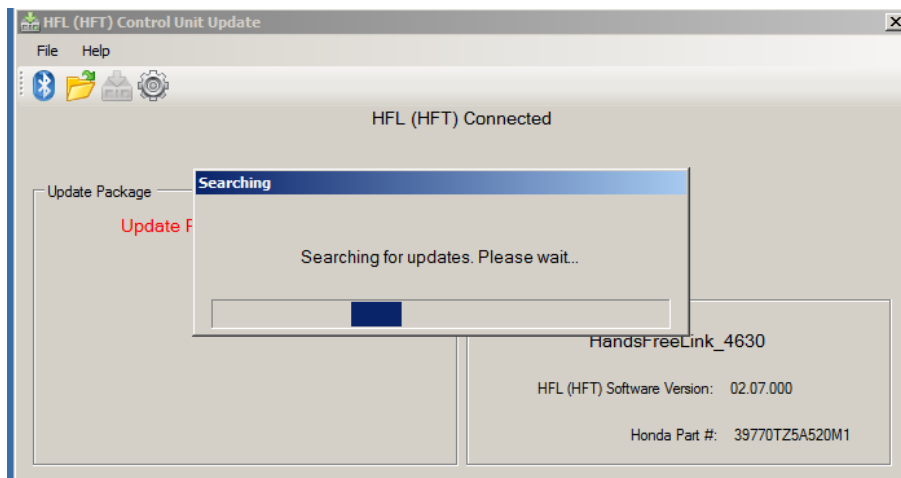
14. Wait for the HFL update tool to complete the *Bluetooth* pairing process.

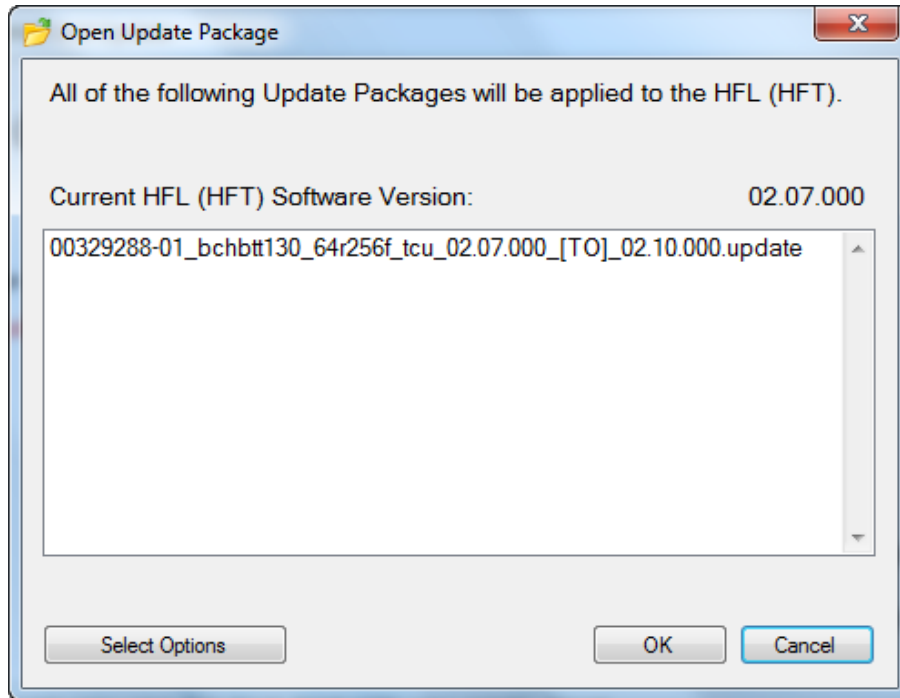
15. In the HFL update tool, the **Open Update Package** window pops up when the *Bluetooth* pairing process is complete. The HFL update tool automatically determines which version of the HFL software is present. The compatible updates will be displayed on the HFL update tool. Click **OK** to begin the HFL control unit reflash process.

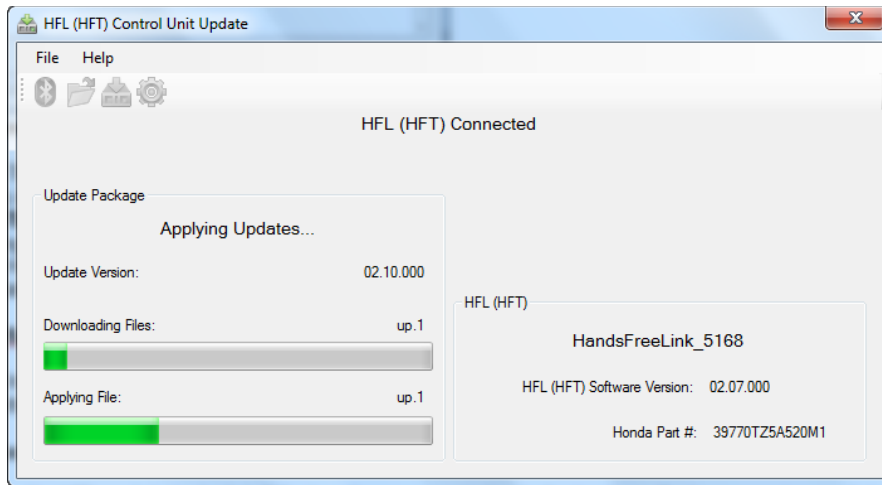
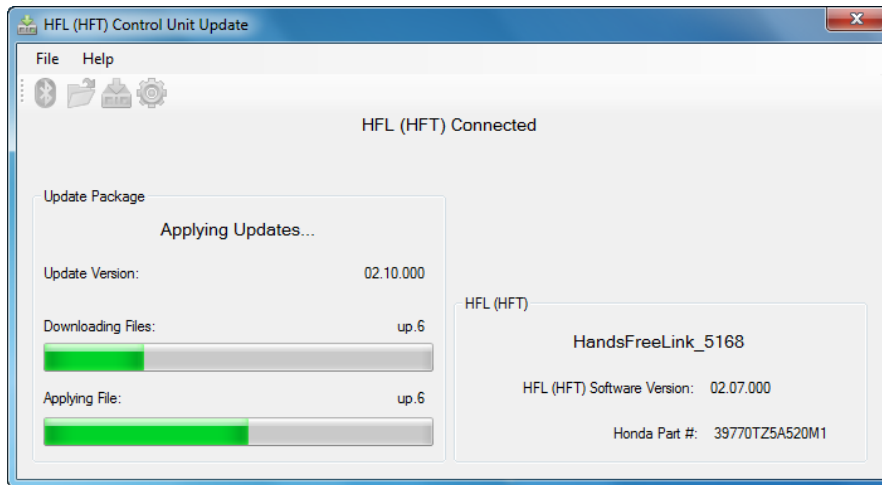
The HFL reflash process begins. Allow several minutes for the programming to complete. The blue bars indicate the programming status and progression.

NOTE: Do not turn the engine OFF while the i-HDS laptop is transferring files to the HFL control unit. Doing so will damage the HFL control unit. If the Bluetooth connectivity between the i-HDS laptop and the HFL control unit is lost, the ignition must remain ON. Reboot the i-HDS laptop, and restart the HFL update tool. Make sure you use the four-digit PIN you wrote down.

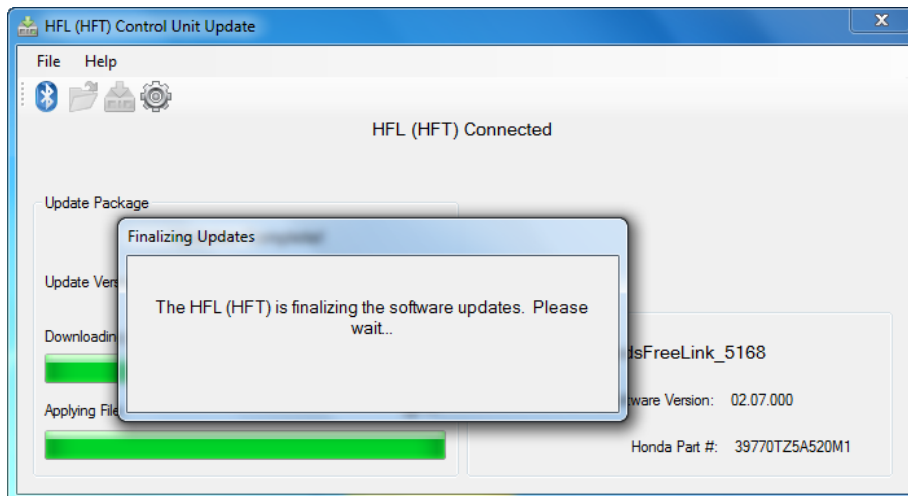
In the i-HDS laptop, a pop-up window alerts you when the reflash process is finalizing, then another popup tells you that the reflash process has completed.

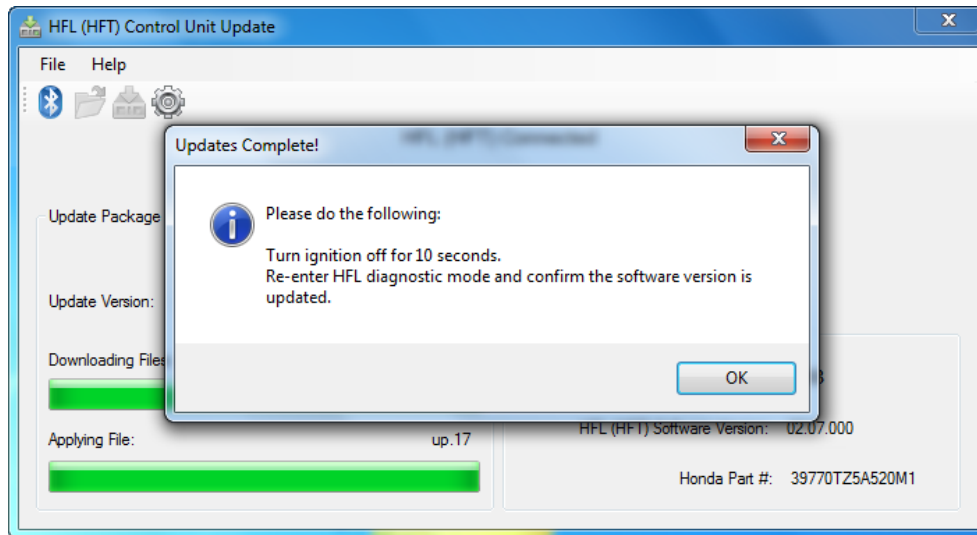
16. In the HFL update tool, click **OK** when the pop-up window indicates the reflash process is complete and the HFL screen indicates the update has completed.

NOTE: Failure to wait for both of the i-HDS laptop message **Updates Complete!**, and the HFL message **Update completed** to display prior to turning the ignition to OFF will interrupt the HFL programming, and will damage the HFL control unit.

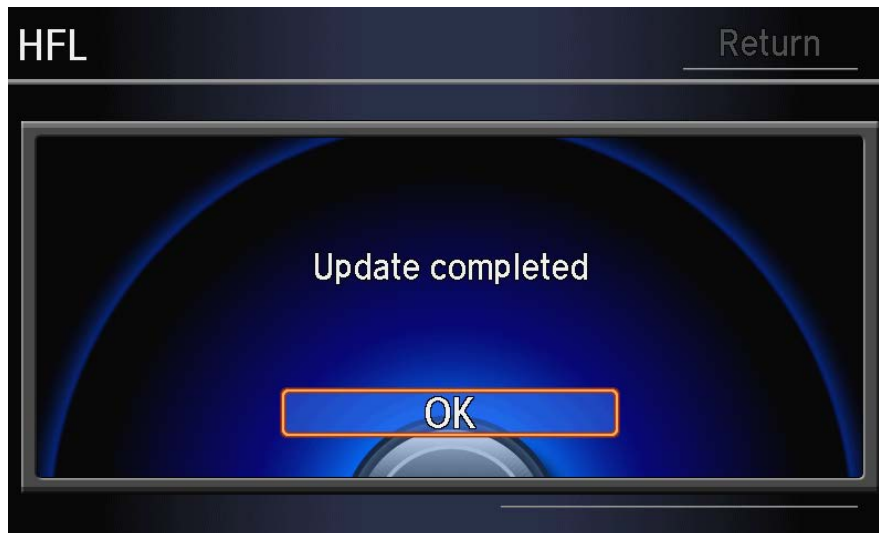
The **HFL** screen will indicate the HFL tool update has been completed.

NOTE: Selecting **OK** will return to the **HFL** screen, which will not show the newly updated software version.

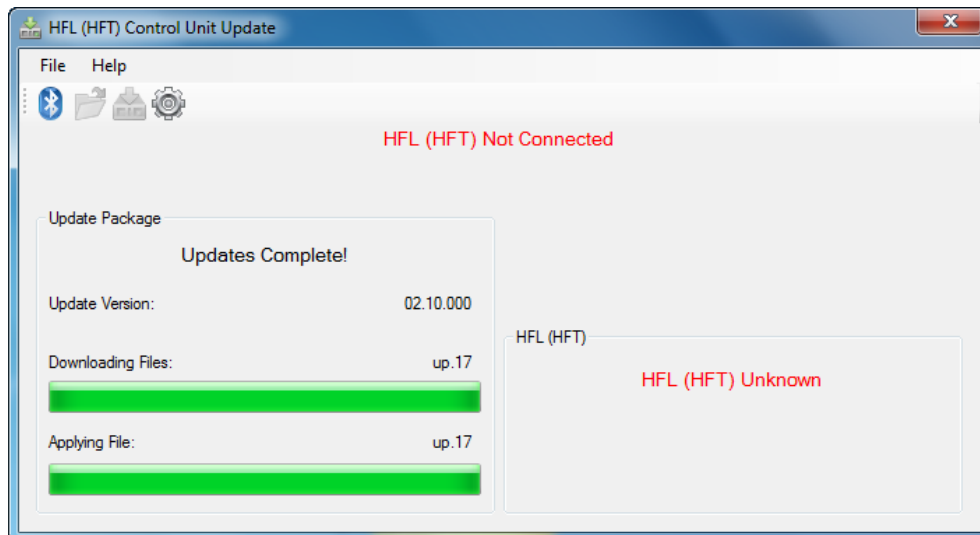
17. The i-HDS laptop will indicate the update is complete and automatically disconnect the Bluetooth connection from the HFL control unit. Close the HFL update tool by clicking the X in the upper right-hand corner.

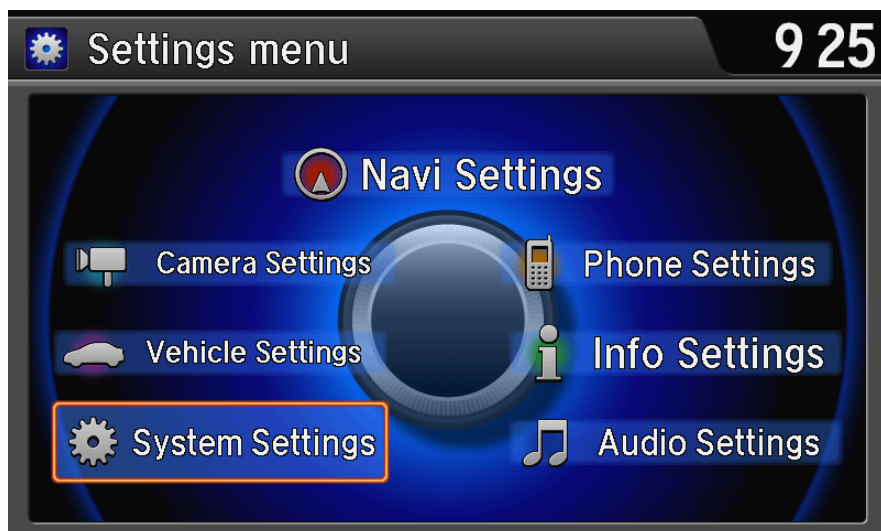
18. Press **SETTINGS** on the center switch panel, and select **System Settings**.

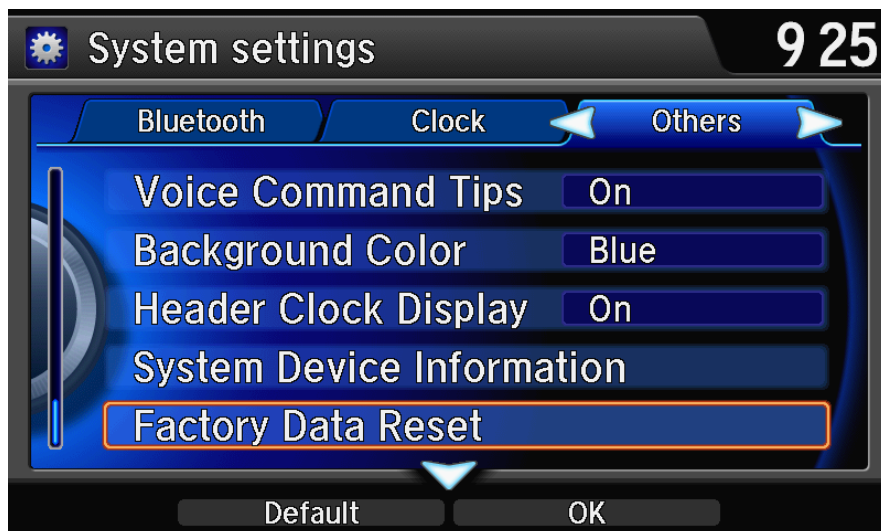
19. Select **Factory Data Reset**.

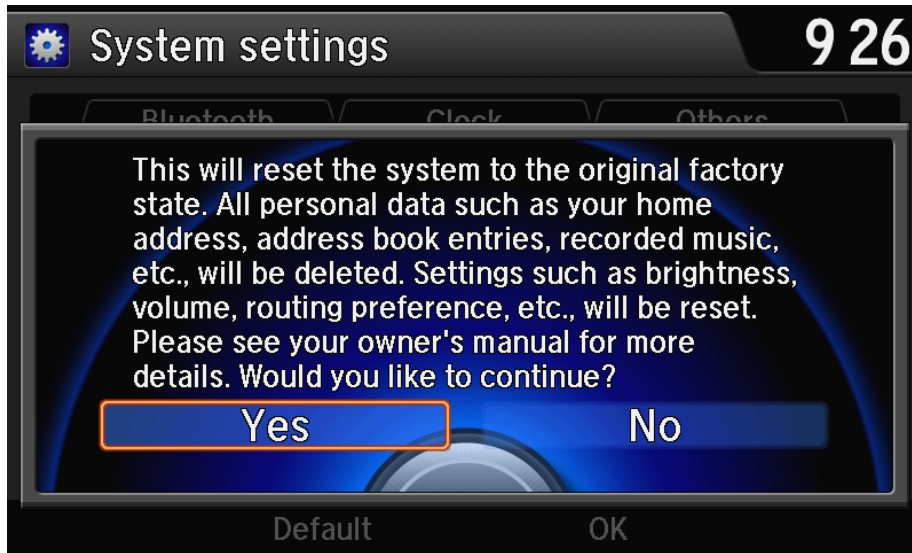
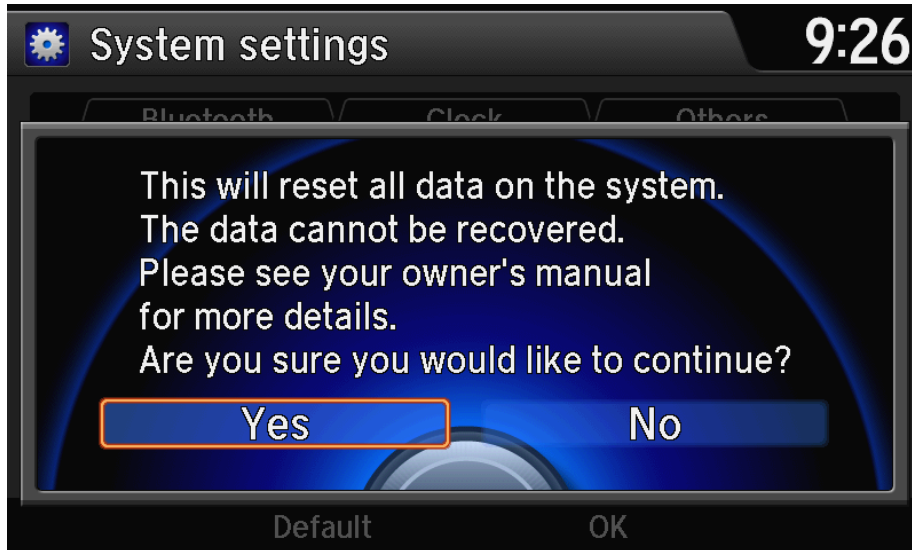
20. Select **YES** on the next two screens and the system reboot will start.
