**August 16, 2017**

07162 Version 2

## MIL Comes On with DTC P0430 (Front Bank Catalyst System Efficiency Below Threshold [Bank 2])

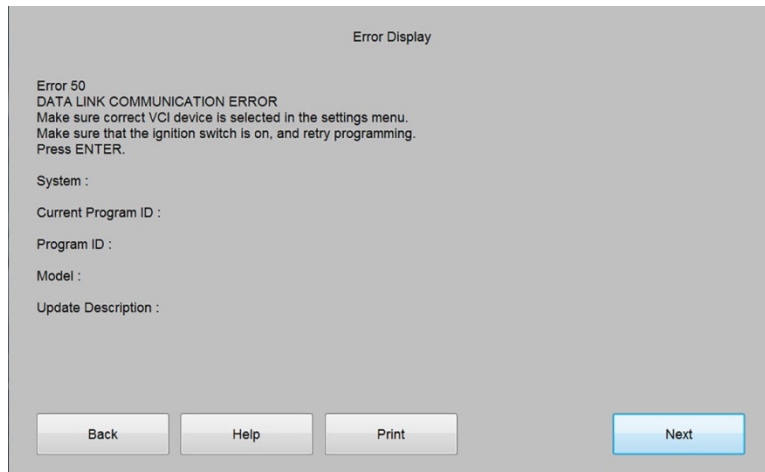
- You cannot update the vehicle using the MVCI as a standalone tool.
- **Do not** use the MongoosePro VCI tool.
- Make sure the 12-volt battery is fully charged before starting an update.
- Connect a fully charged jumper battery to the vehicle, and leave it connected during the entire procedure to maintain steady voltage.
- Never turn the ignition to OFF or ACCESSORY during the update. If there is a problem with the update, leave the ignition turned to ON.
- To prevent PCM damage, do not operate anything electrical (headlights, audio system, brakes, A/C, power windows, door locks, etc.) during the update.
- If you see the following **Error Display**, check that you are using the correct tool (MVCI or DST-i) with the i-HDS.

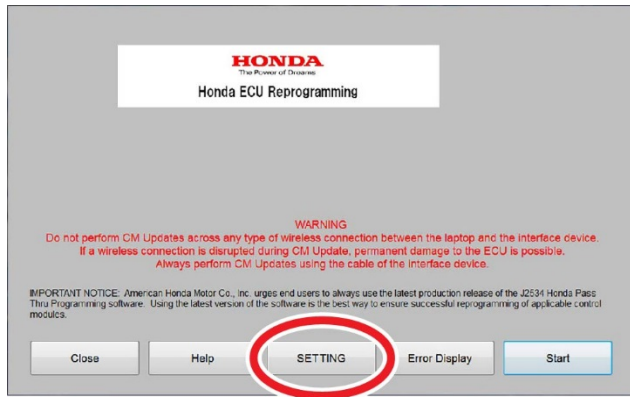
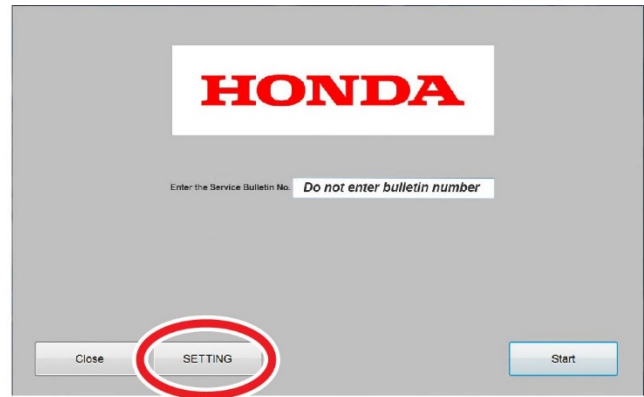
To change this, click on either of the **SETTING** selection buttons at the bottom of the J2534 initial screens as shown.

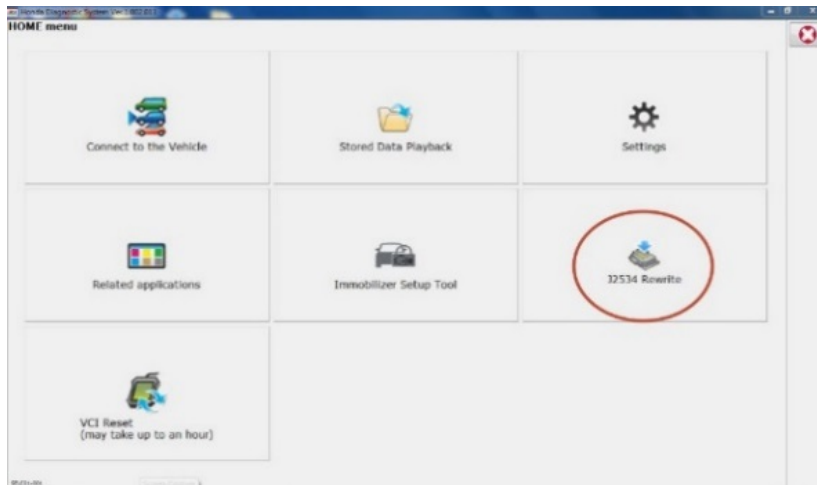
2. Select **J2534 Rewrite**.

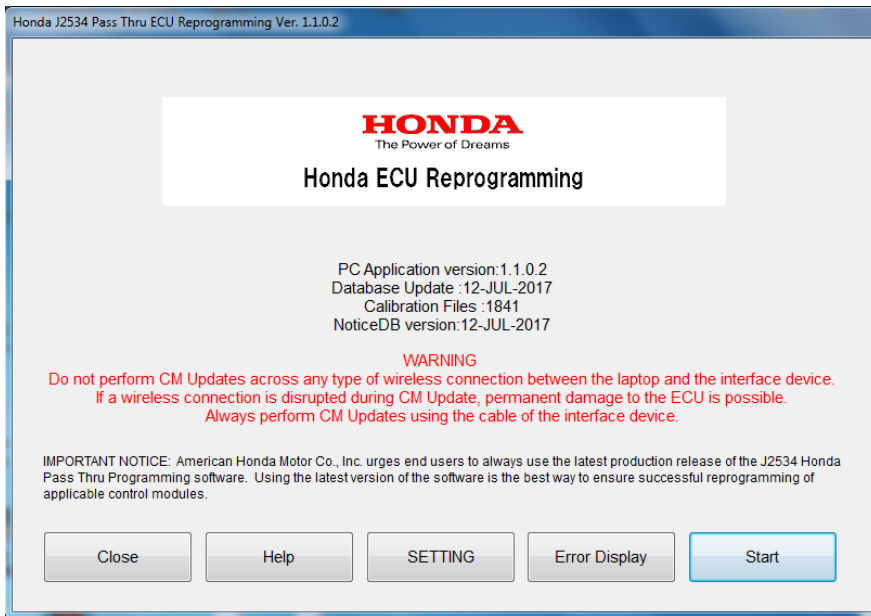
3. Confirm the software is the same **or later** as listed in SOFTWARE INFORMATION.

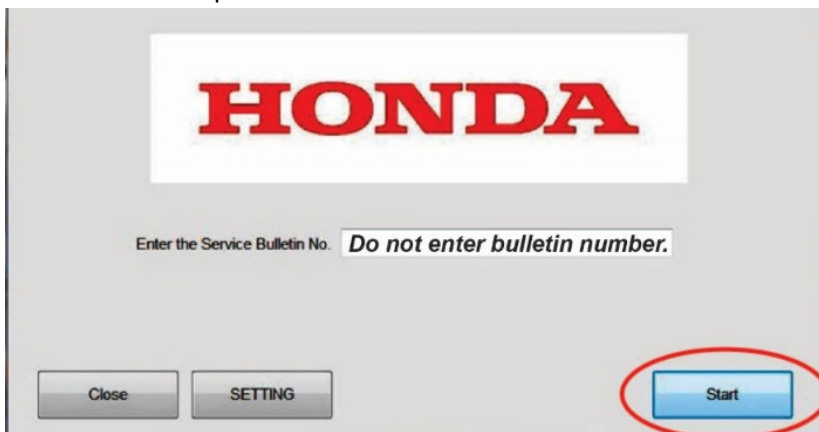
4. Select **Start**, then follow the screen prompts.

- Do not enter a bulletin number.
- If you receive a message that the vehicle has been already updated or that no update is available, check the **PGM-FI Data List**. The header should indicate one of the following numbers (or later):

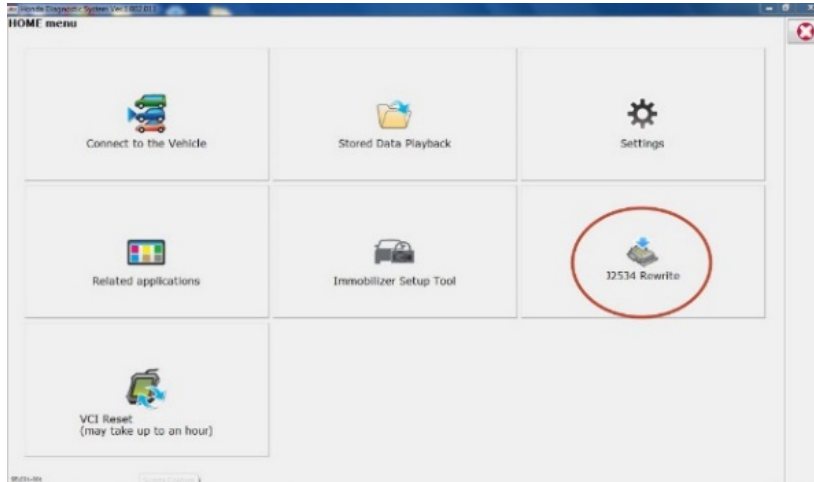
1. Select **J2534 Rewrite**.

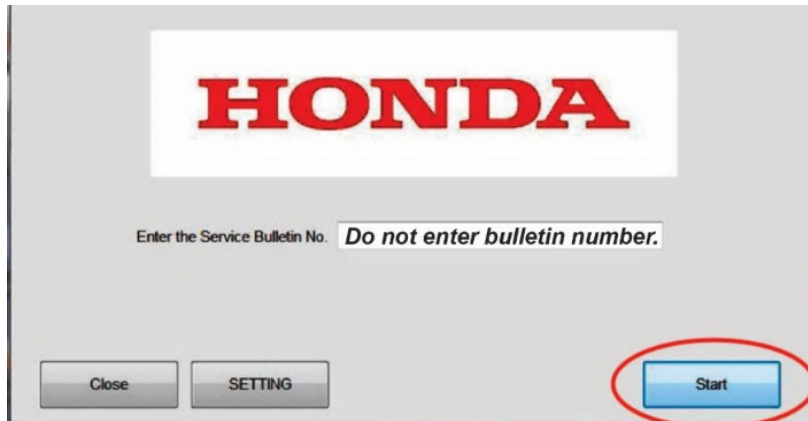
2. Select **Start**.

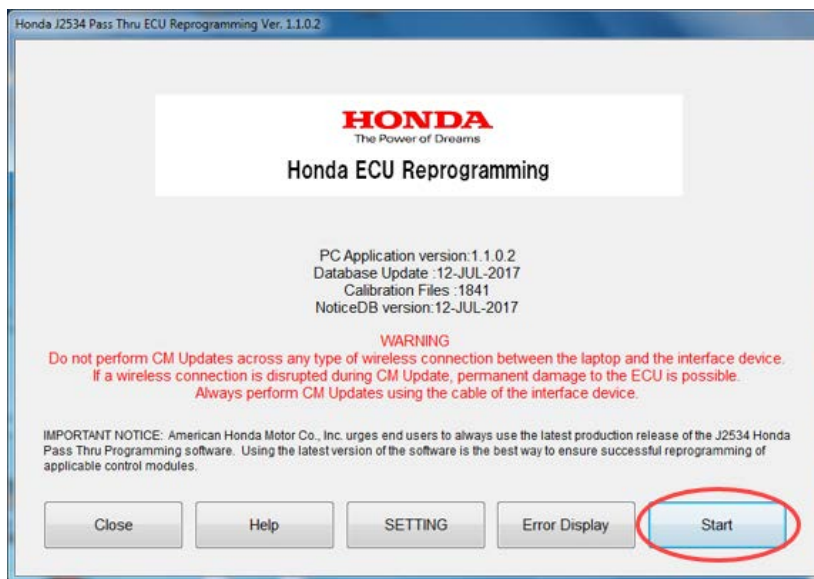
3. Select **Start**.

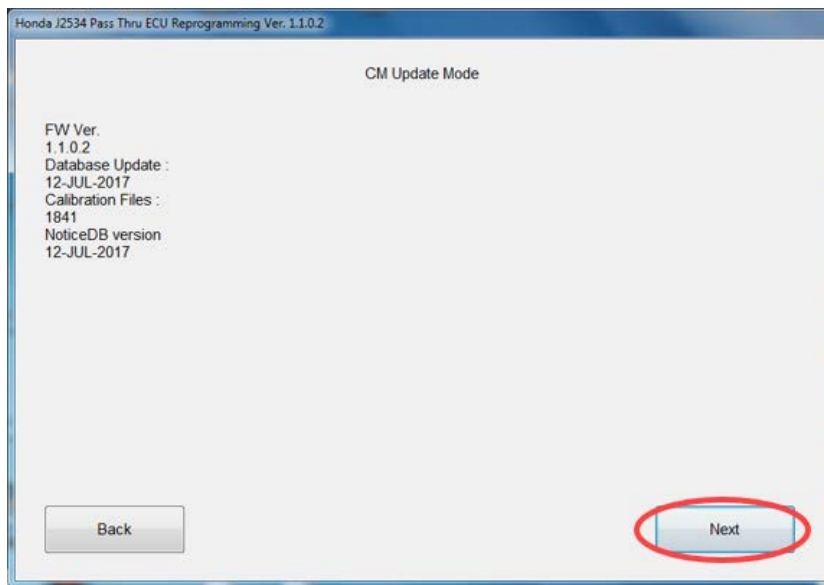
4. Select **Next**.

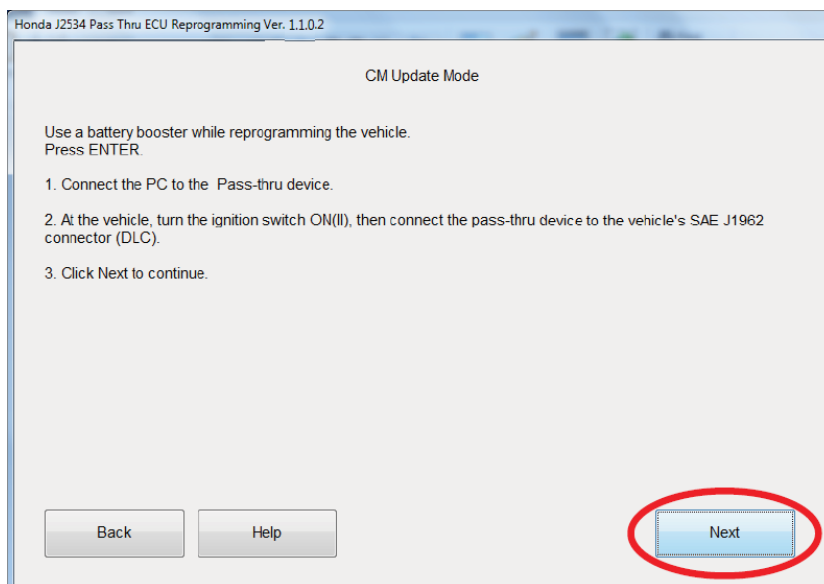
5. Select **Next**.

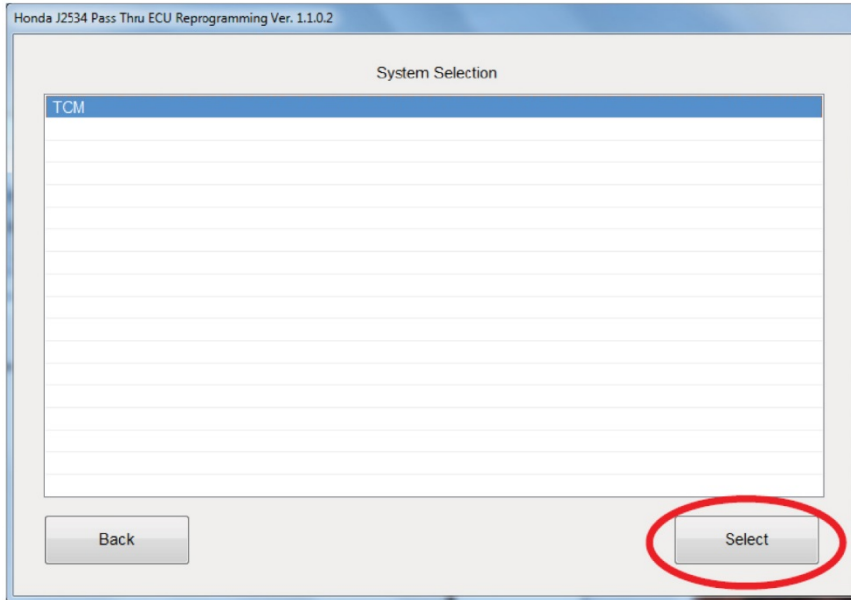
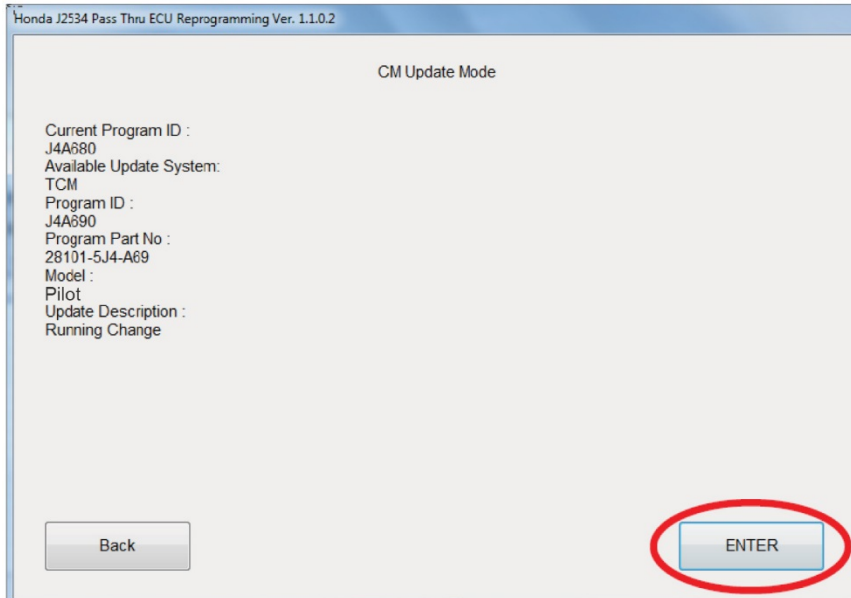
7. Check if **TCM** appears under **System Selection**?

- If it appears, choose **Select** then **ENTER** on the next screen to update the TCM software.
- If it does not appear, the TCM software is up to date.
