MODEL
2017MY
Forte (YDm)
2.0L MPI

NUMBER
165 (Rev 1, 06/05/2017)

TECHNICAL SERVICE BULLETIN

SUBJECT: SERVICE ACTION: ECU LOGIC IMPROVEMENT
FOR DTC P030X (SA285)

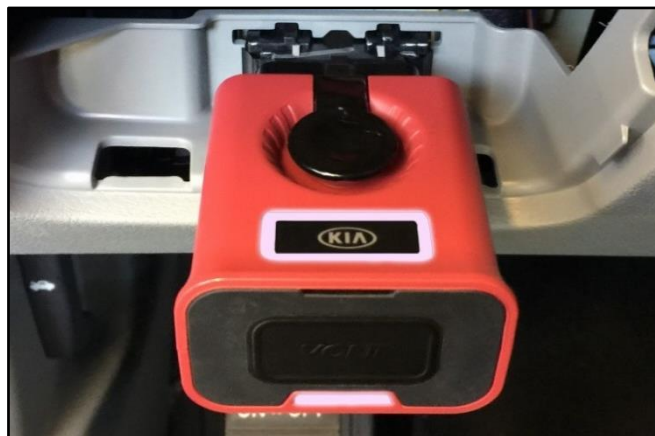
1. Connect the VCI-II to the OBD-II connector, located under the driver's side of the instrument panel.

The ECU upgrade function on KDS is operating wirelessly. It is not necessary to perform the upgrade via USB cable.

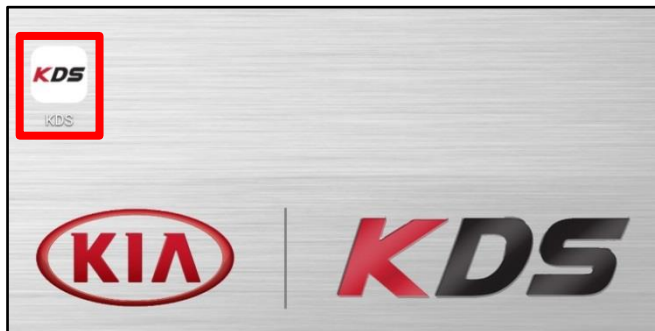
2. With the ignition ON, turn ON the KDS tablet. Select **KDS** from the home screen.

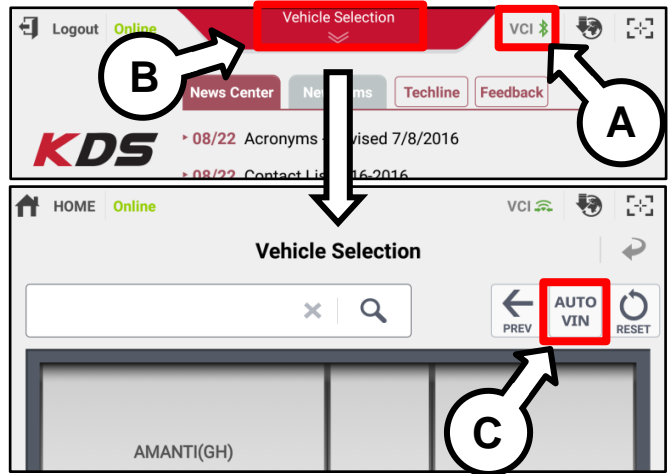
- Confirm communication with VCI (A) and then configure the vehicle (B) using the **AUTO VIN** (C) feature.

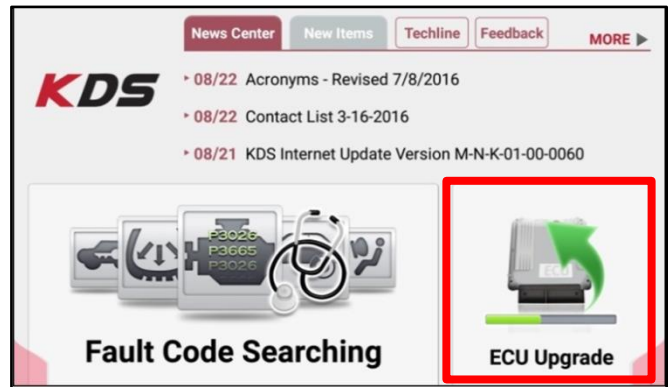
- Select **ECU Upgrade**.

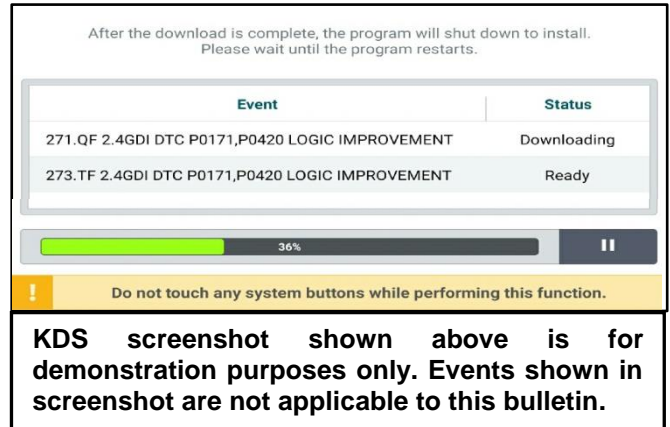
- The KDS will check the server for recently uploaded Events and then automatically download **Upgrade Event (317)**.

*** NOTICE**
 The vehicle must be identified in Vehicle Selection to download an Event for that vehicle.

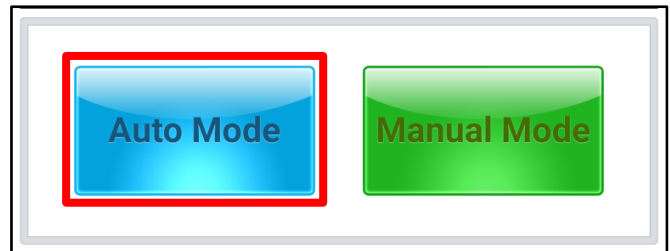
- Select **Auto Mode**.

CAUTION
 Do NOT attempt to perform a Manual Mode upgrade **UNLESS Auto Mode fails**. Always follow the instructions given on the KDS in either Auto or Manual mode.

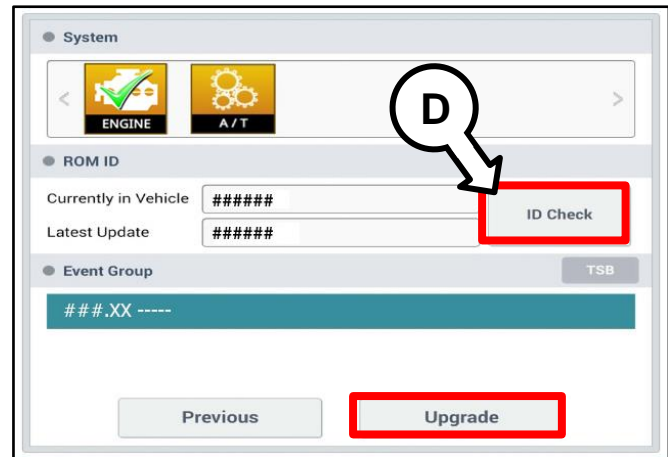
7. Select the Engine system under the System selection menu.

Touch **ID Check** (D) and confirm that the latest update is available.

Select **Upgrade Event (317)** and select **Upgrade** to continue.

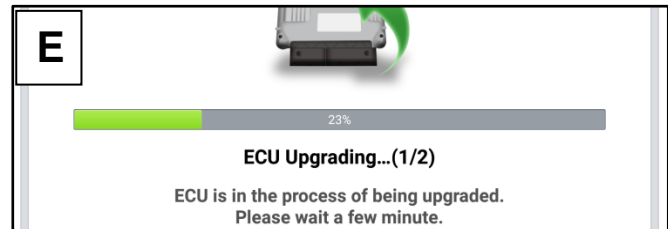
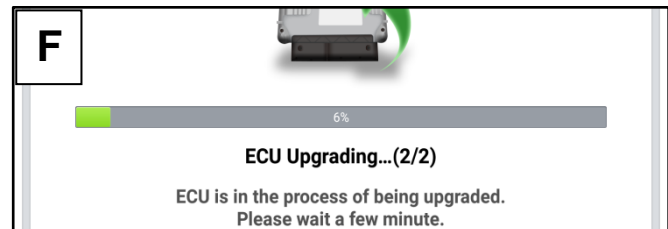
8. The ECU upgrade will begin and the progress of the upgrade will appear on the bar graph. Upgrade part (1/2) (E) will download the upgrade event to the VCI-II. Upgrade part (2/2) (F) will upgrade the ECU.

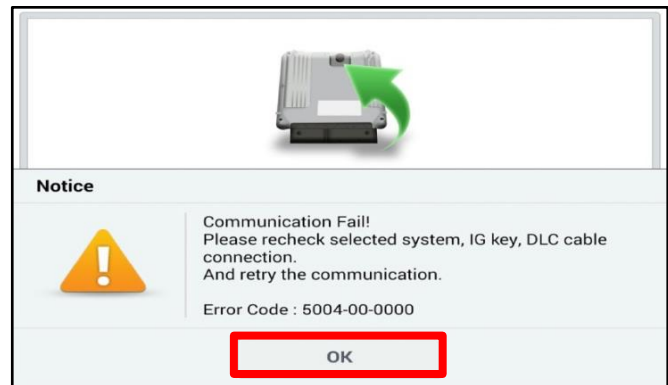
9. If a "Communication Fail" screen appears, verify that the VCI-II and KDS are communicating properly. Touch **OK** and restart the procedure from step 4.

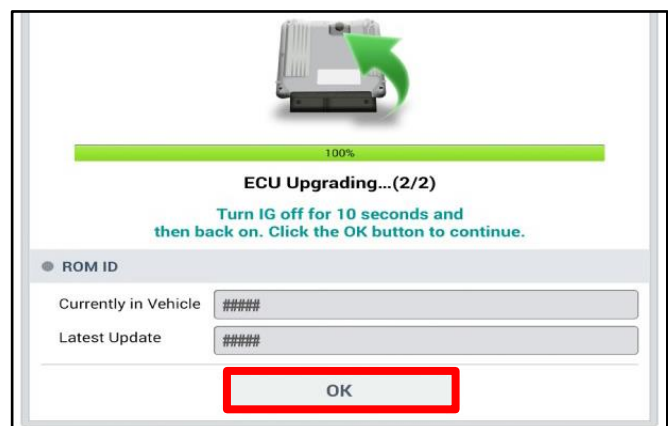
10. When instructed on the KDS, turn the ignition **OFF** for ten (10) seconds then back on. Touch **OK** to continue.

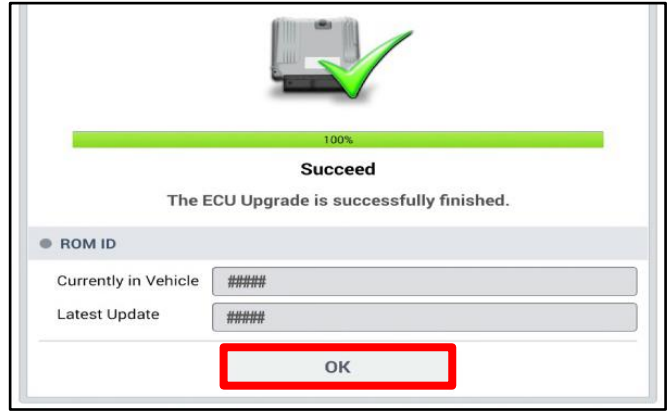
- 11. Once the upgrade is complete, touch **OK** to finalize the procedure.

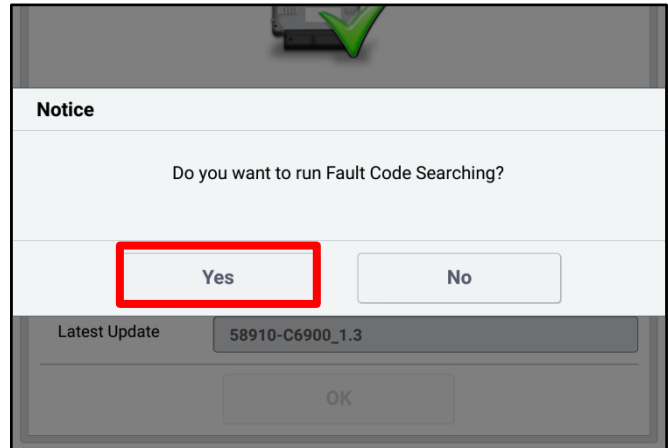
- 12. When prompted, select **YES** to check for Diagnostic Trouble Codes (DTC) and erase any DTCs stored such as EPS, ESC, and TPMS that may have been set during the upgrade.
