MODEL
**2016MY
Optima (JFa) 2.4L**

NUMBER
168 (Rev 1, 6/9/2017)

TECHNICAL SERVICE BULLETIN

SUBJECT: COMBINATION TSB / SERVICE ACTION: IDLE STABILITY
& SHIFT QUALITY IMPROVEMENT (SA294A)

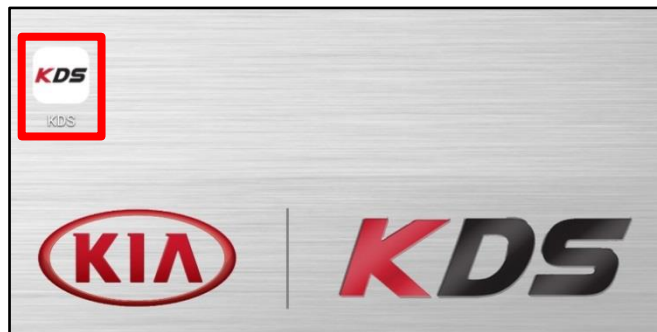
2. With the ignition ON, turn ON the KDS tablet. Select **KDS** from the home screen.

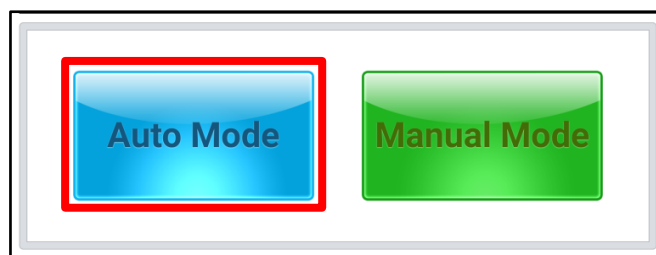
6. Select **Auto Mode**.

Do NOT attempt to perform a Manual Mode upgrade UNLESS Auto Mode fails. Always follow the instructions given on the KDS in either Auto or Manual mode.

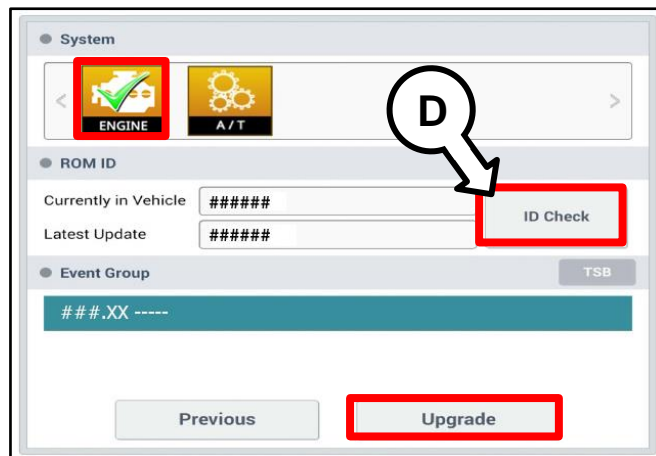
7. Select the **Engine** system under the System selection menu.

Touch **ID Check** (D) and confirm that the latest update is available.

Select **Upgrade Event (327)** and select **Upgrade** to continue.

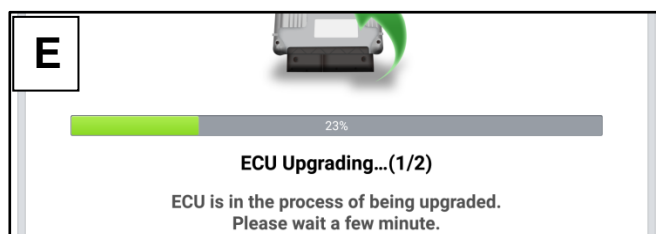
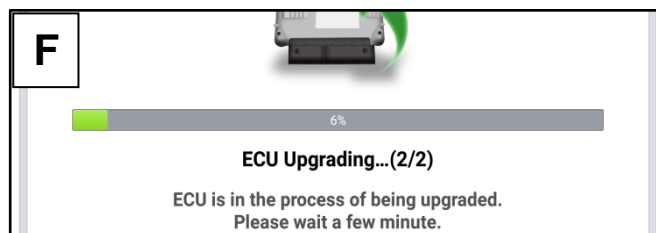
8. The ECU upgrade will begin and the progress of the upgrade will appear on the bar graph. Upgrade part (1/2) (E) will download the upgrade event to the VCI-II. Upgrade part (2/2) (F) will upgrade the ECU.

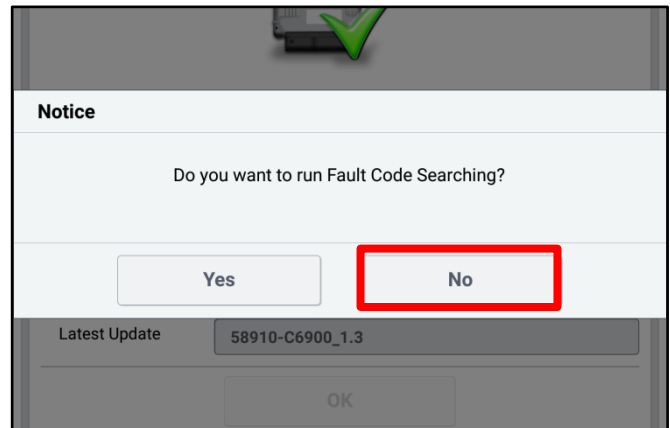
12. When prompted, select **No** for the Diagnostic Trouble Codes (DTC) check, then return to the KDS Home Page.

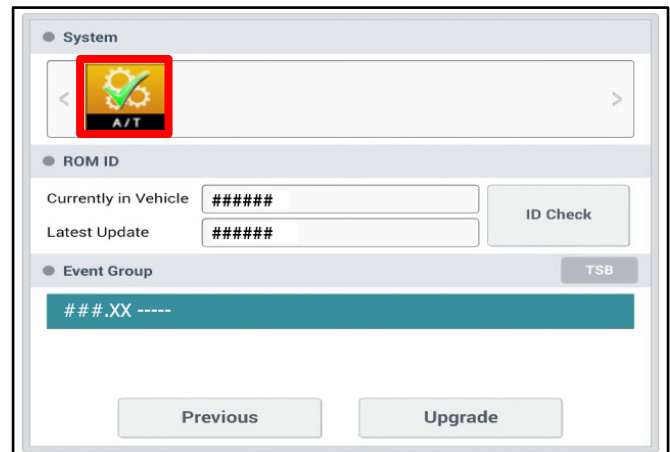
13. Repeat steps 4-11 and perform **Upgrade Event (328)** with the **A/T** system selected under the System selection menu.

When prompted, select **YES** to check for Diagnostic Trouble Codes (DTC) and erase any DTCs stored such as EPS, ESC, and TPMS that may have been set during the upgrade.
