GROUP <b>ENG</b>	MODEL <b>2017MY Forte (YDm) 2.0L MPI</b>
	NUMBER <b>170</b>	DATE <b>June 2017</b>
<b>TECHNICAL SERVICE BULLETIN</b>		
<b>SUBJECT: ADAPTIVE VALUES RESET FOR DTC P0016</b>

This bulletin provides the procedure to reset adaptive values on some 2017MY Forte (YDm) 2.0L MPI vehicles, produced from May 15, 2016 through April 26, 2017, which may experience a malfunction indicator lamp illumination with DTC P0016 due to a stuck intake CVVT assembly. To correct this concern, reset the adaptive values of the engine ECU using the KDS as described in this bulletin.

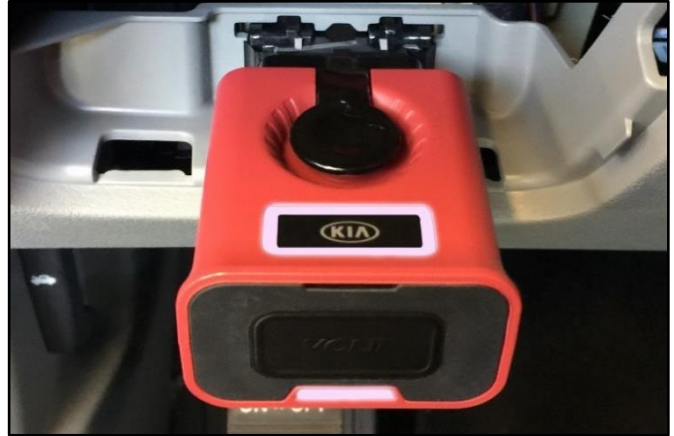
1. Connect the VCI-II to the OBD-II connector, located under the driver's side of the instrument panel.

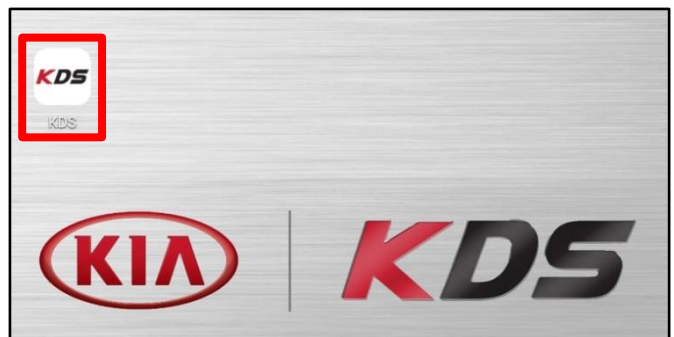
2. With the ignition ON, turn ON the KDS tablet. Select **KDS** from the home screen.

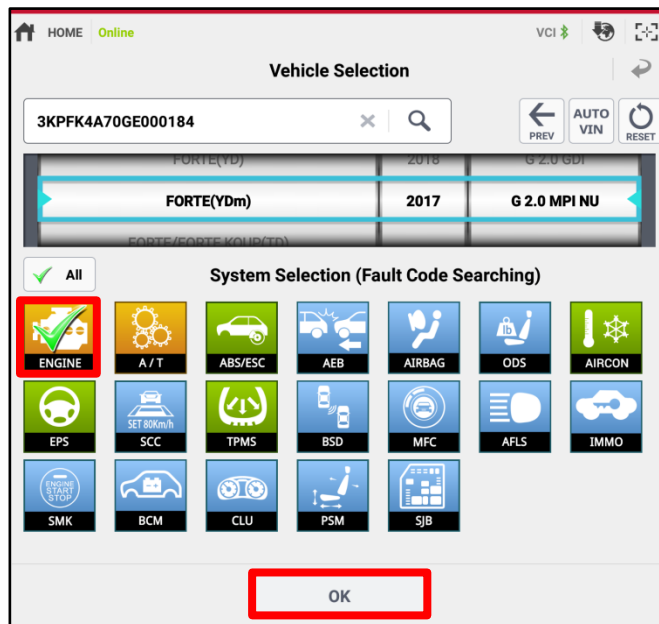
5. Select “Engine” and select “OK” to perform the fault code search.

Record and then clear any **Engine** related fault codes.

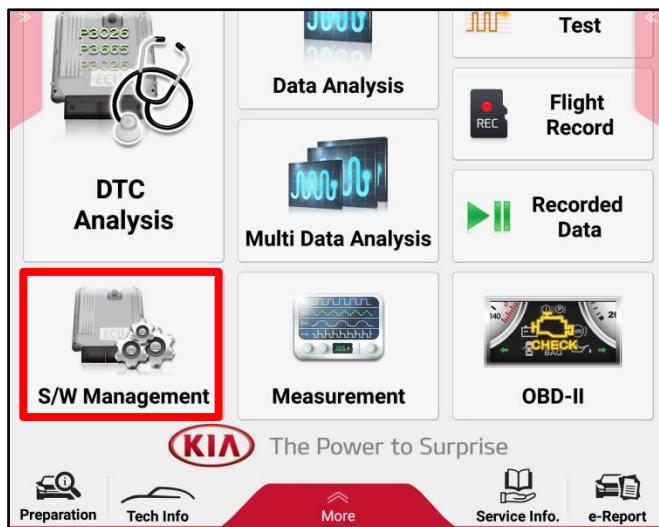
6. Return to the KDS app home page and select “S/W Management”.

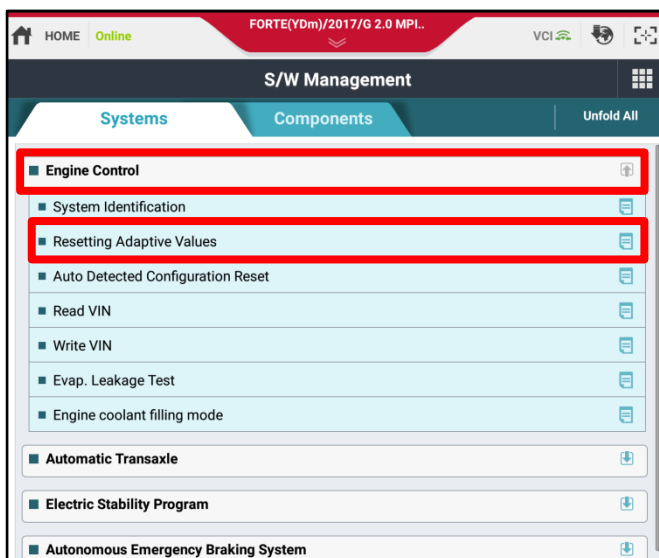
7. Select “Engine Control” → “Resetting Adaptive Values” under the “Systems” tab.
