MODEL
2016MY
Optima (JFa) 2.0T
Sorento (UMa) 2.0T,
2.4L, 3.3L

NUMBER
069 (Rev 1, 6/9/2017)

TECHNICAL SERVICE BULLETIN

COMBINATION TSB / SERVICE ACTION: SHIFT
QUALITY IMPROVEMENT (SA292A)

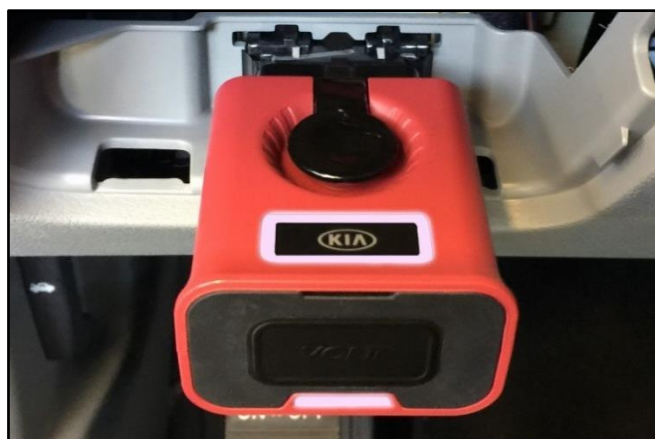
2. With the ignition ON, turn ON the KDS tablet. Select **KDS** from the home screen.

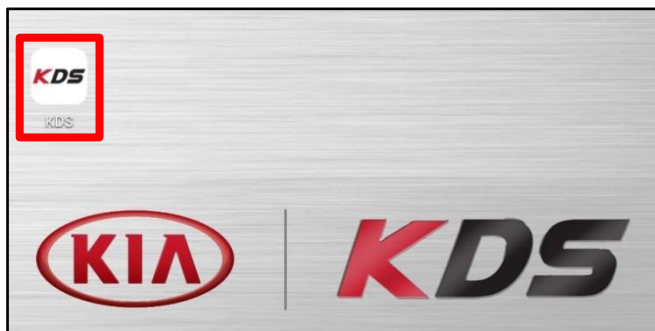
- Confirm communication with VCI (A) and then configure the vehicle (B) using the **AUTO VIN** (C) feature.

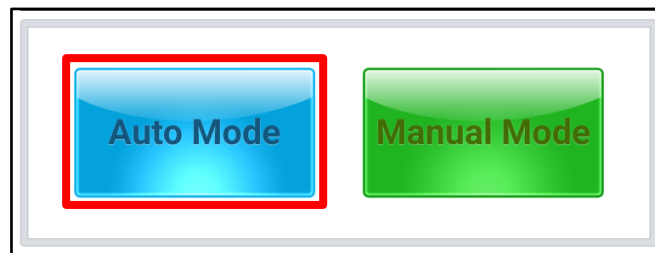
7. Select **A/T** system under the System selection menu.

Touch **ID Check** (D) and confirm that the latest update is available

Select **Upgrade Event (326, 329, 330, or 333)** and select **Upgrade** to continue.

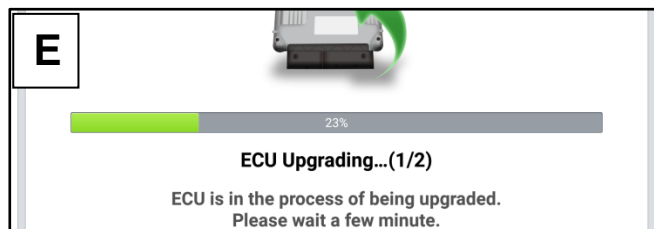
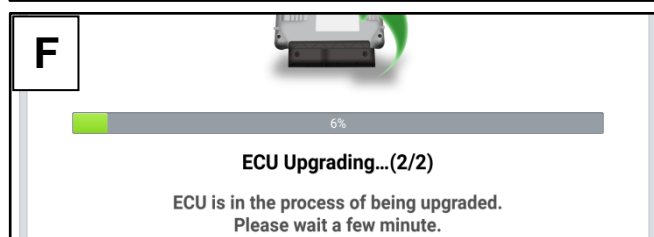
9. If a "Communication Fail" screen appears, verify that the VCI-II and KDS are communicating properly. Touch **OK** and restart the procedure from step 4.

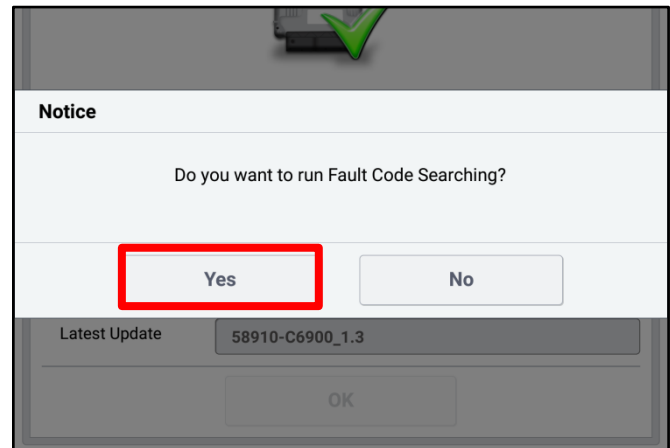
13. Start the engine to confirm proper operation of the vehicle.
