# TECHNICAL BULLETIN

Fuel Gauge Calibration

MODEL:	MODEL YEAR:	VIN:	ASSEMBLY PLANT:
Discovery Sport (LC)	2015-2016	500000-584024	Halewood

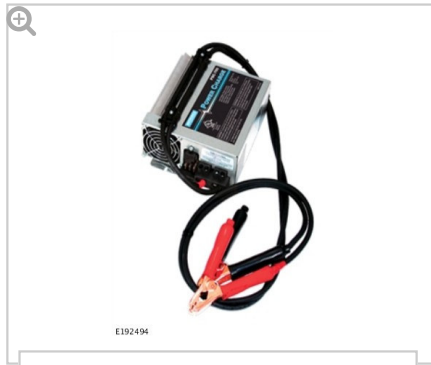
Jaguar Land Rover-approved Midtronics battery power supply

- **A Jaguar Land Rover-approved Midtronics battery power supply must be connected to the vehicle battery during diagnosis / module programming.**
- **Make sure all ignition ON/OFF requests are carried out; failure to perform these steps may cause damage to control modules in the vehicle.**

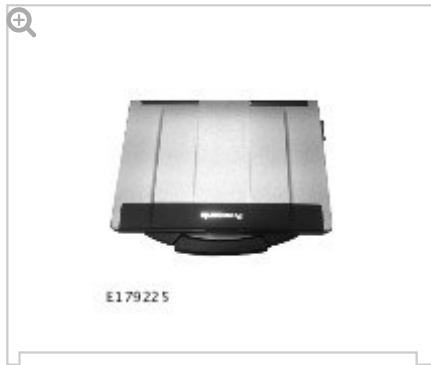
Jaguar Land Rover-approved diagnostic tool with latest SDD software, Calibration File
