TECHNICAL BULLETIN

419-00: Electronic Feature Group

Tow Assist or Park Assist - Towbar Alignment

MODEL:	MODEL YEAR:	VIN:	ASSEMBLY PLANT:
Discovery Sport (LC)	2015-2016	501001-544577	Halewood

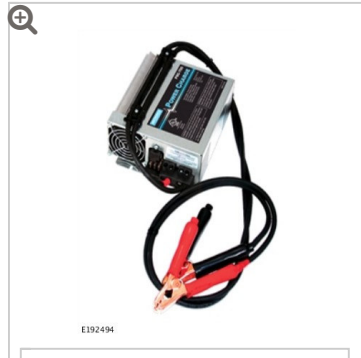
Jaguar Land Rover-
approved
Midtronics battery
power supply

- **A Jaguar Land Rover-approved Midtronics battery power supply must be connected to the vehicle battery during diagnosis / module programming.**
- **Make sure all ignition ON/OFF requests are carried out; failure to perform these steps may cause damage to control modules in the vehicle.**

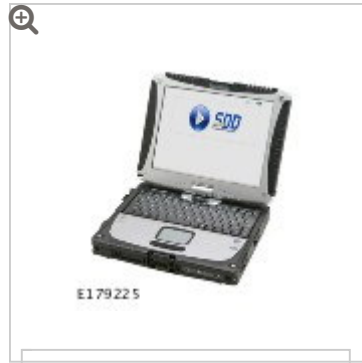
Jaguar Land Rover-approved diagnostic tool with latest SDD software and Calibration File
