TECHNICAL BULLETIN

415-00: Information and Entertainment Systems

Service Action: InControl Touch Pro Phase 2.5 Software Update

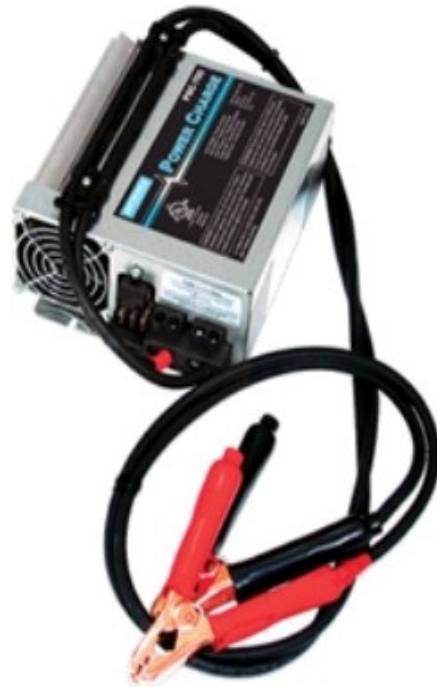
E192494

Jaguar Land Rover-approved Midtronics Battery Power Supply

- Battery support unit: it is extremely critical to use a battery support unit and have a vehicle with a battery that has a good state of health to start. The battery support unit must also be in proper working condition to be able to supply 13v consistently. If the voltage is compromised during the installation of software, the IMC may switch 'OFF'.
