LTB01009NAS3

TECHNICAL BULLETIN

415-00: Information and Entertainment Systems

InControl® Touch Pro™ Features May Not Function As Expected
(Additional Updates)

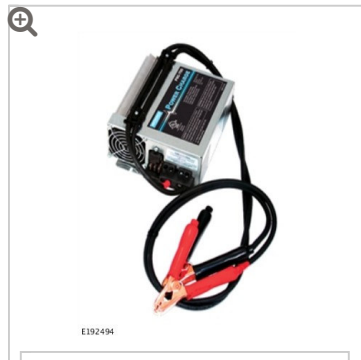
Jaguar Land Rover-approved
Midtronics battery
power supply

- Battery support unit: it is extremely critical to use a battery support unit and have a vehicle with a battery that has a good state of health to start. The battery support unit must also be in proper working condition to be able to supply 13v consistently. If the voltage is compromised during the installation of software, the IMC may switch off.

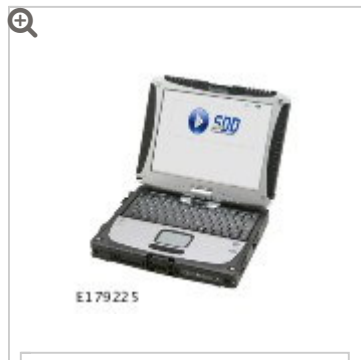
Jaguar Land Rover-approved
diagnostic tool with
latest SDD
software,
Calibration File, and
InControl© Touch
Pro™ Software

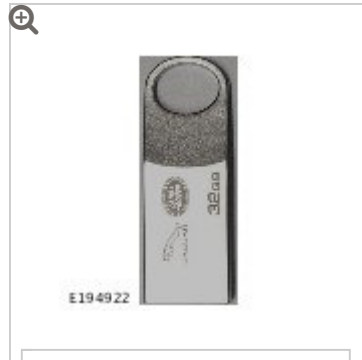
**DTSE9G2/32GB**

Jaguar Land Rover-
approved USB
memory device
