# TECHNICAL BULLETIN

415-01: Information and Entertainment System

Service Action: InControl Touch Phase 3.2

| MODEL: | MODEL YEAR: | VIN: | ASSEMBLY PLANT: | APPLICABILITY: |
|---|---|---|---|---|
| Discovery Sport (LC) | 2016 | 544552-598293 | Halewood | Vehicles With: InControl Touch |

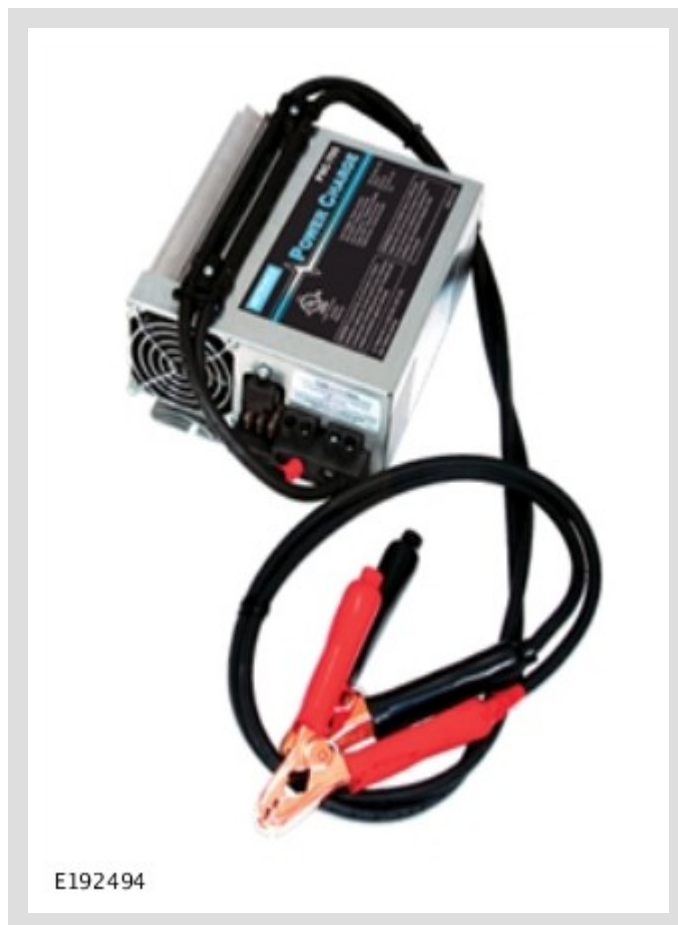
Jaguar Land Rover-approved Midtronics Battery Power Supply

- A Jaguar Land Rover-approved Midtronics battery power supply must be connected to the vehicle battery during diagnosis / module programming.
- Make sure all ignition ON/OFF requests are carried out; failure to perform these steps may cause damage to control modules in the vehicle.

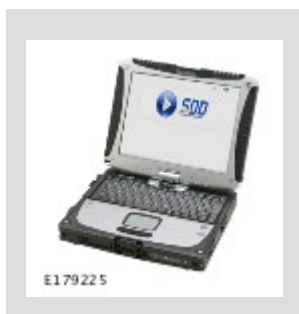
Jaguar Land Rover-approved diagnostic tool with latest SDD software and Calibration File
