## SERVICE BULLETIN

Classification:	Reference:	Date:
AT16-004c	NTB16-068c	June 29, 2017

### 2016-2017 TITAN XD; TRANSMISSION SHIFT QUALITY ISSUES

**APPLIED VEHICLES:** 2016-2017 Titan XD (A61)  
**APPLIED ENGINE:** Cummins 5.0L V8 Diesel  
**APPLIED TRANSMISSION:** 6AT: RE6R01A

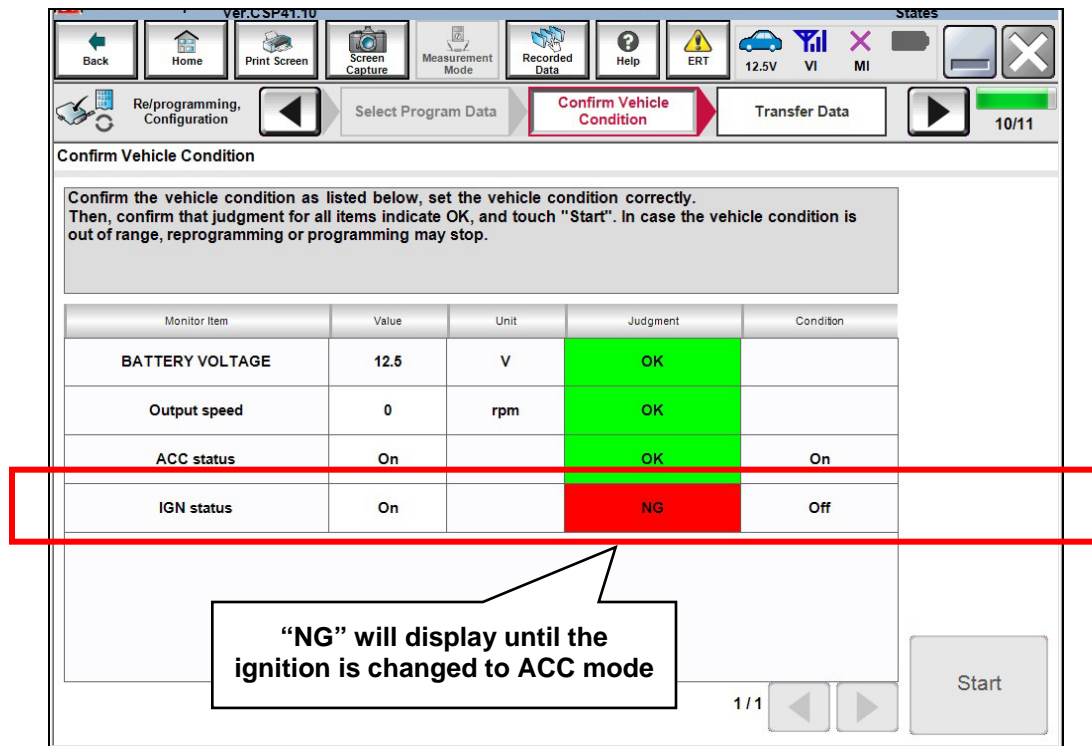
Figure 14A

### 23. Change the ignition to **ACC mode**.

- Make sure the IGN status judgement changes to **OK**. See Figure 15A.
