## June 29, 2017

06959 Version 3

# Audio Unit Software Update

HONDA

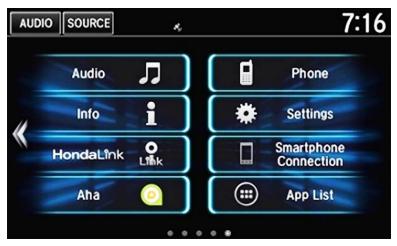
Plug the purple USB update device into the USB port below and behind the audio unit near the driver's knee area.
NOTE: The previous orange USB tool (p/n 07AAZ-TBAA100) is to be destroyed and replaced by the new purple tool.

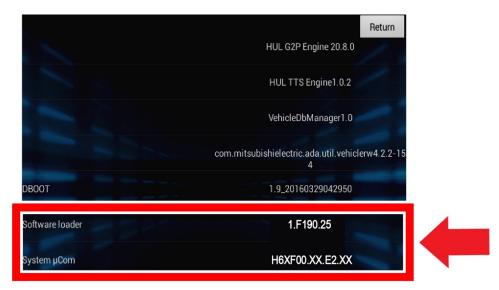
- 12. Scroll all the way to the bottom to: **Software loader** and **System μCom** and check the versions. The software should be updated to the following versions:
  - Software loader : 1.F190.25
  - System μCom : H6XF00.XX.E2.XX (the X values are different depending on model)

HUL G2P Engine 20
	HUL TTS Engine1.0.2
	VehicleDbManager1.0
	com.mitsubishielectric.ada.util.vehiclerw4.2.2-15 4
DBOOT	1.9_20160329042950
Software loader	1.F190.25
System µCom	H6XF00.XX.E2.XX

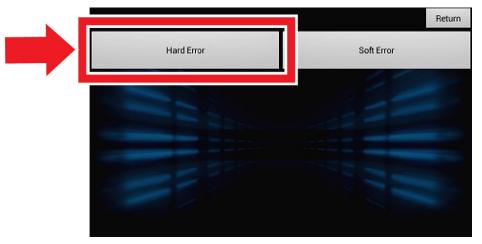
16. Select Hard Error.

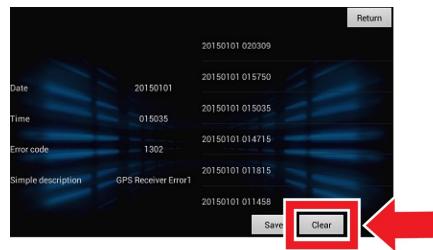
17. Select Clear.

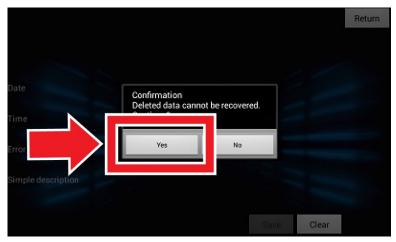
18. Select Yes.

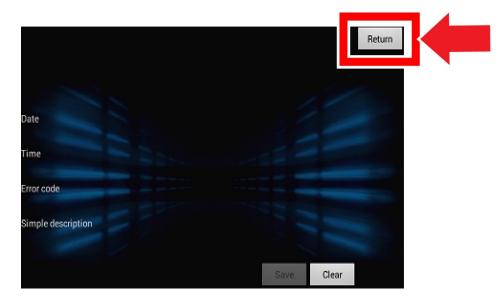
19. Select **Return** 5 times to go back to the home screen.
